# ***In Vitro* Investigation into the use of Dual Mobility for Partial Revision of a Failed Metal Hip Resurfacing**

**Elaine Lovelady**

Thesis presented for the degree of  
Doctor of Philosophy

School of Engineering and Computing Sciences

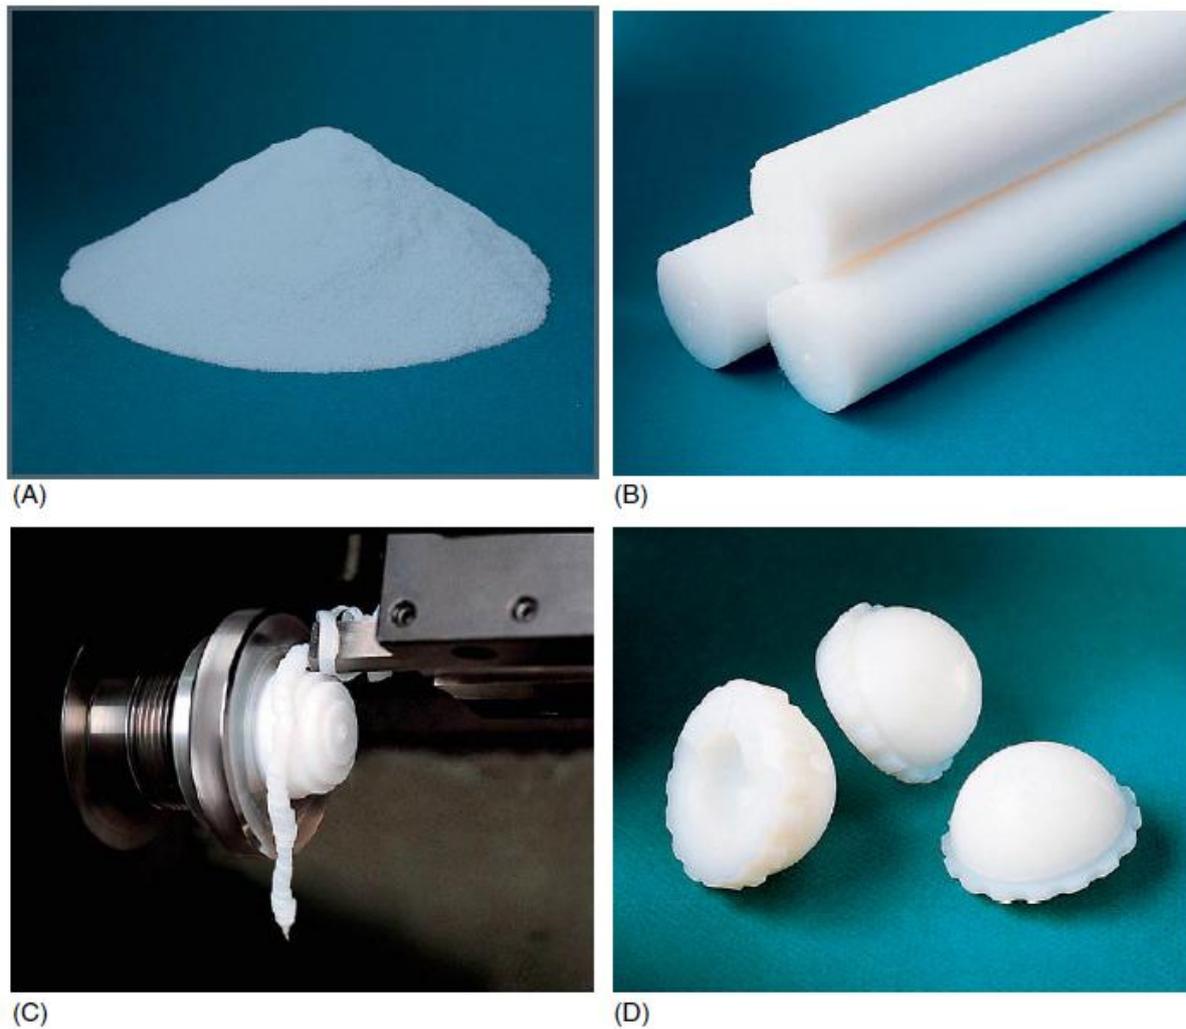
**Figure 2.4: Production of UHMWPE acetabular cups. A: UHMWPE resin powder. B: Semi-finished UHMWPE rods that have been consolidated from the resin powder. C: Machining of the UHMWPE rods on a lathe. D: UHMWPE acetabular cups after machining. Images from Kurtz *et al.* 2009 [30].**

In order to produce UHMWPE acetabular cups, ethylene gas must be polymerised to form UHMWPE in the form of a resin powder which is then consolidated into sheets or rods and machined into its final shape, as shown in [30].

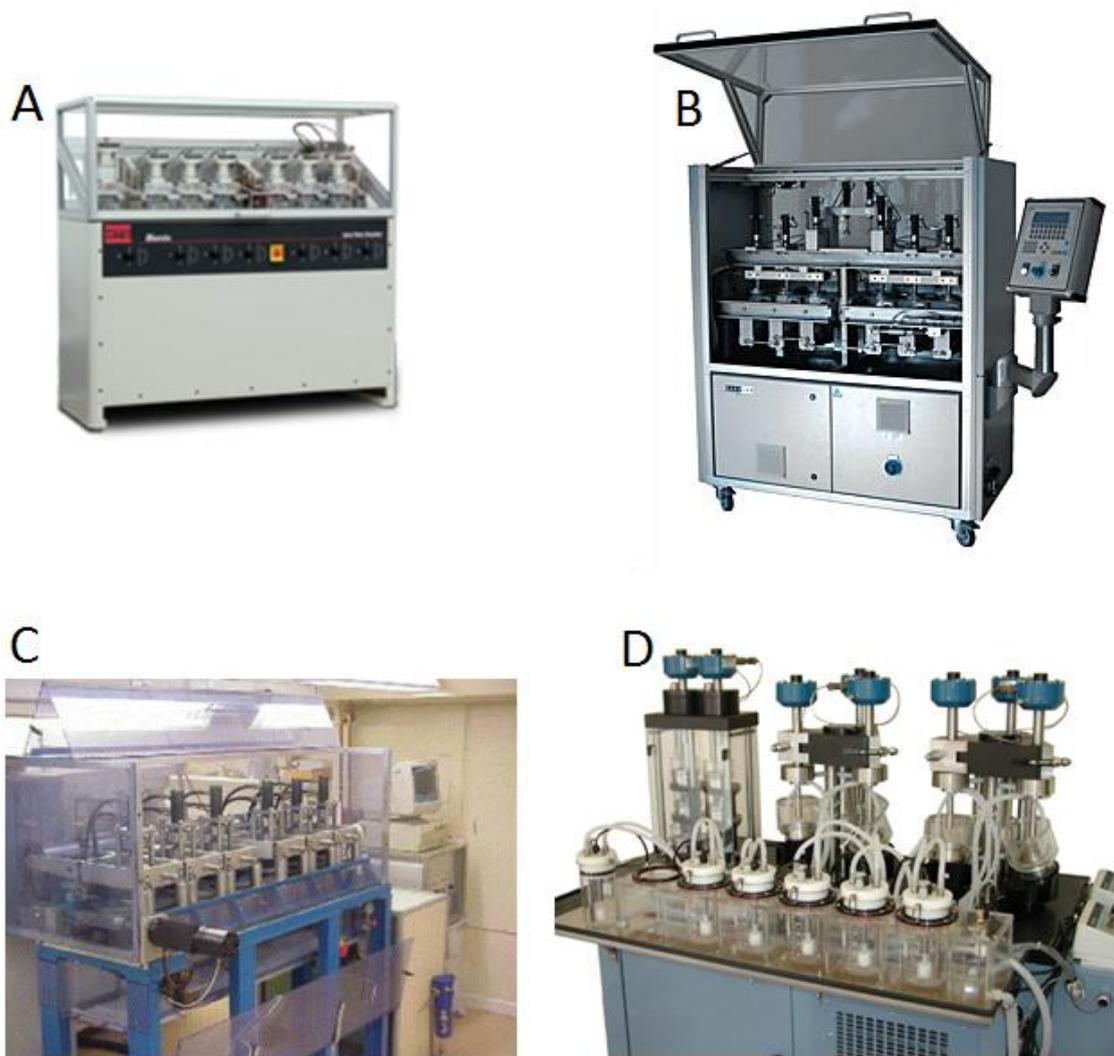
**Figure 2.16: Images of simulators used for *in vitro* mechanical testing of orthopaedic implants. A: MTS-Bionix Hip Simulator, B: Endolab Hip Simulator, C: Leeds Mark II Hip Simulator, D: Shore Western Hip Simulator.**

Images from four of the simulators described in Table 2.3 can be seen in Figure 2.16. The *in vitro* mechanical testing of orthopaedic implants carried out during this project utilised the Durham Mark II hip simulator and the ProSim hip simulator. Calonijs *et al.* [109] showed both of these simulators to produce wear vectors comparable to ISO-14242-1. Images of the aforementioned simulators are provided later in Chapter 4. ISO 14242-1 is provided in the Appendix. The standard specifies the relative angular movement between articulating components, the pattern of the applied force, speed and duration of testing for wear testing of hip joint prosthesis. Figure 2.17 shows the variation with time of angular movement to be applied to the femoral test specimen in accordance with ISO 14242-1.

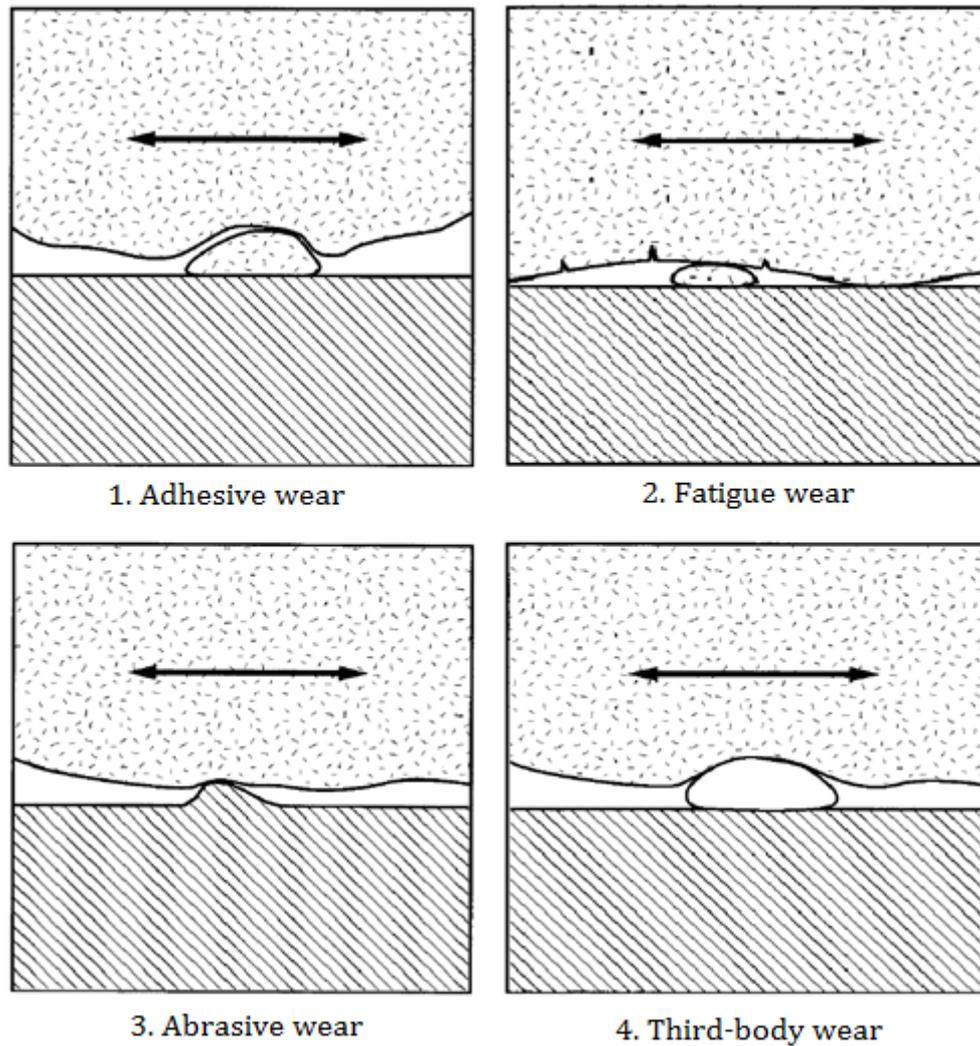
Figure 2.20: Common wear mechanisms, Wright *et al.* 2001 [159].

Third-body particles act in the same way as an asperity of a harder material in abrasive wear by removing material from its path.

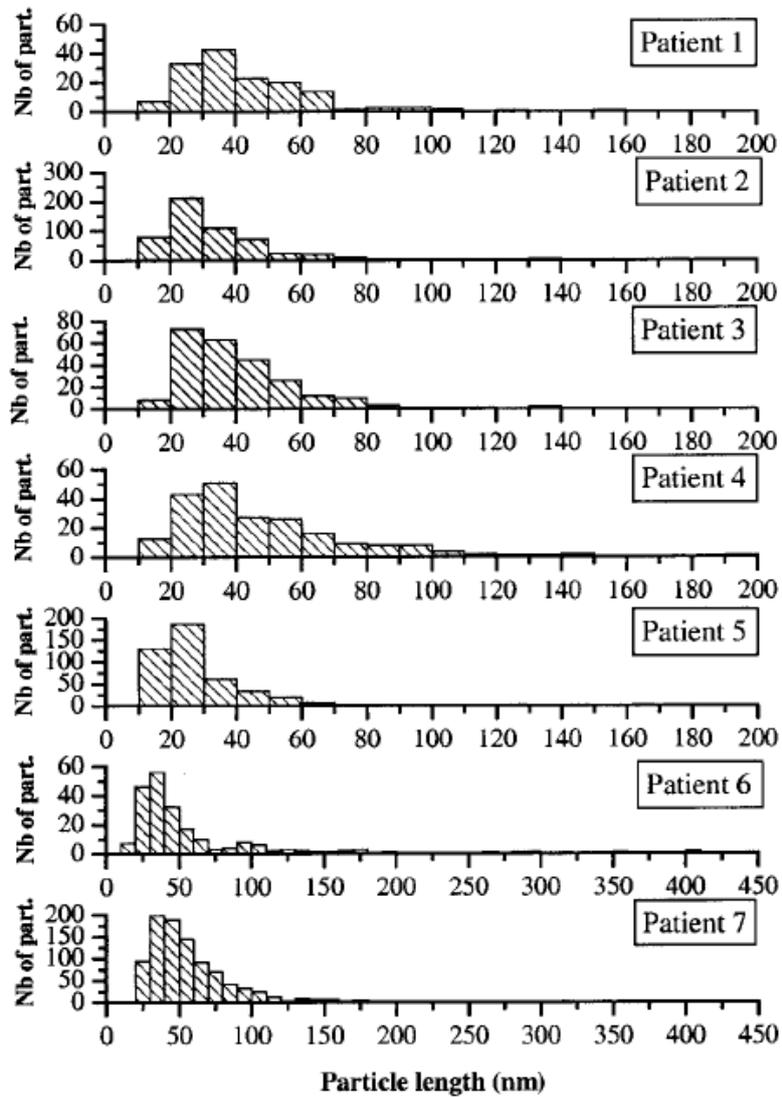
Figure 2.21: Length of particles isolated from tissue samples collected from different periprosthetic capsular sites, measured by image analysis of TEM micrographs, Catelas *et al.* 2004 [183].

Metal wear particles released from artificial hip implants are also phagocytised by macrophages that accumulate around the implant, in the periprosthetic tissues and local bone marrow [182]. Metal wear debris are typically much smaller than polyethylene wear particles and are nanometre in size, see Figure 2.21 [183].

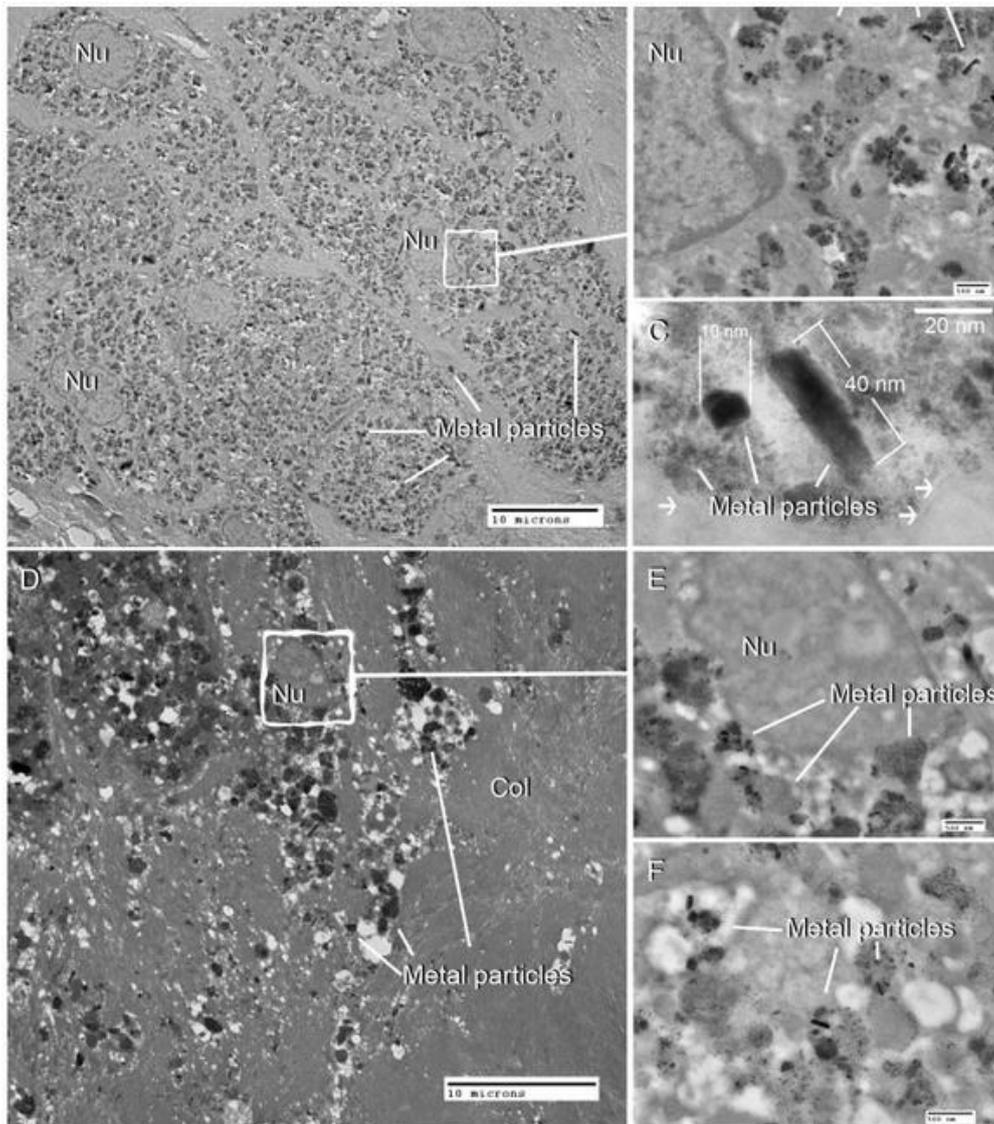
**Figure 2.23: TEM micrographs showing the presence of metal wear nanoparticles in living macrophages and in tissue taken at biopsy from a pseudotumor, Xia *et al.* 2011 [188].**

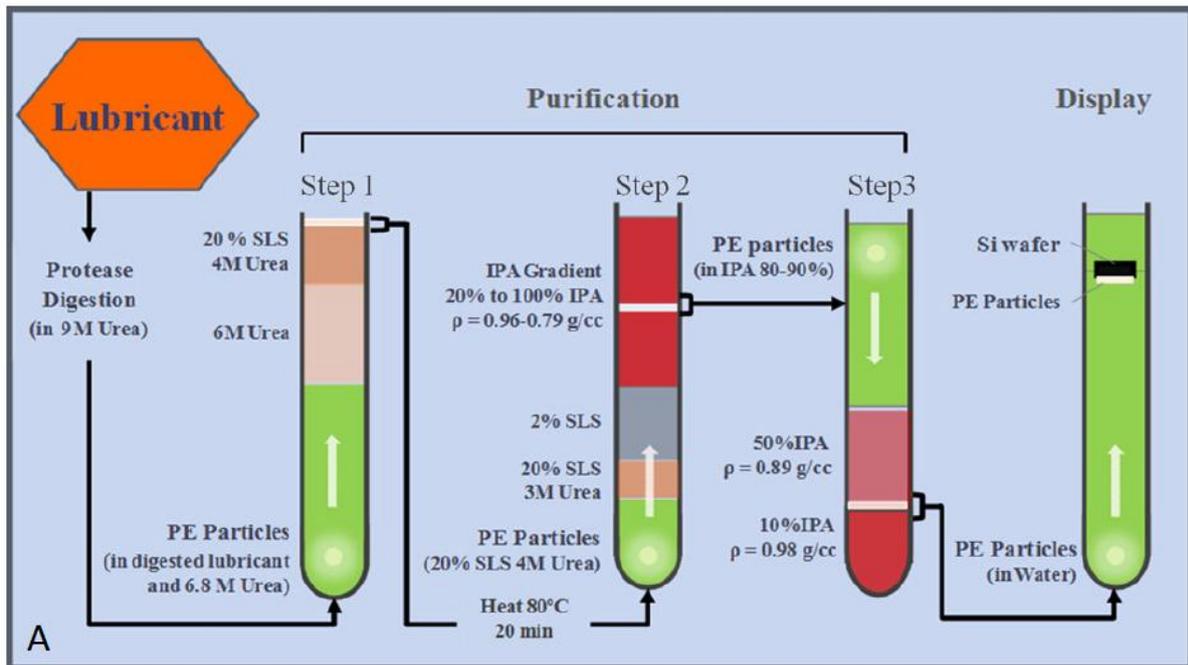
Figure 2.24: A: Schematic diagram showing the SWD Protocol, B: polyethylene wear debris displayed on silicon wafer, C: magnified polyethylene wear debris, Billi *et al.* 2012 [194].

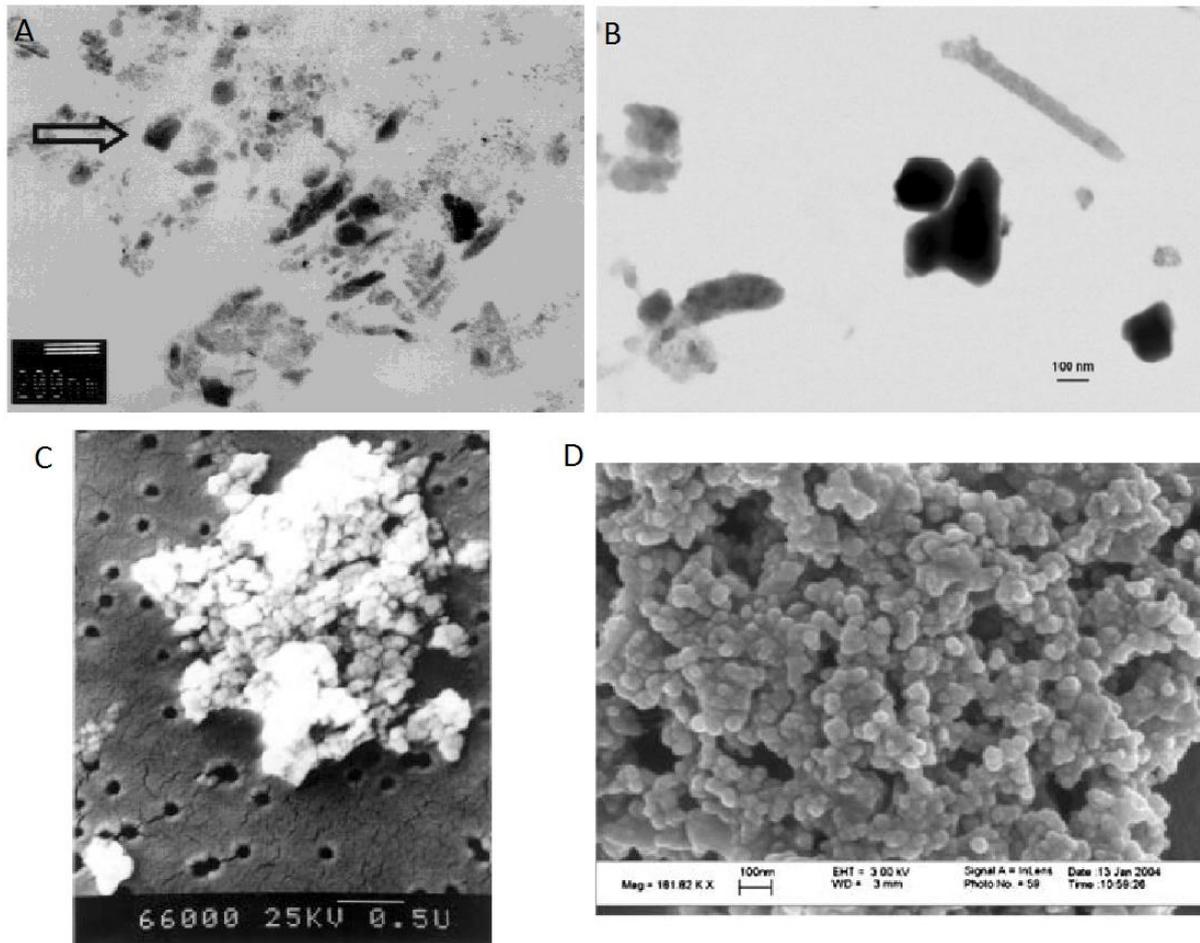
**Figure 2.25:** Images of isolated metal wear particles from A: Catelas *et al.* 2001 [201] (TEM image). B: Billi *et al.* 2011 [203] (TEM image) The darker particles indicate presence of cobalt. C: Tipper *et al.* 1999 [23] (SEM image). D. Brown *et al.* 2007 [144] (SEM image).

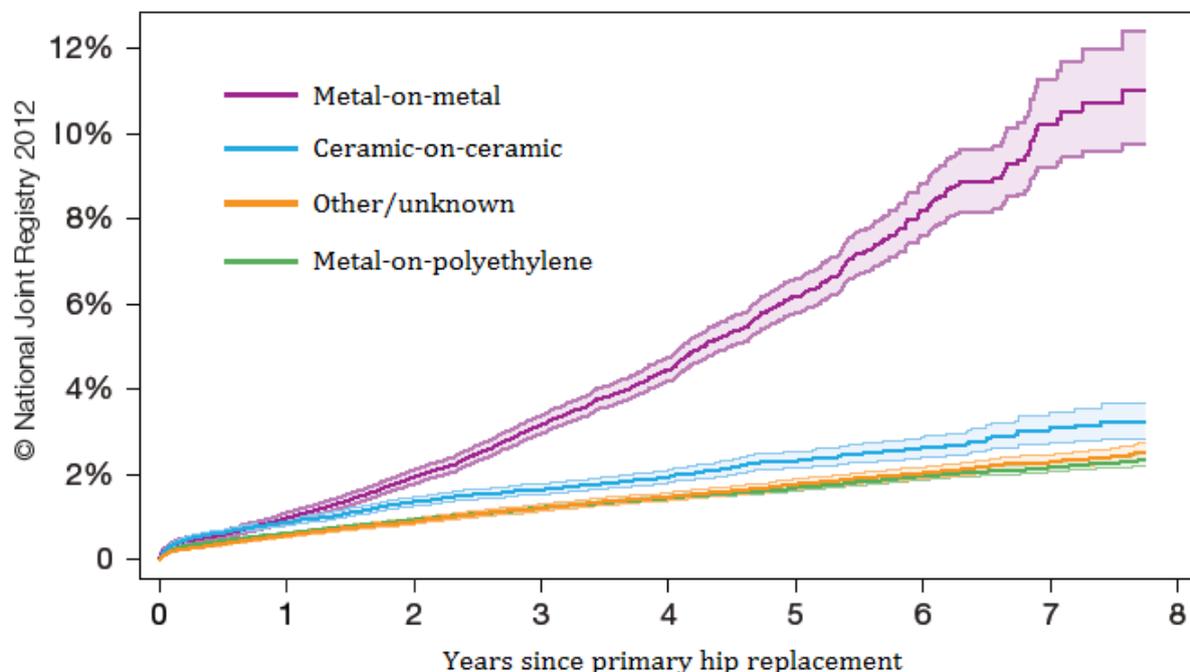
Figure 2.26: Risk of revision by bearing surface (cumulative hazard with 95% confidence intervals), UK National Joint Registry [66].

About 40,000 primary THAs are performed in NHS hospitals in England with about 4,000 revision procedures being performed each year [210]. Figure 2.26 is taken from the UK Joint Registry 2012 [66] and shows the risk of revision according to the primary bearing surface. A large number of patients are receiving THAs at a younger age, and also living longer, so it is important that the initial implant allows for revision. Revision surgery can involve either the revision of the acetabular component, with restoration of bone stock, or revision of the femoral component.

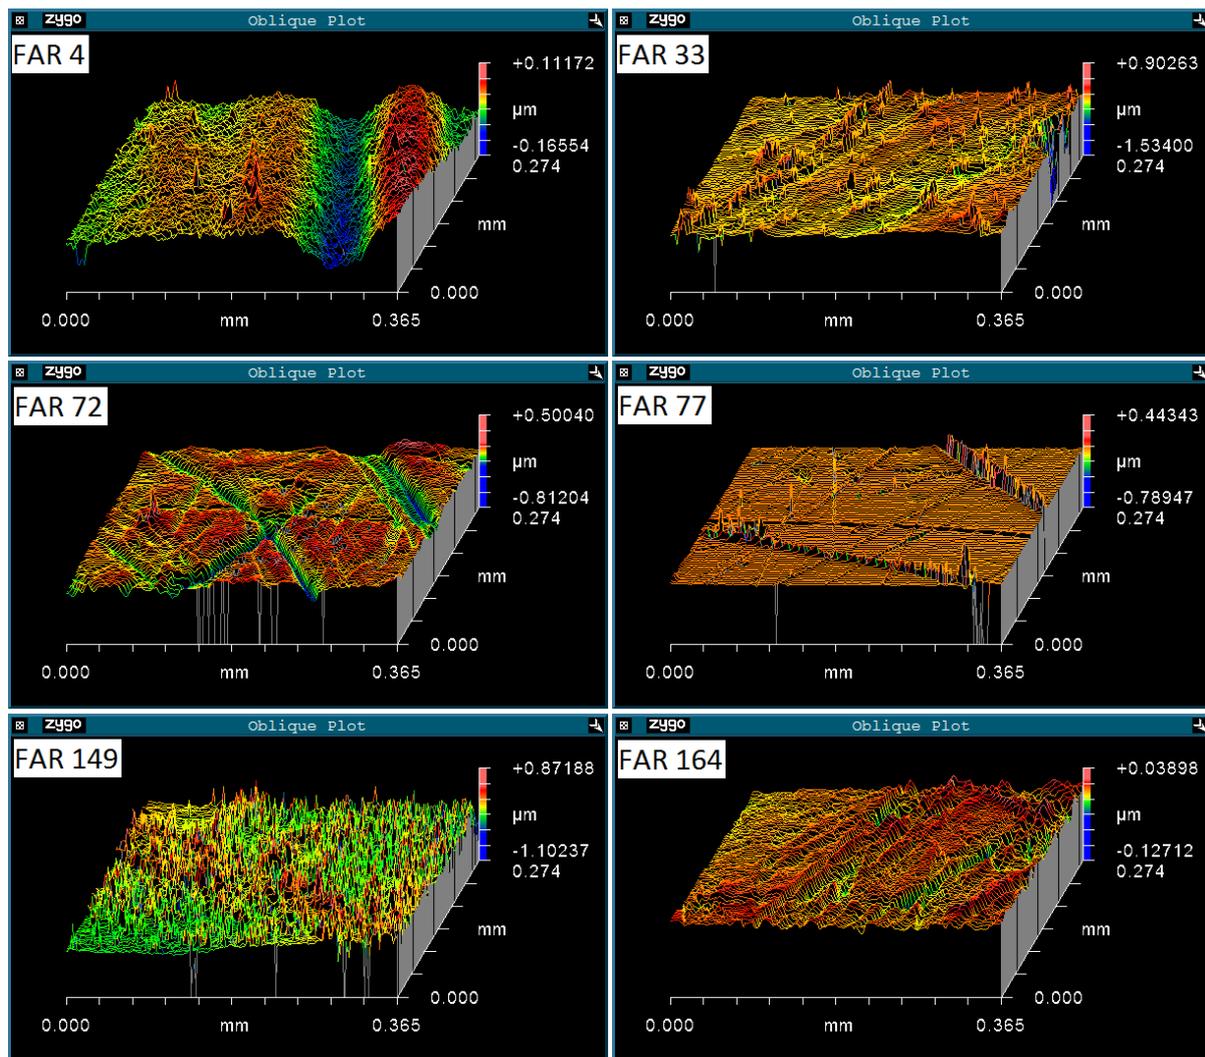
**Figure 3.5: Selection of surface profiles taken from retrieved femoral heads.**

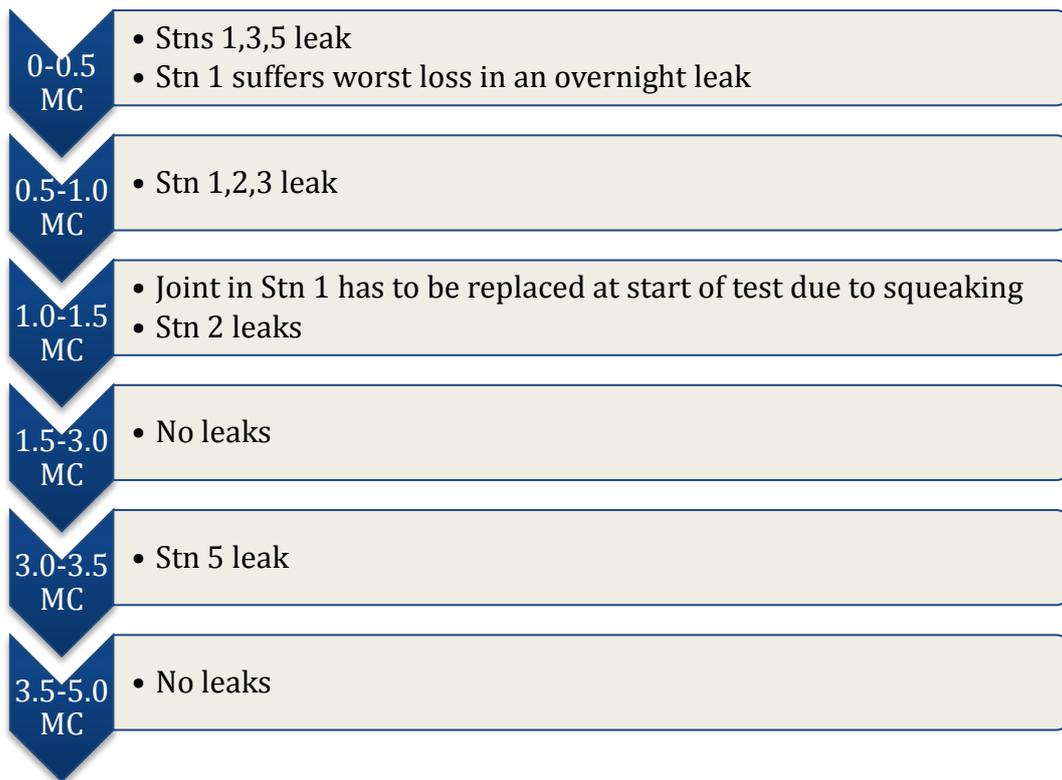
**Figure 4.11: Summary of complications with gaiters throughout 5 MC.**

During the test, only Station 1b and 4 did not suffer any leaks at all, so the wear data has been split into those that suffered leaks and those that did not. There is a considerable difference between the two sets of data and the change in lubrication conditions and mode of wear has had a significant effect on the rate of wear.

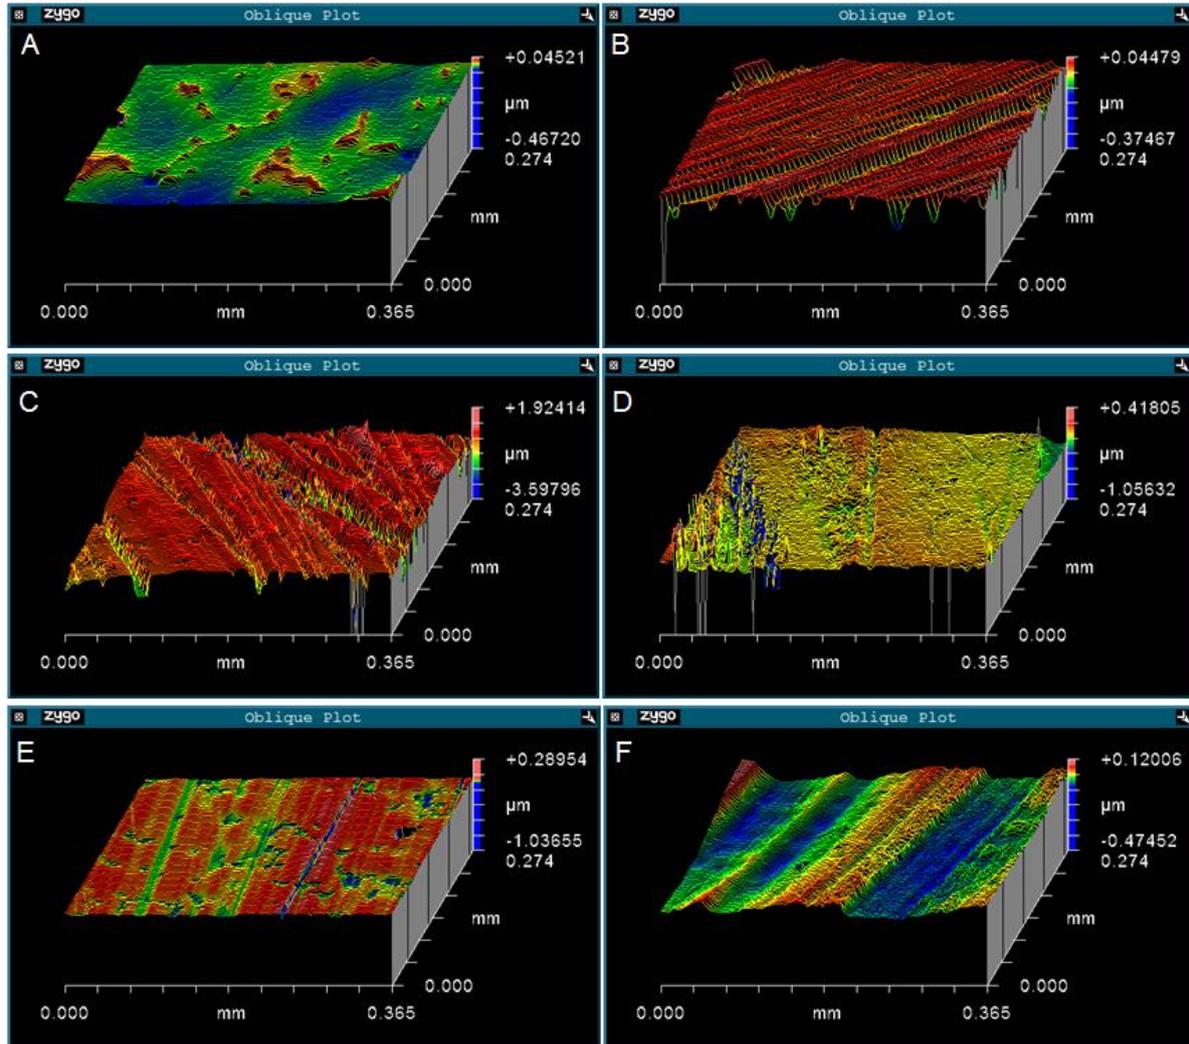
Figure 4.20: Surface profiles of femoral resurfacing heads imaged throughout this test. A: OMC from Station 1b, B: 5 MC from Station 1b, C: 5 MC from Station 2, D: 5 MC from Station 3, E: 5 MC from Station 4, F: 5 MC from Station 5.

Figure 4.20 and Figure 4.21 show a selection of zygo images showing 3D profiles of the surface of the femoral and acetabular components. The first is a typical image taken from the cups at 0 MC. The images that follow are taken after 5 MC from each station. The surface topography from the bearings in Stations 1b and 4, shown in images B and E from both Figure 4.20 and Figure 4.21, is much smoother than from the bearings that experienced leaks.

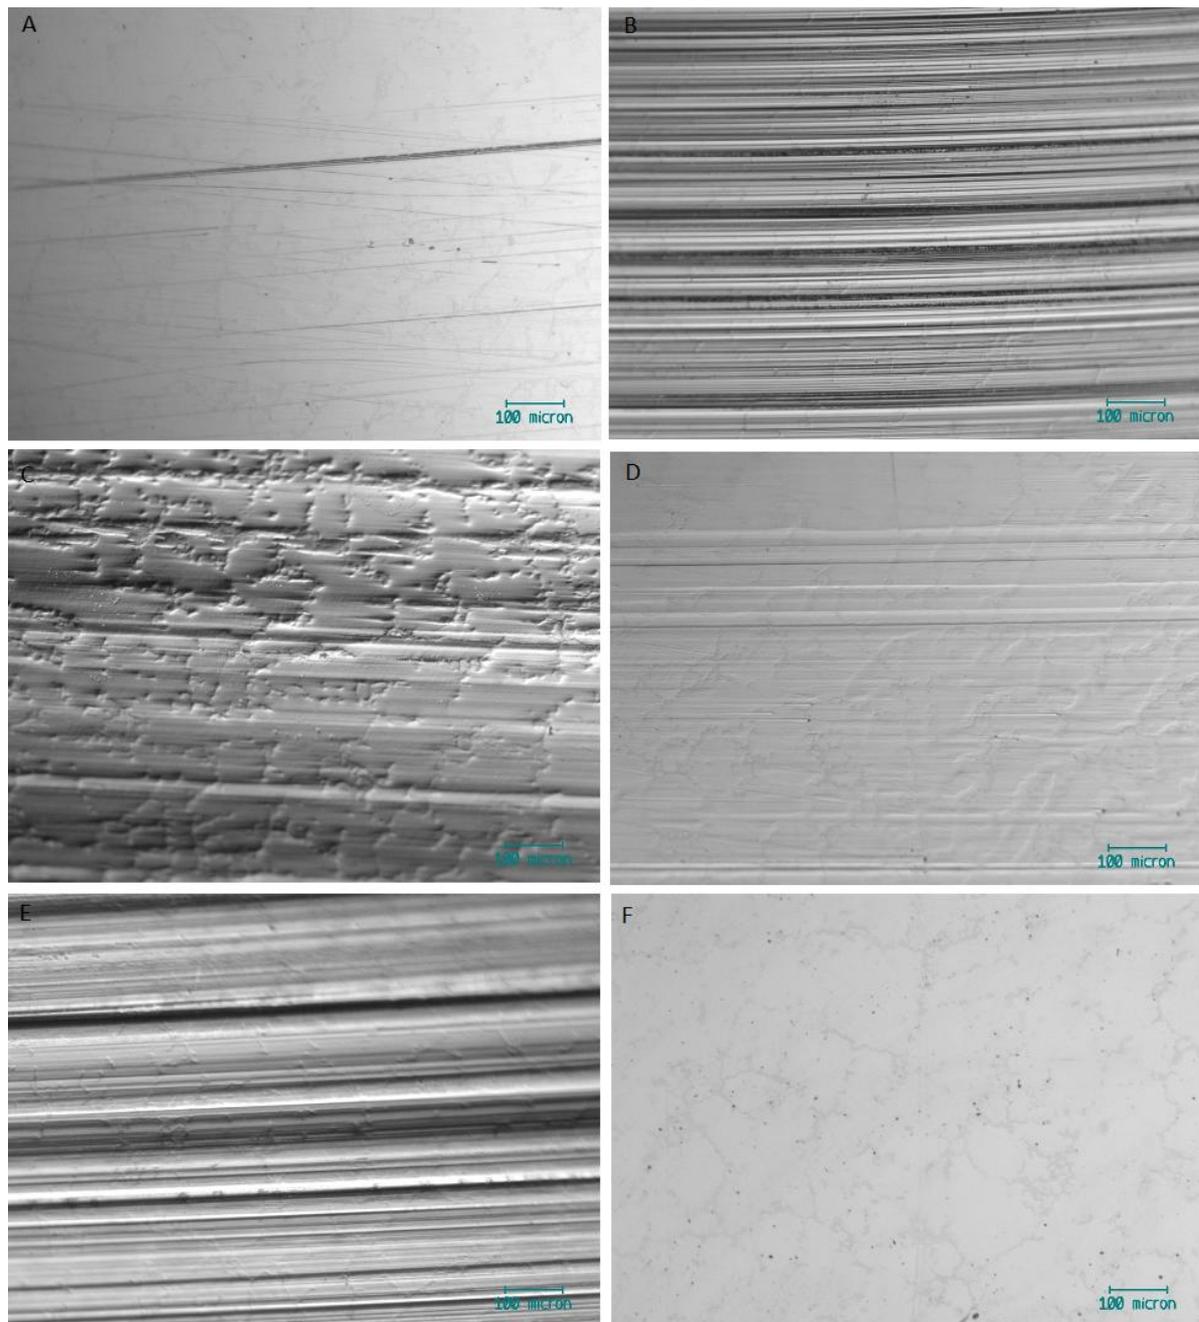
**Figure 4.24: Surface images taken after 5 MC of this test. A: Station 1b, B: Station 2, C: Station 3, D: Station 4, E: Station 5, F: the load control station.**

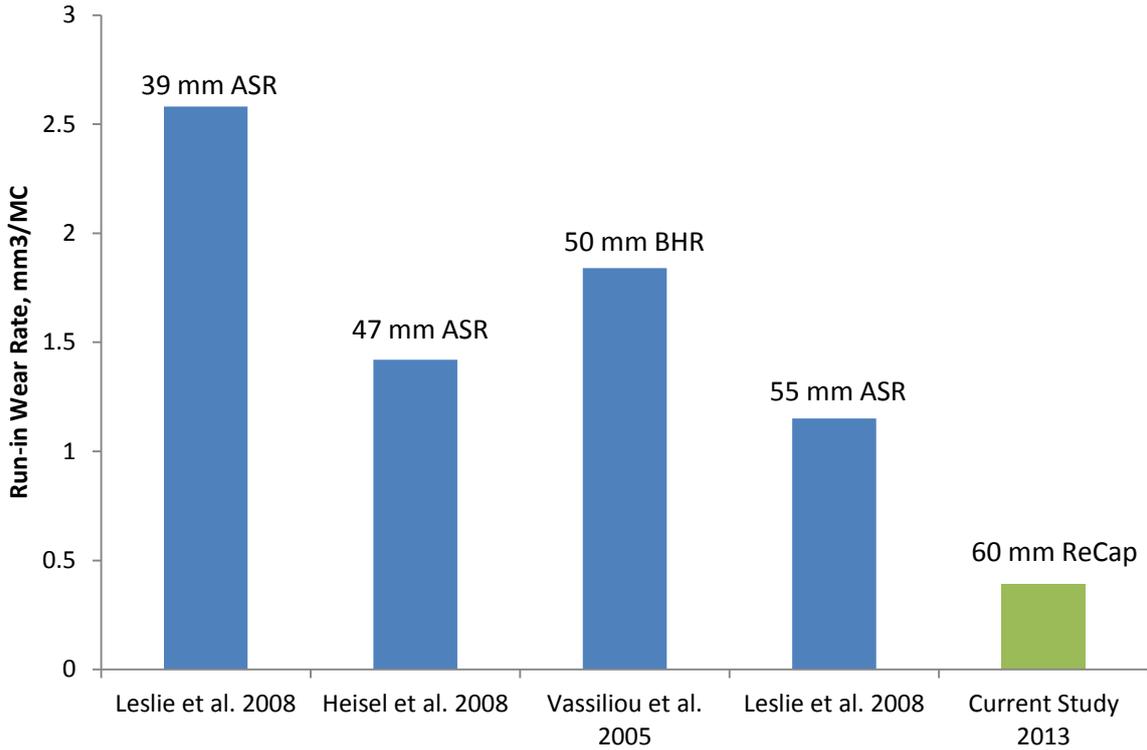
Figure 4.26: Comparison of the run-in wear data from Stns 1b and 4 with previously published simulator studies.

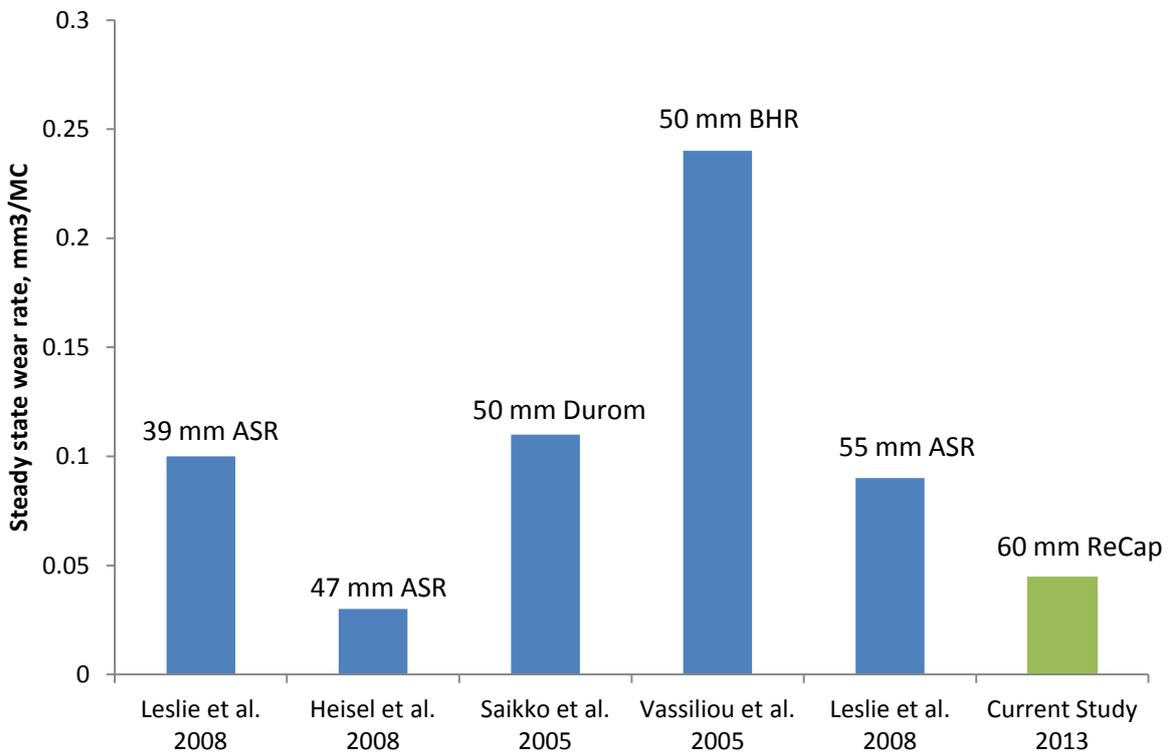
Figure 4.27: Comparison of the steady state wear data from Stns 1b and 4 with previously published simulator studies.

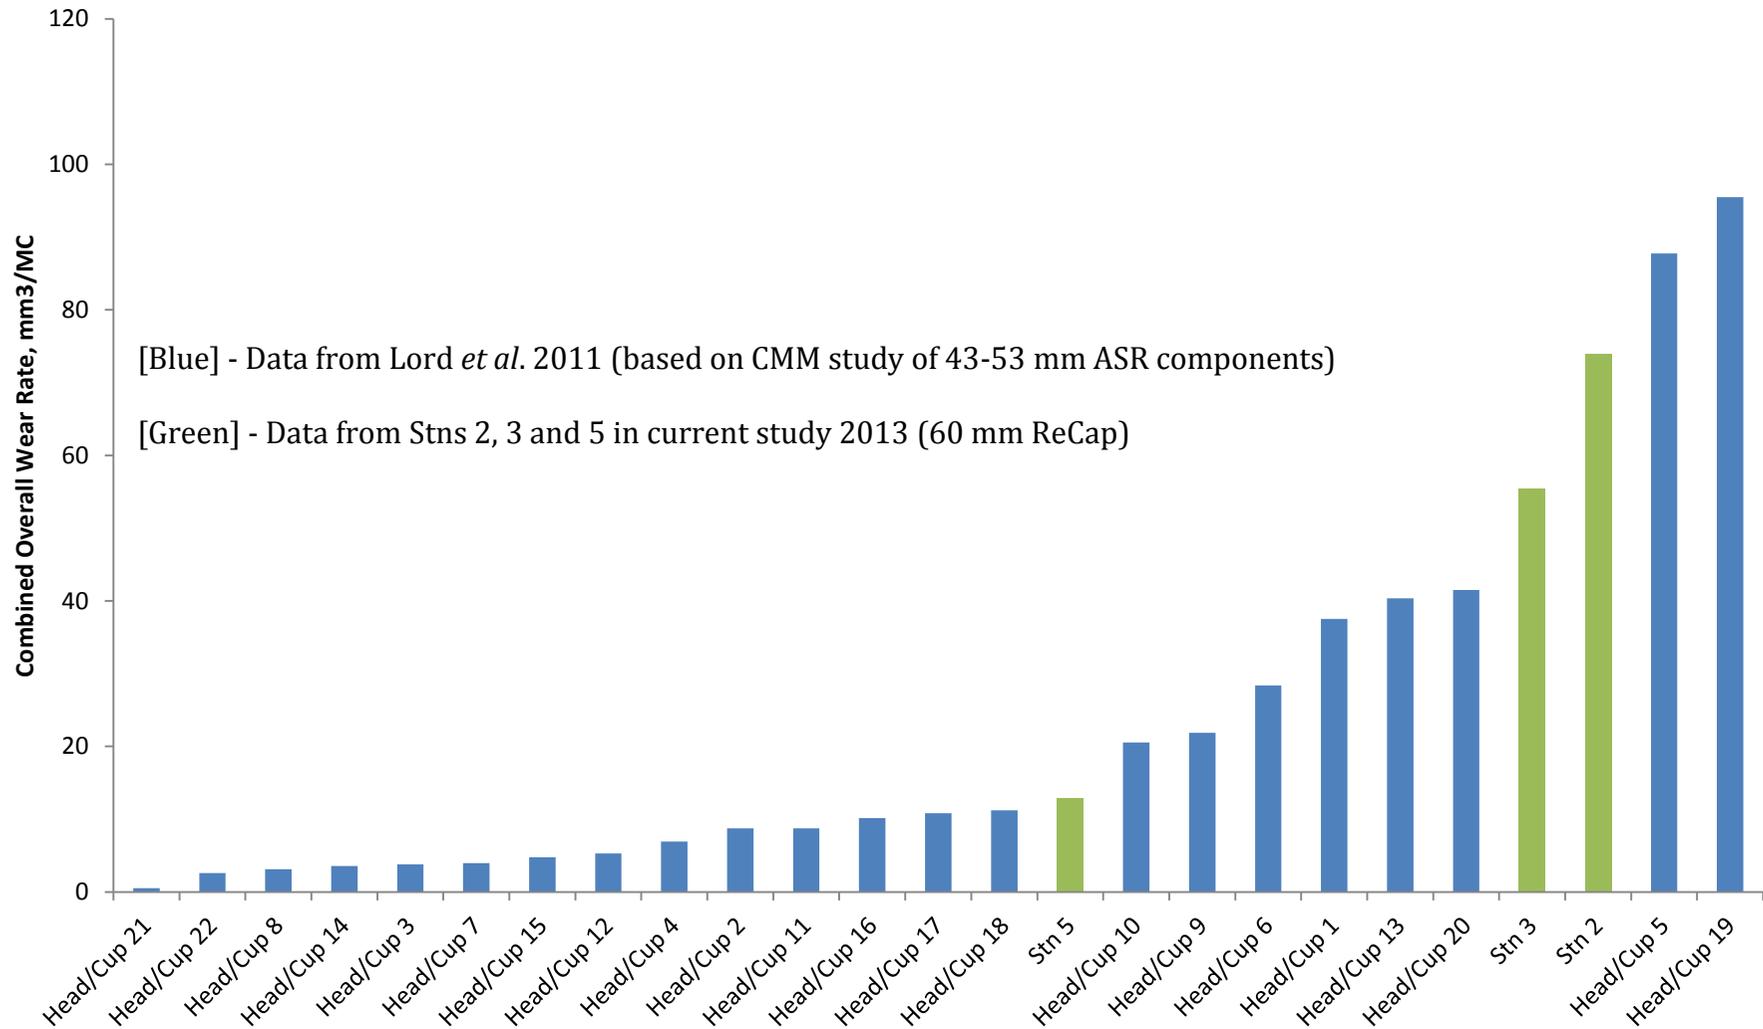
Figure 4.28: Comparison of the wear data from Stns 2, 3 and 5 with retrieval data published by Lord *et al.* [10].

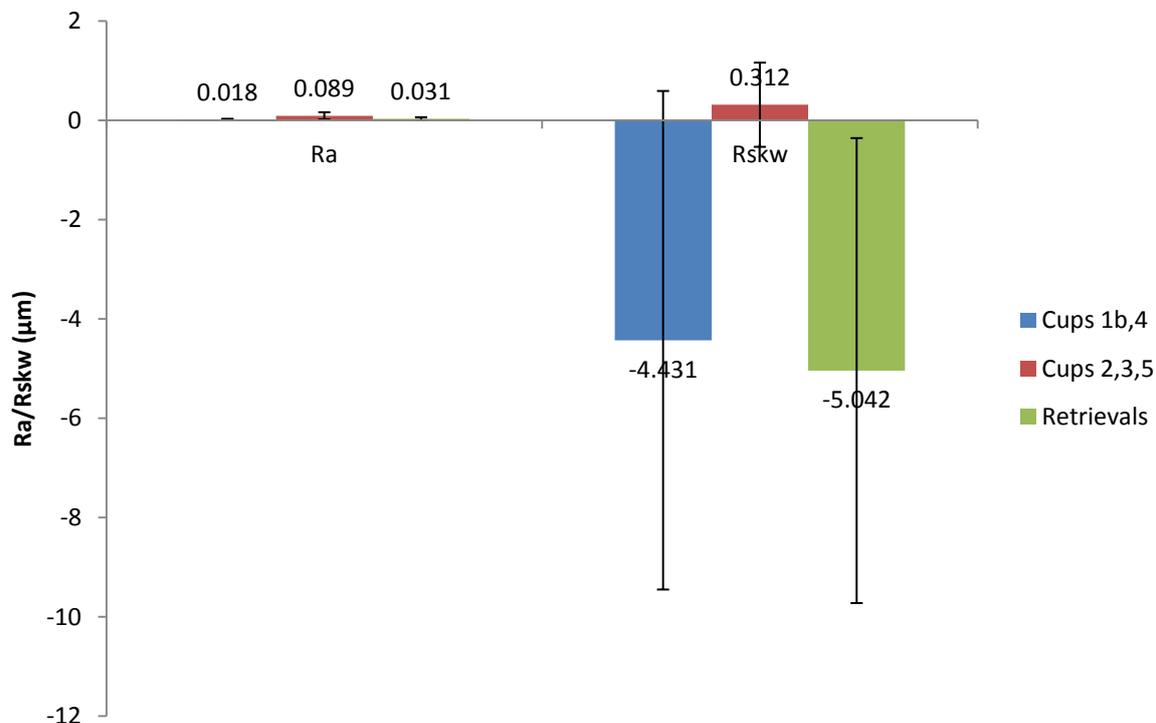
Figure 4.29: Zygo data showing average surface roughness (Ra) and skewness (Rskw) values across all test components in comparison to retrieved acetabular components.

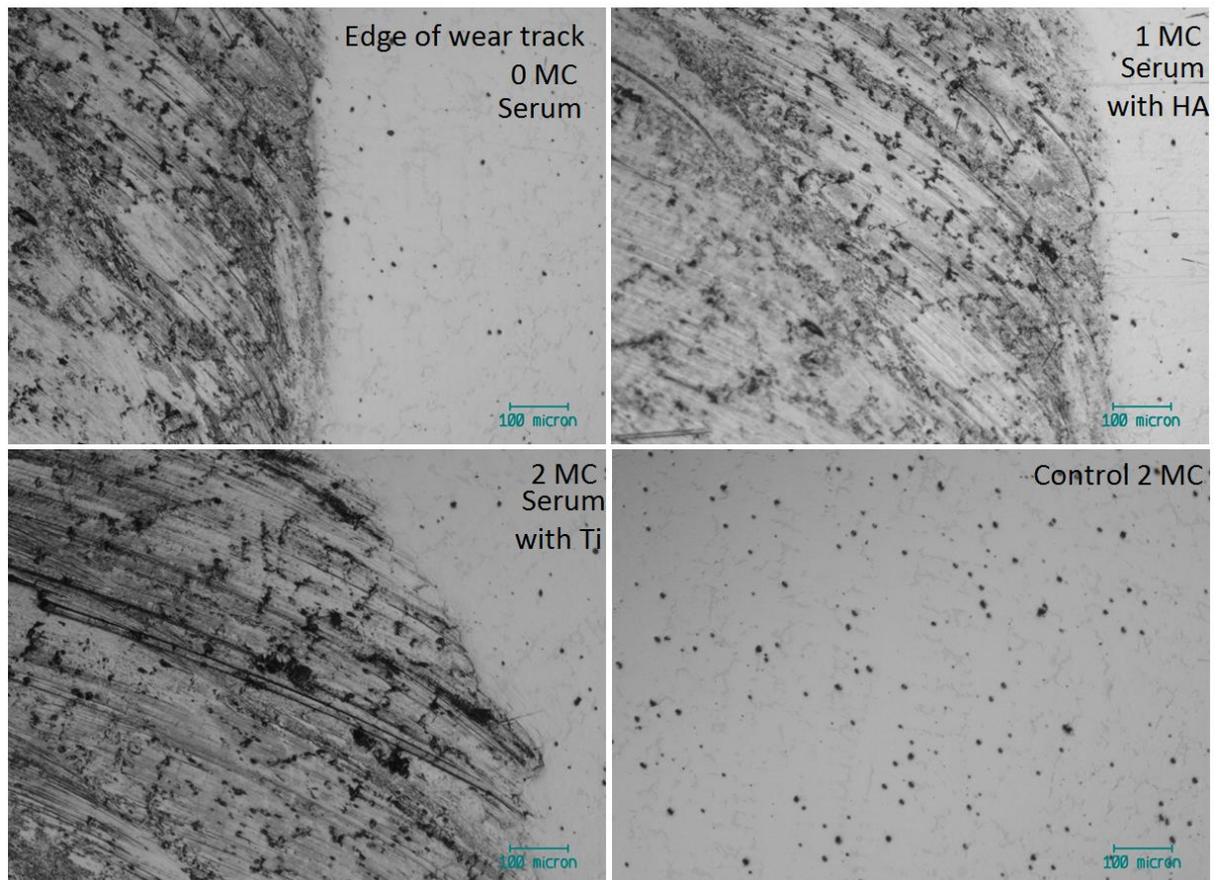
**Figure 4.38: The edge of wear track on plate 2 throughout test in comparison to the soak control.**

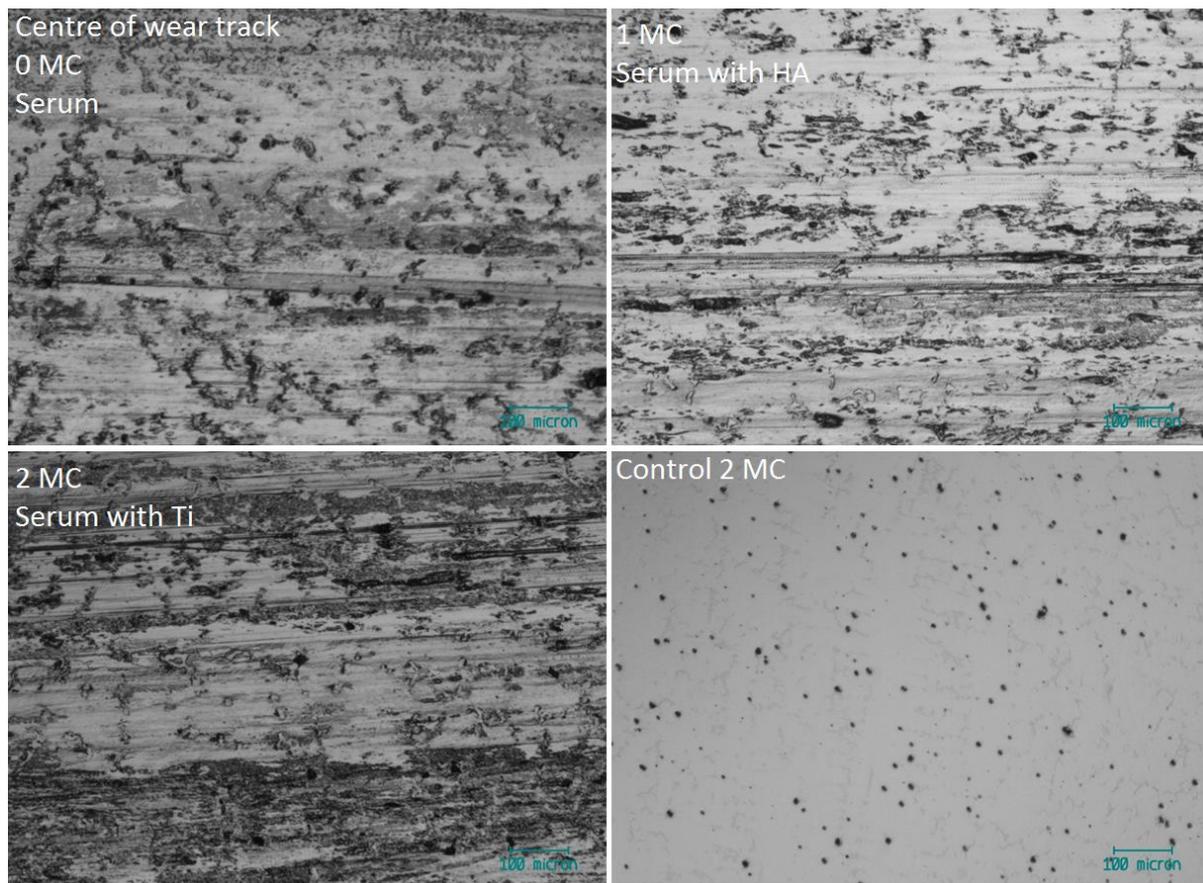
**Figure 4.39: The centre of the wear track on plate 1 throughout test in comparison to the soak control.**

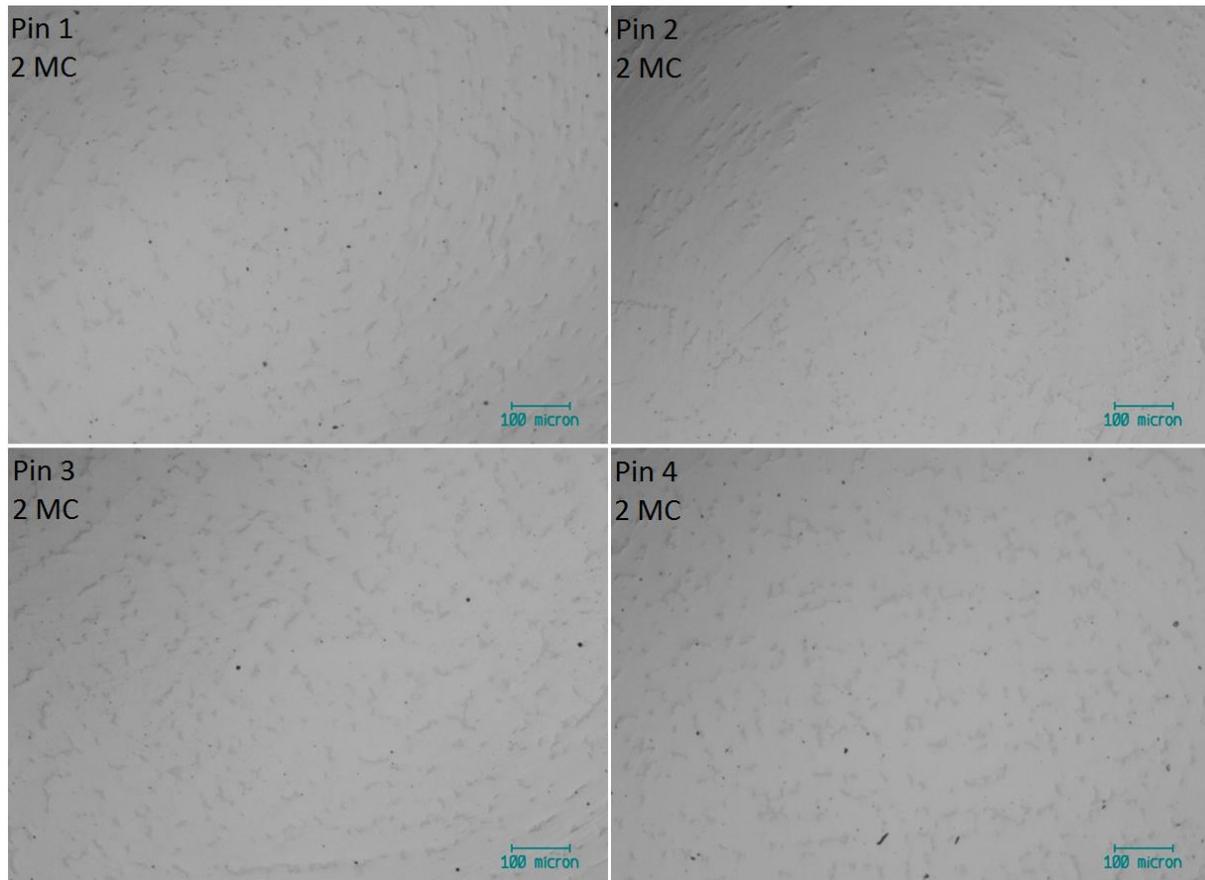
Figure 4.40: Centre of all active pins at 2 MC.
