# ***In Vitro* Investigation into the use of Dual Mobility for Partial Revision of a Failed Metal Hip Resurfacing**

**Elaine Lovelady**

Thesis presented for the degree of  
Doctor of Philosophy

School of Engineering and Computing Sciences

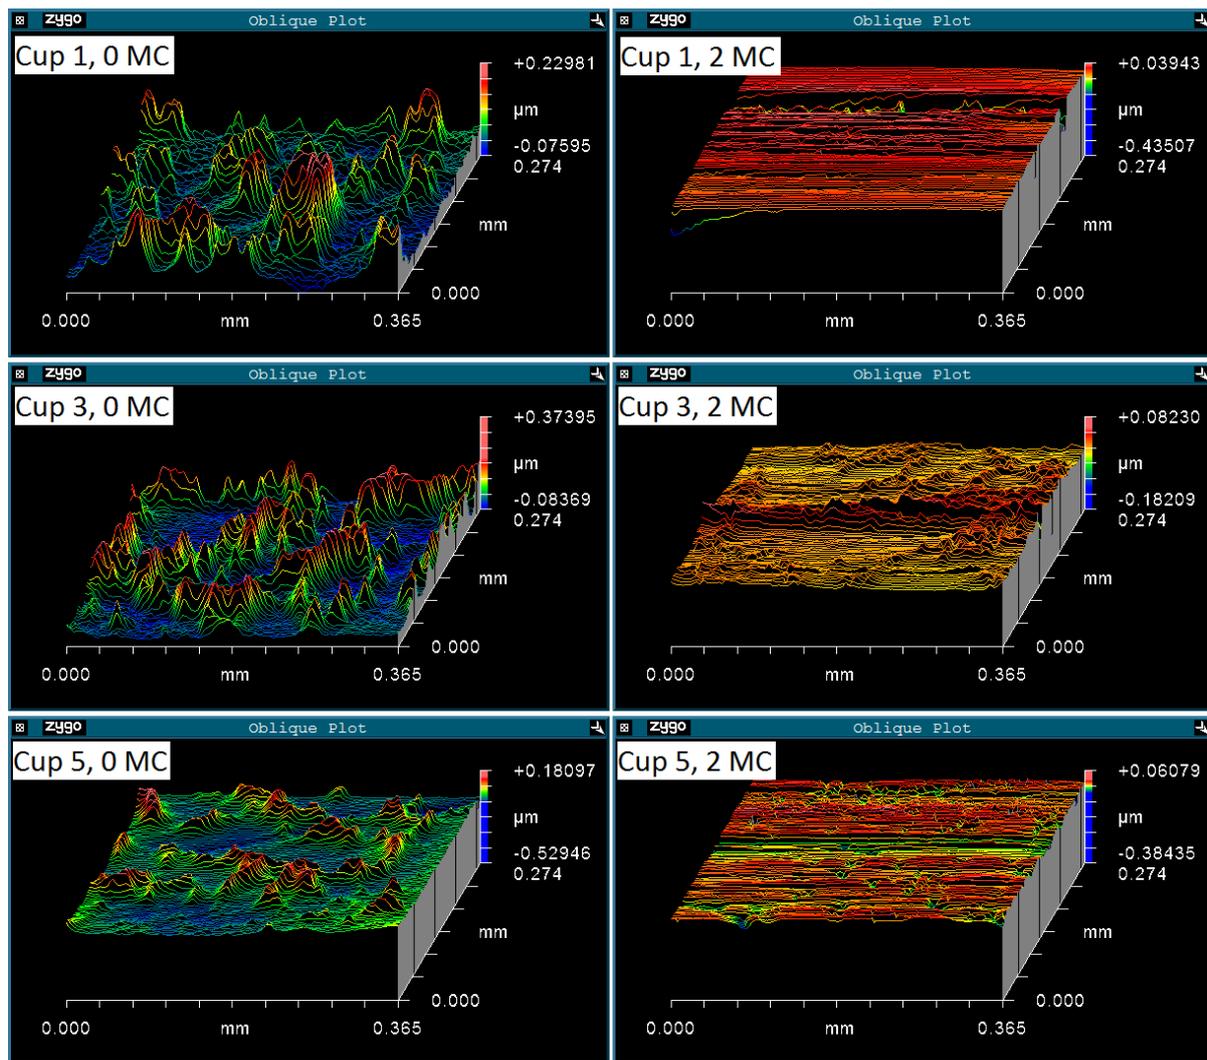
Figure 4.50: Comparison of surface profiles of the CoCrMo cups at the end of the dual mobility test with the resulting surface at the end of the third-body particle test.

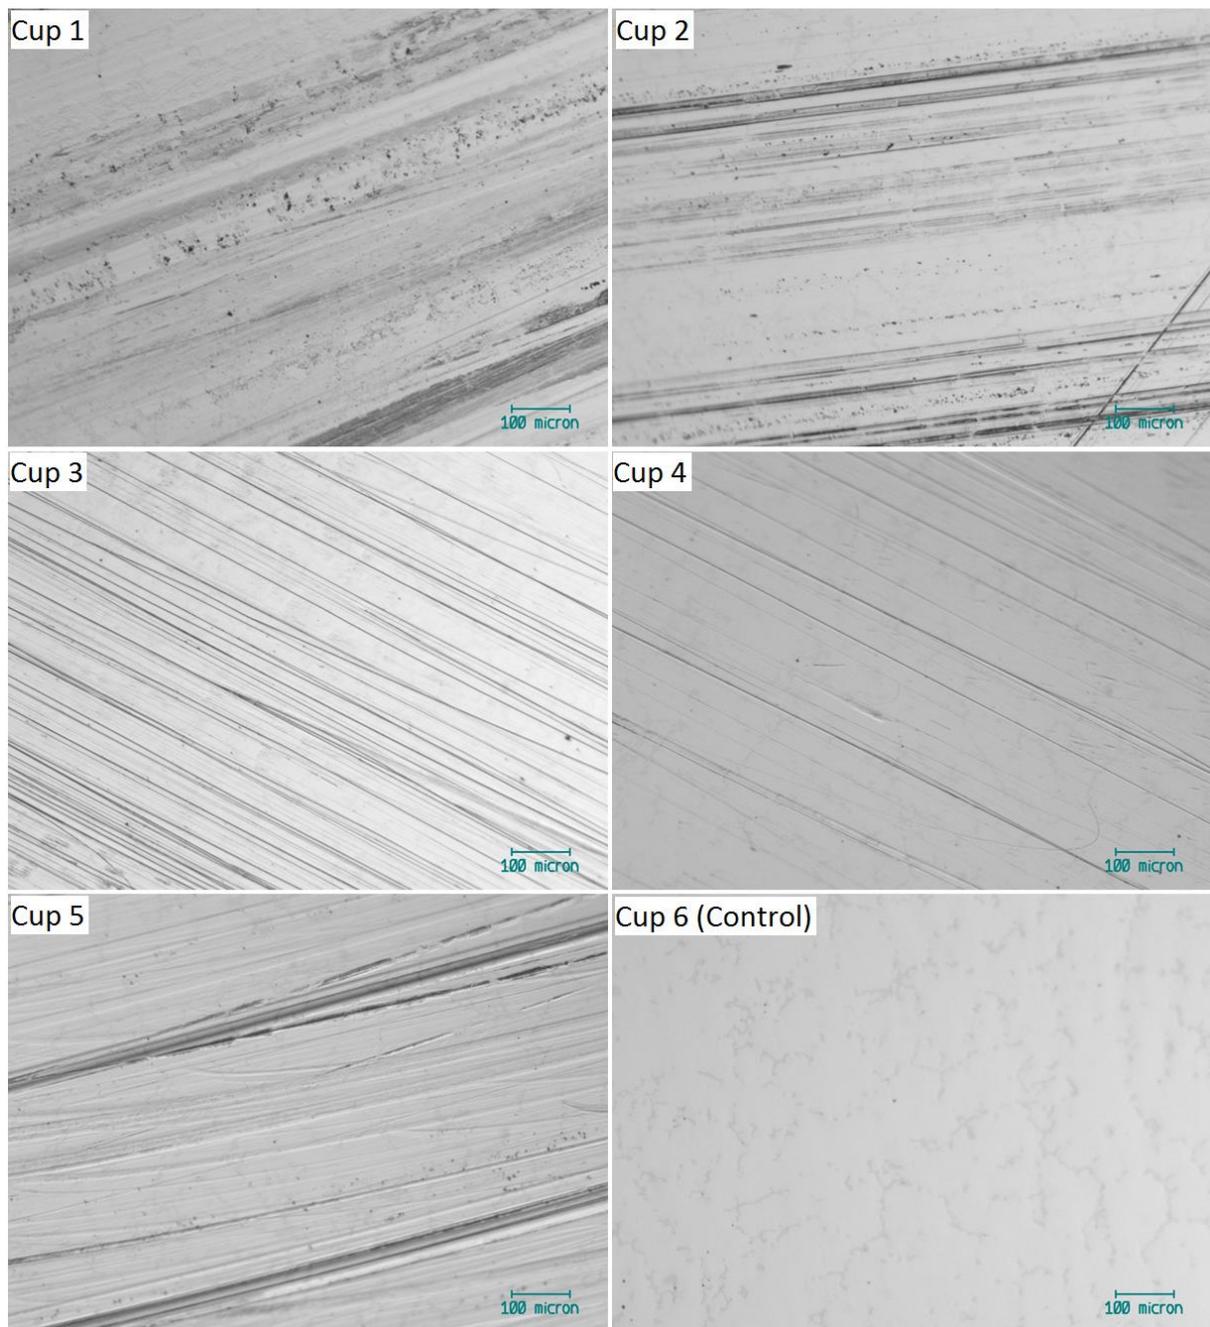
**Figure 4.52: Optical images taken within the wear patch of 60 mm CoCrMo cups after 0.5 MC (serum with HA).**

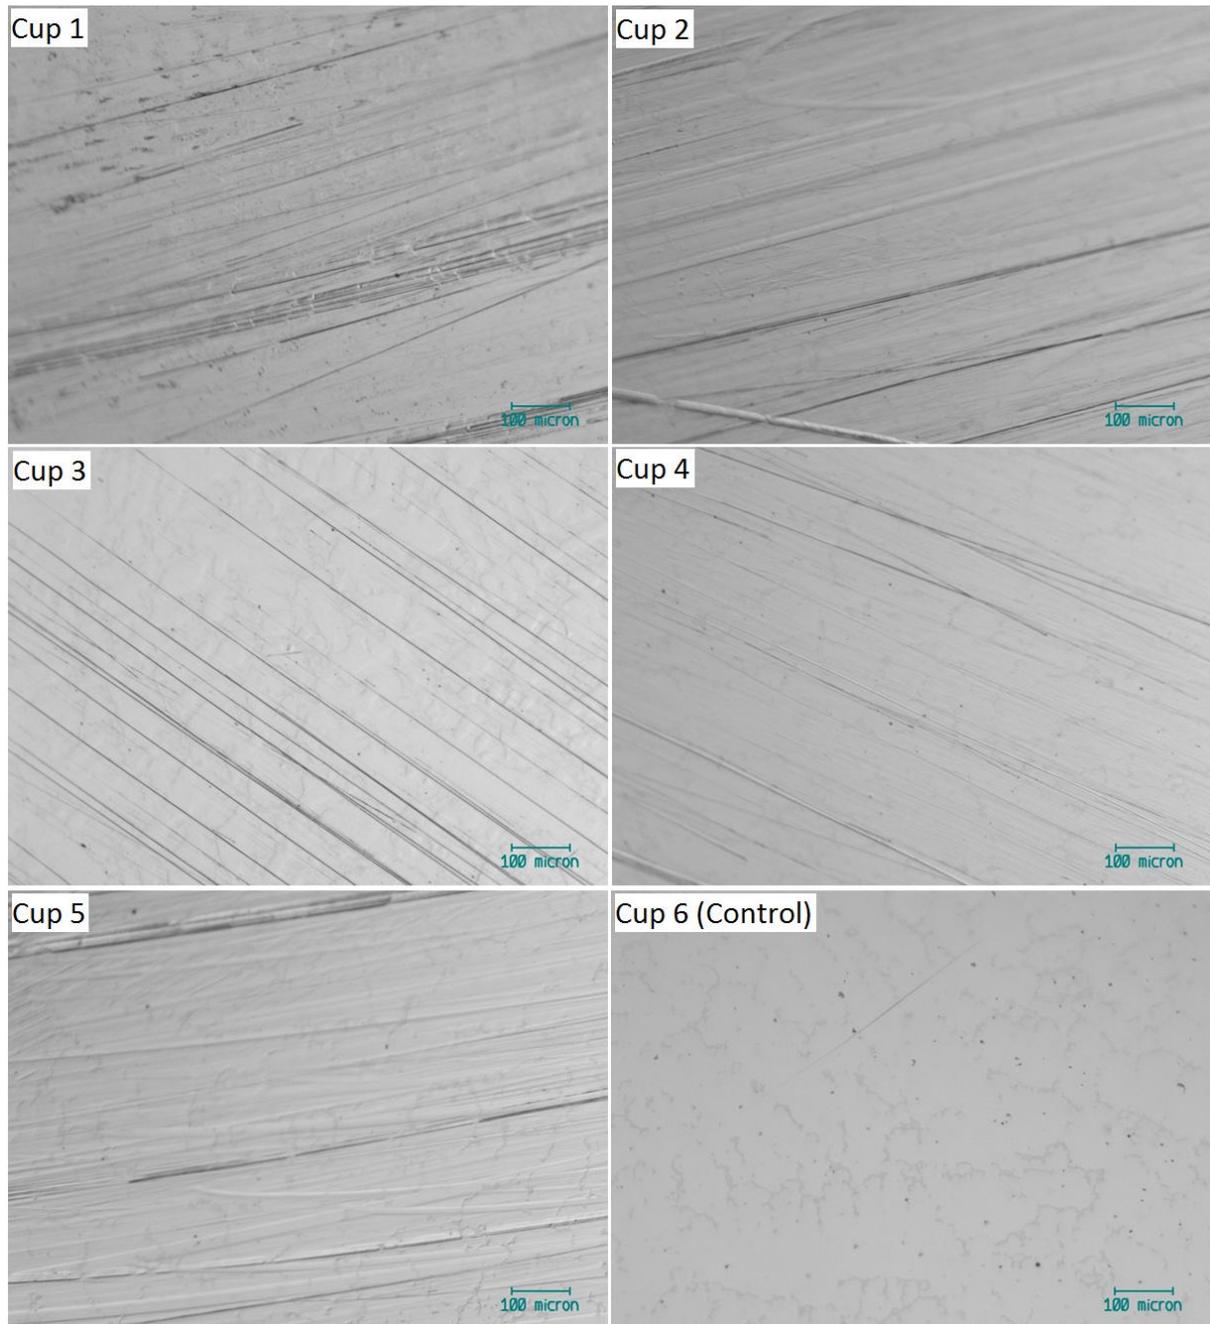
**Figure 4.53: Optical images taken within the wear patch of 60 mm CoCrMo cups after 1.0 MC (serum).**

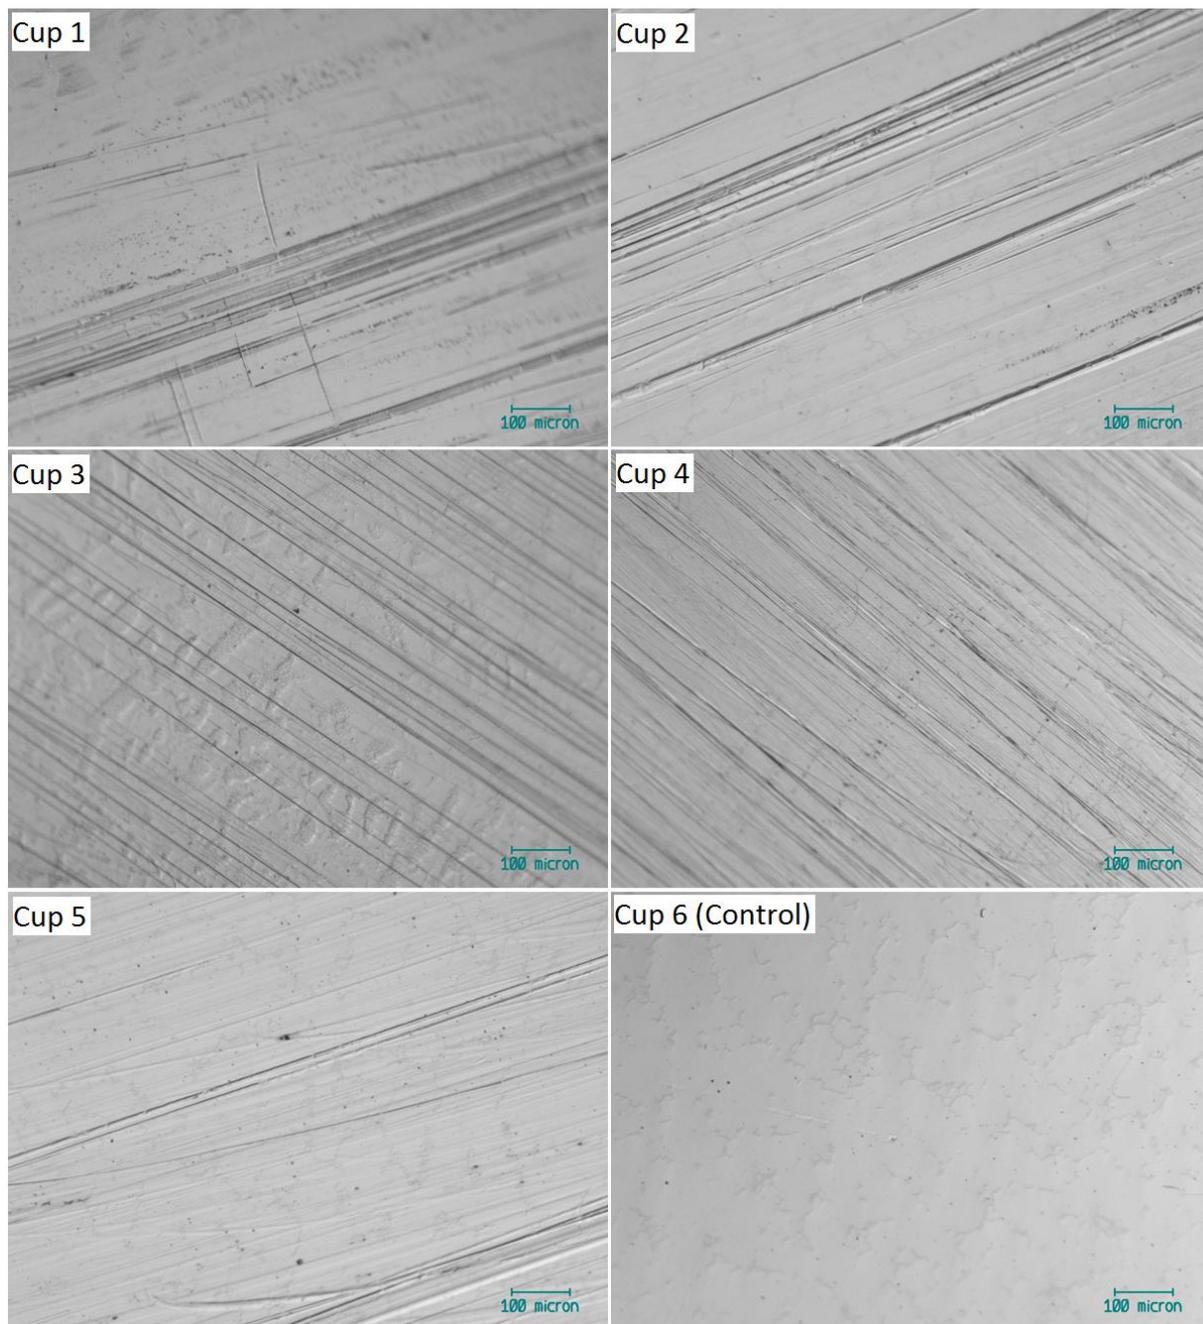
**Figure 4.54: Optical images taken within the wear patch of 60 mm CoCrMo cups after 1.5 MC (serum with Ti).**

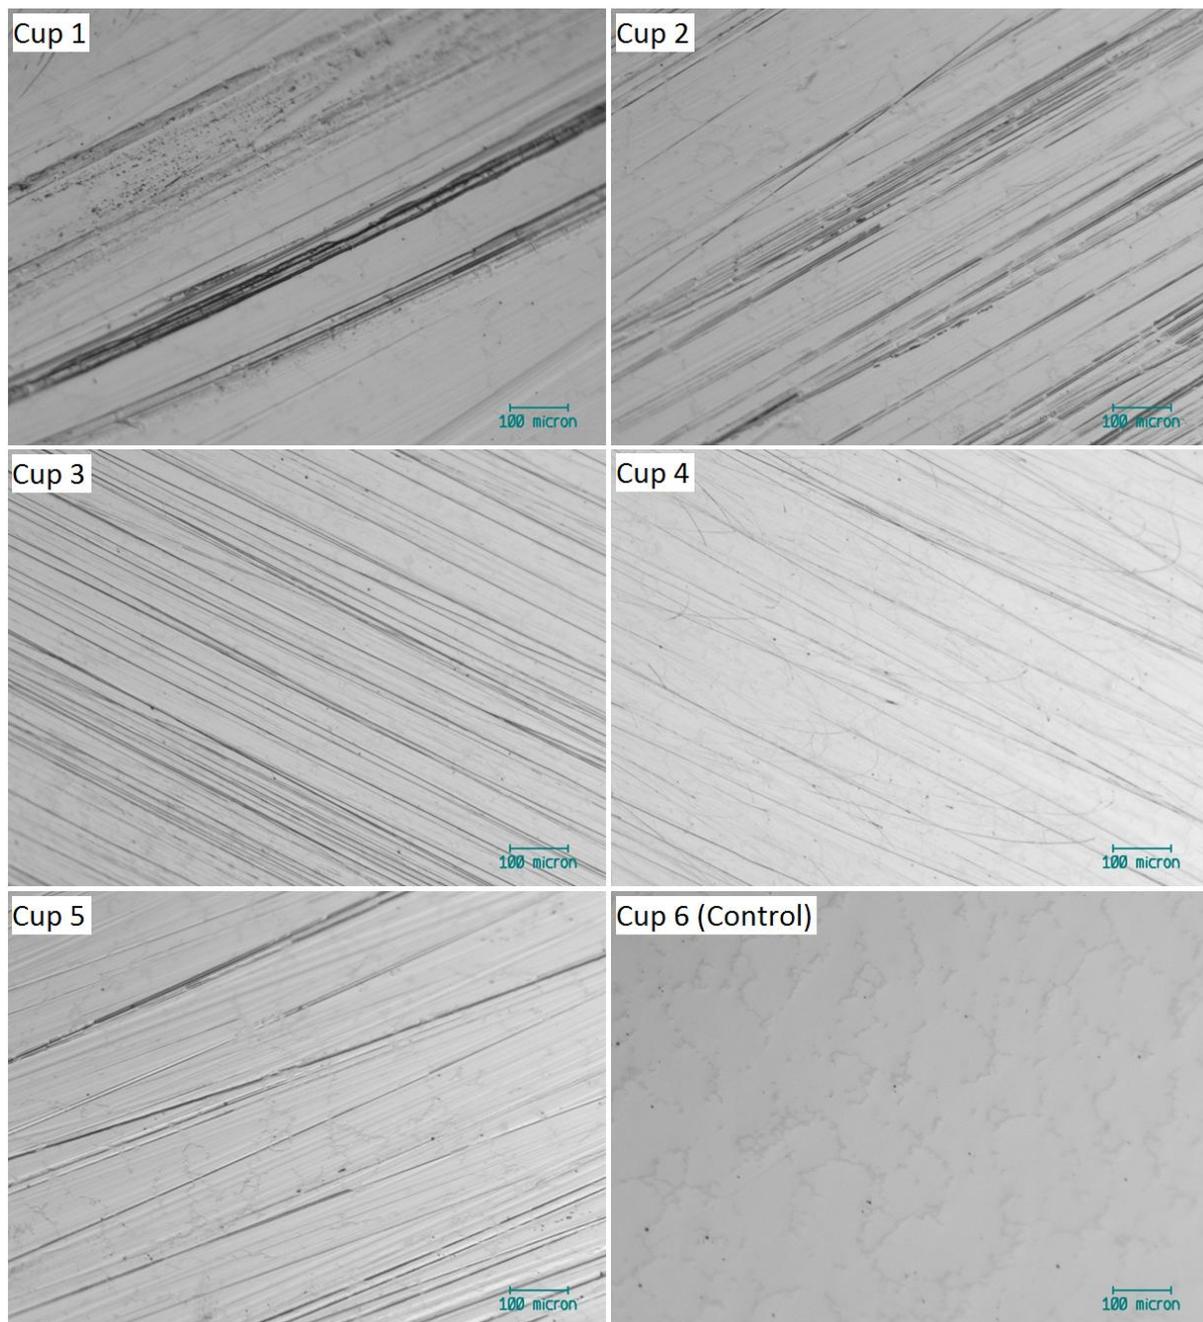
Figure 4.55: Optical images taken within the wear patch of 60 mm CoCrMo cups after 2.0 MC (serum).

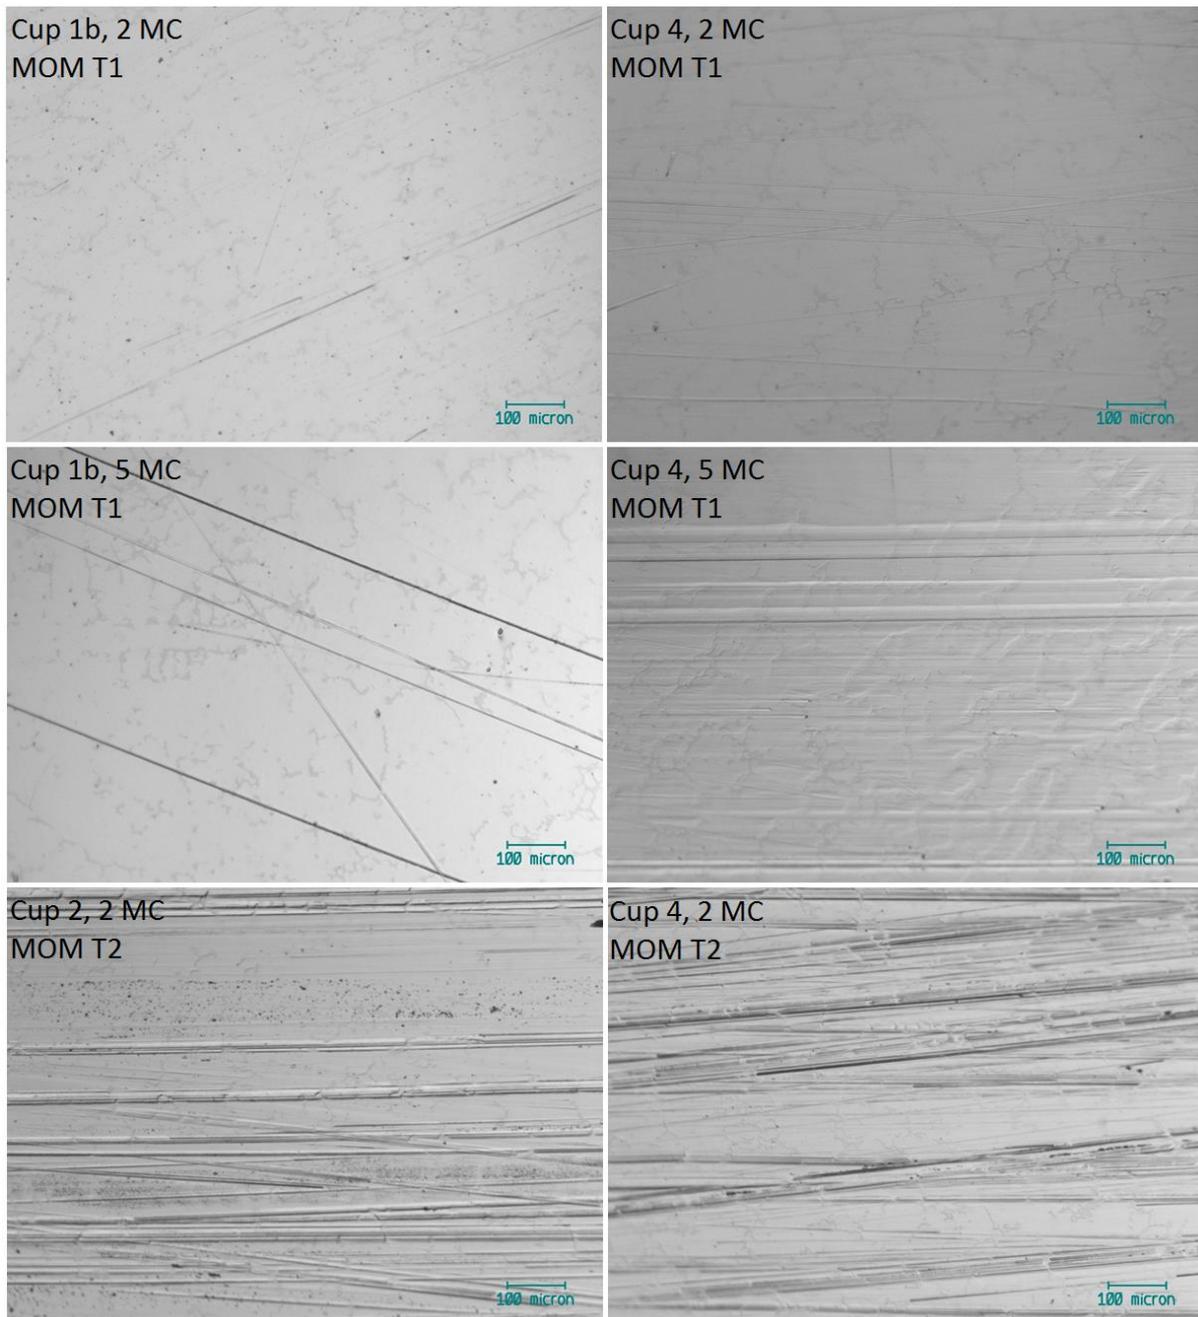
**Figure 4.59: Optical images taken from CoCrMo cups in MOM T1 and MOM T2.**

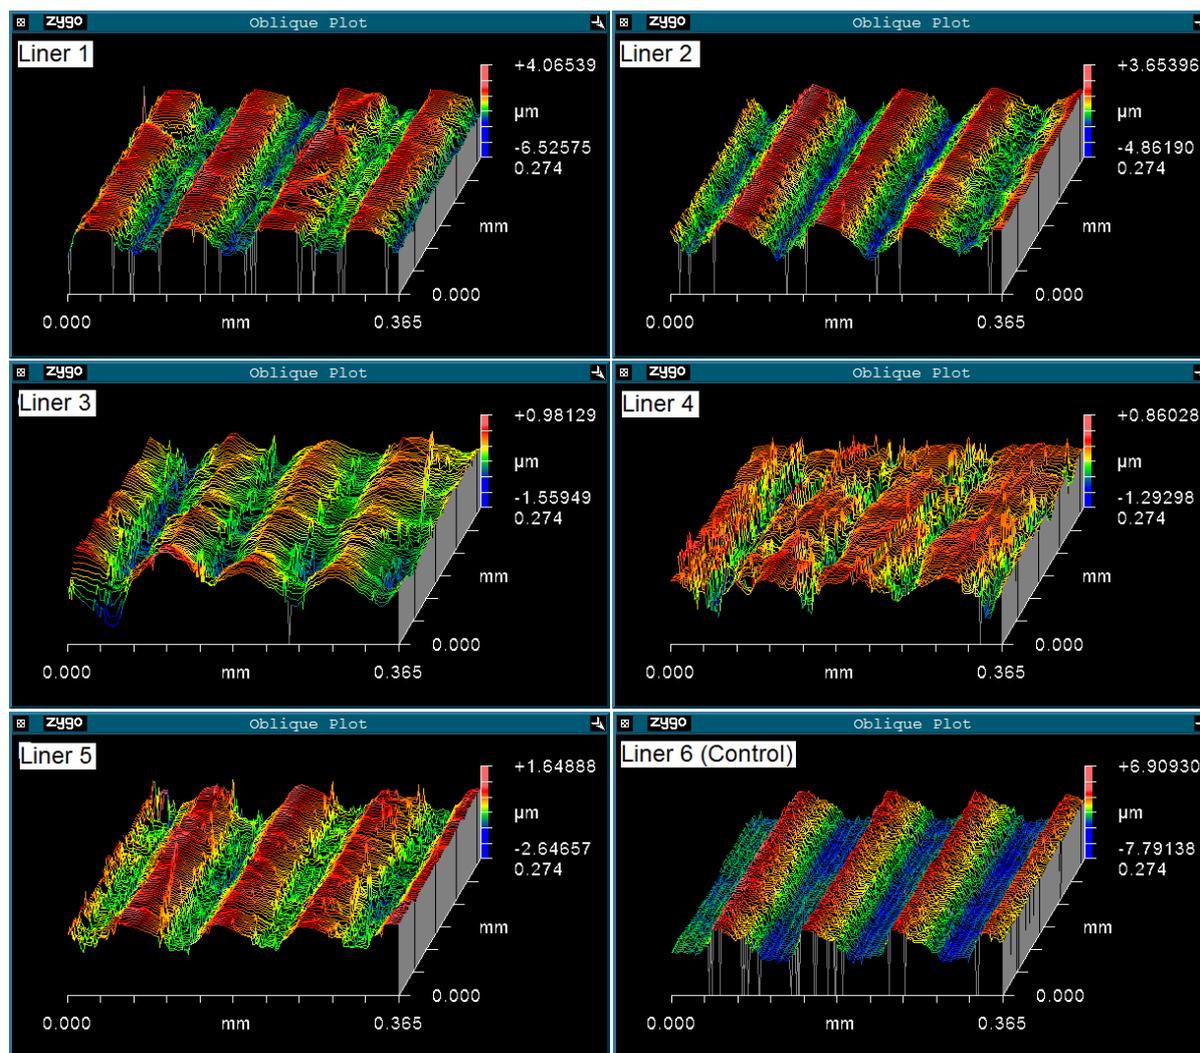
Figure 5.21: Surface profiles of E1 liners imaged after 5 MC at 45 °.

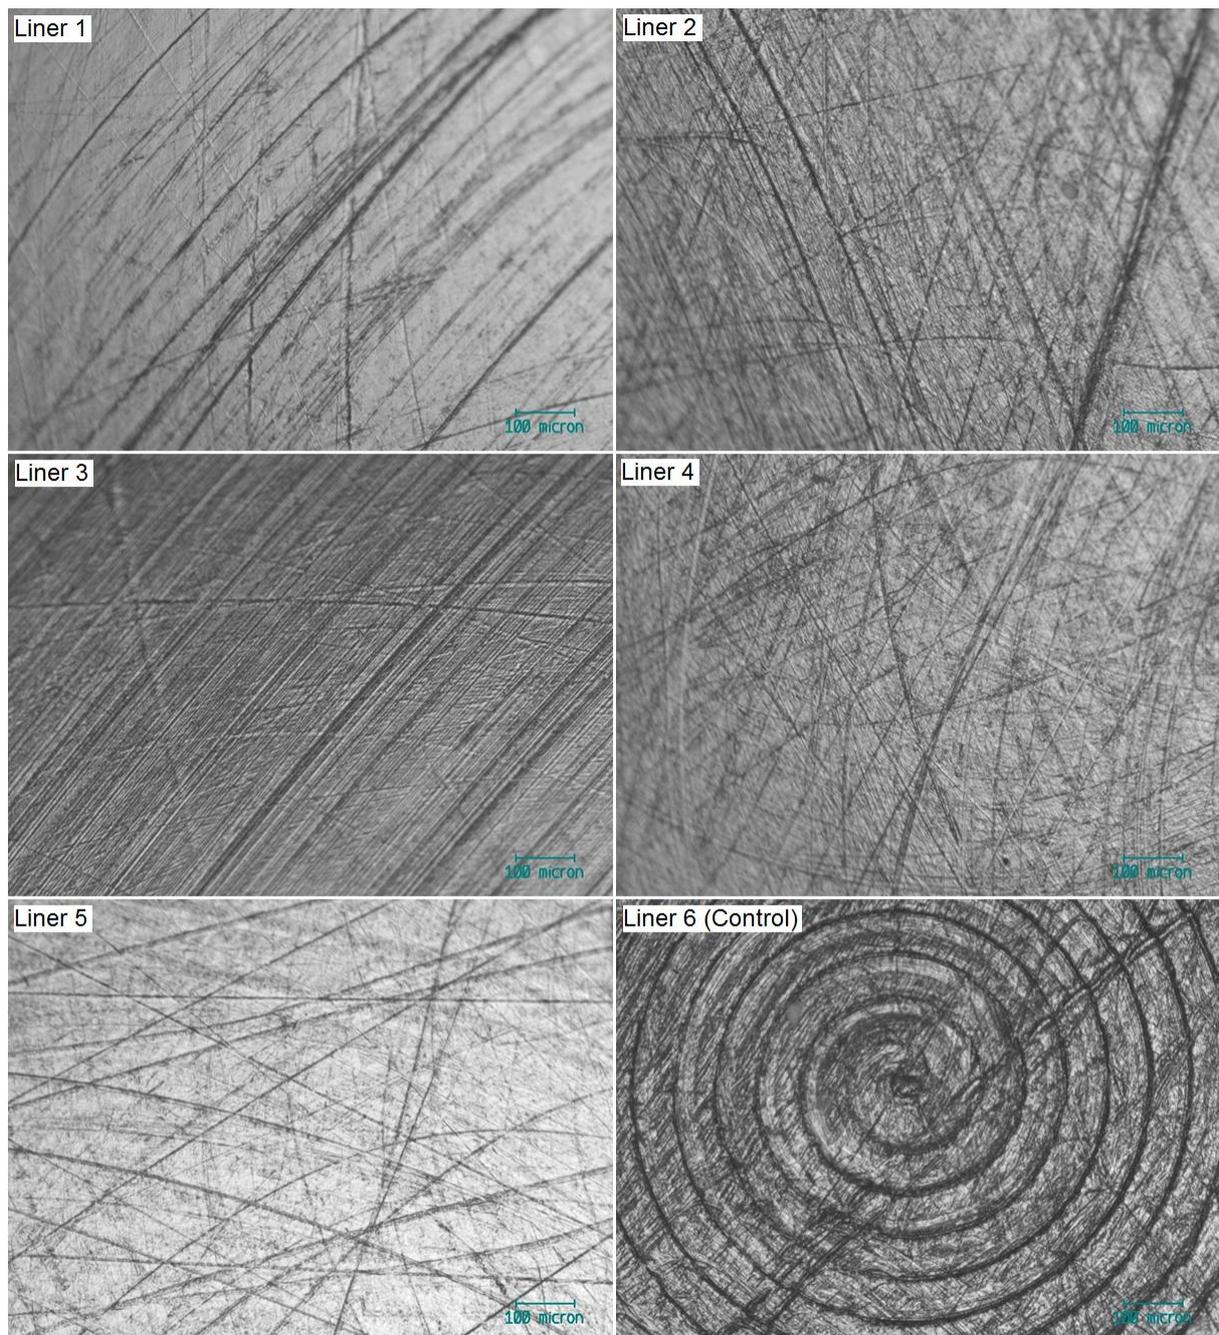
**Figure 5.22: Inner pole of E1 liners after 0.5 MC.**

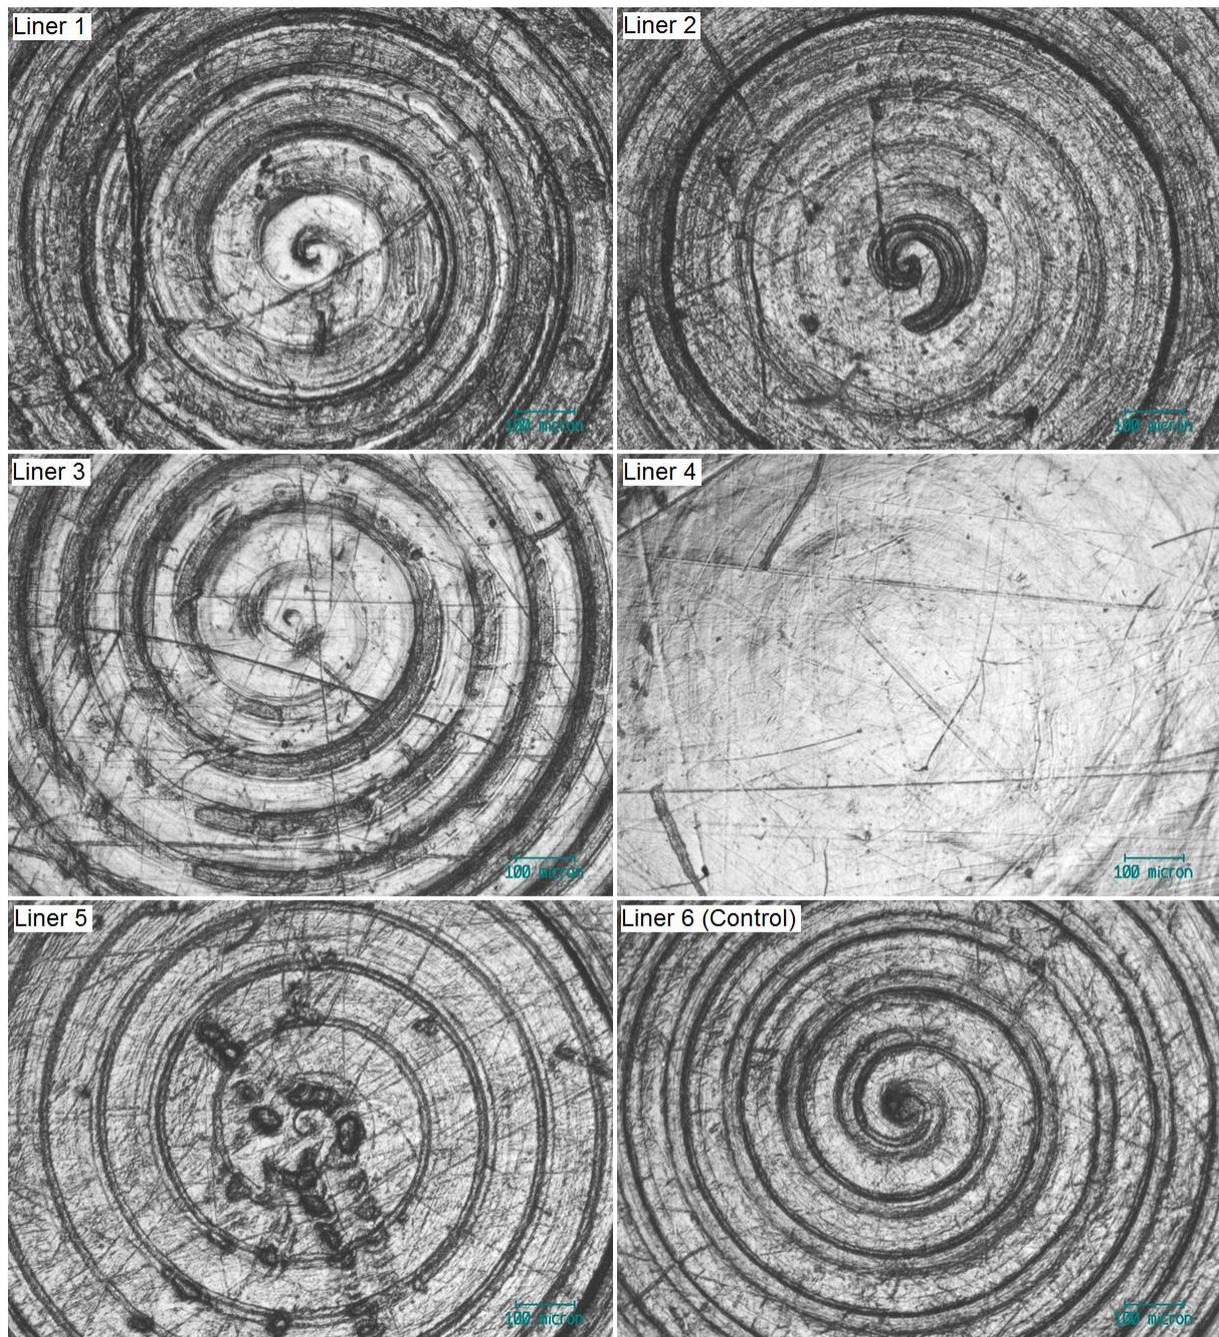
**Figure 5.23: Outer pole of E1 liners after 0.5 MC.**

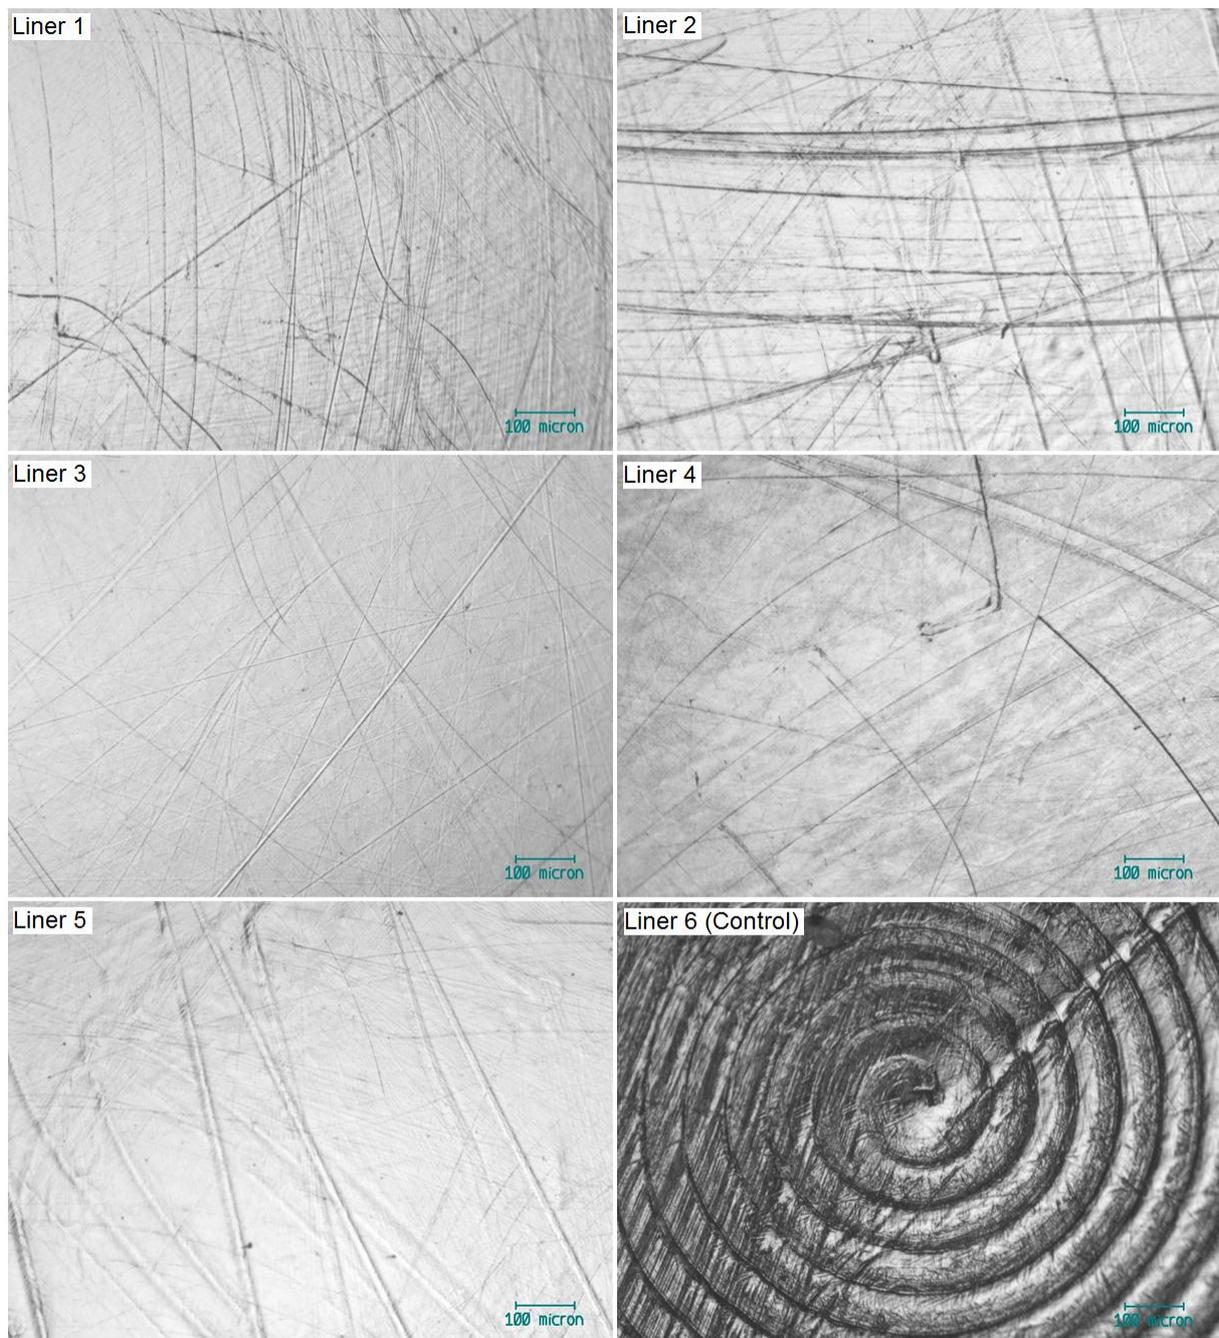
**Figure 5.24: Inner pole of E1 liners after 2.5 MC.**

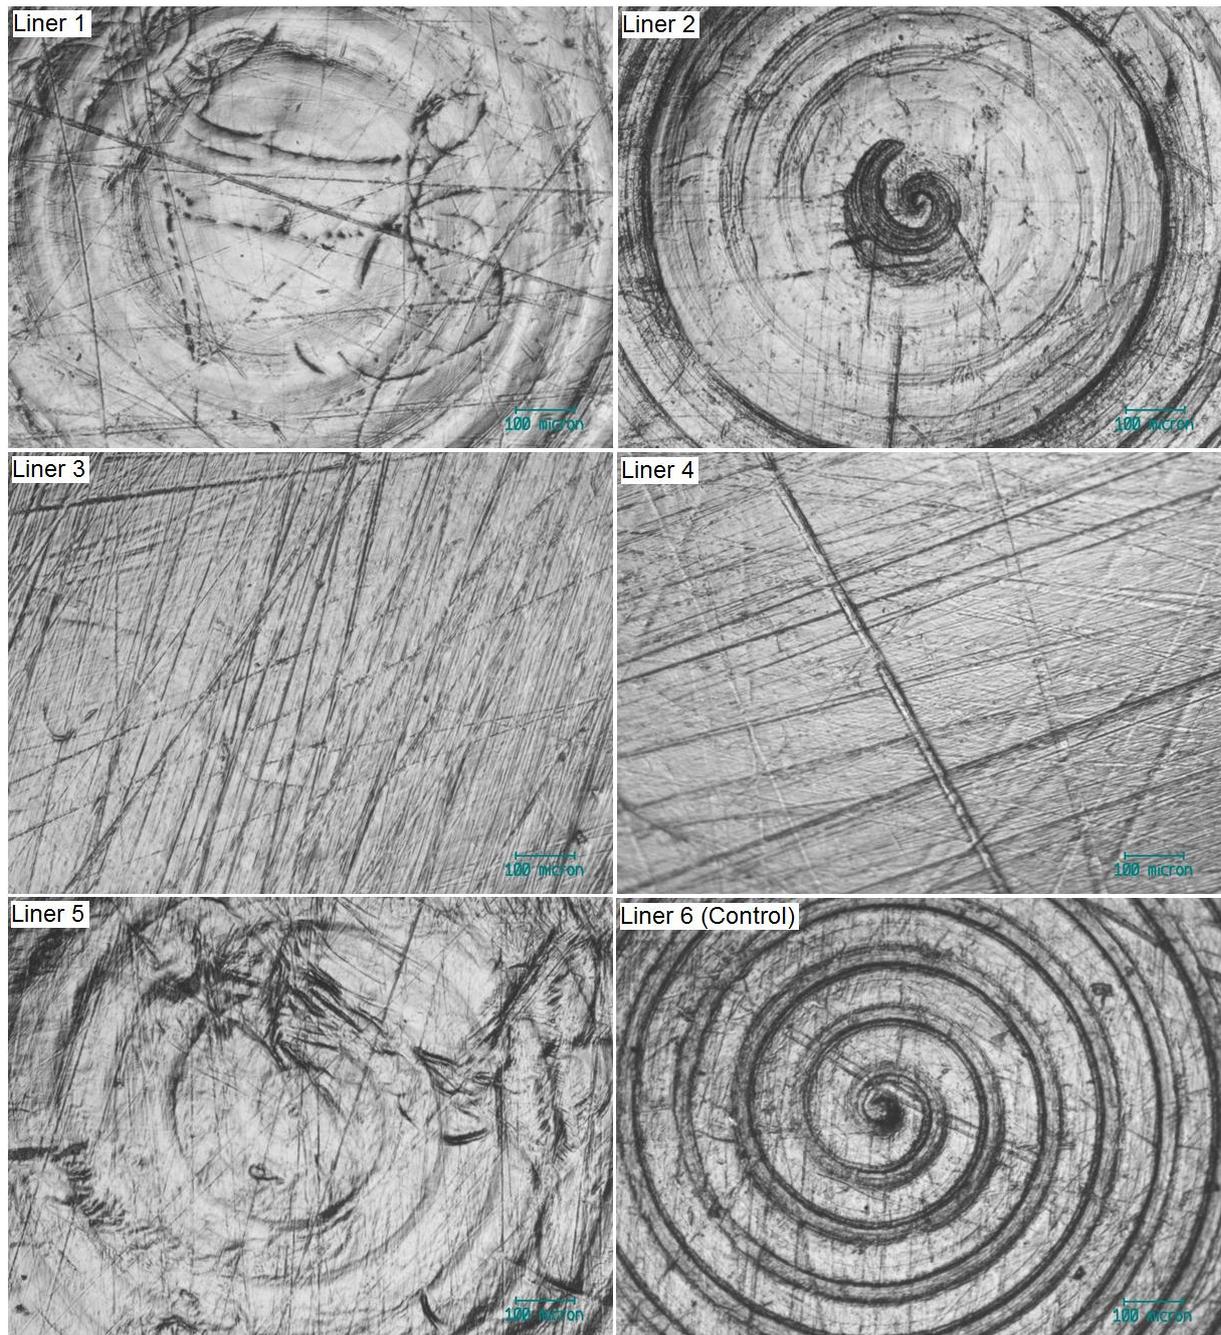
**Figure 5.27: Outer pole of E1 liners after 5.0 MC.**

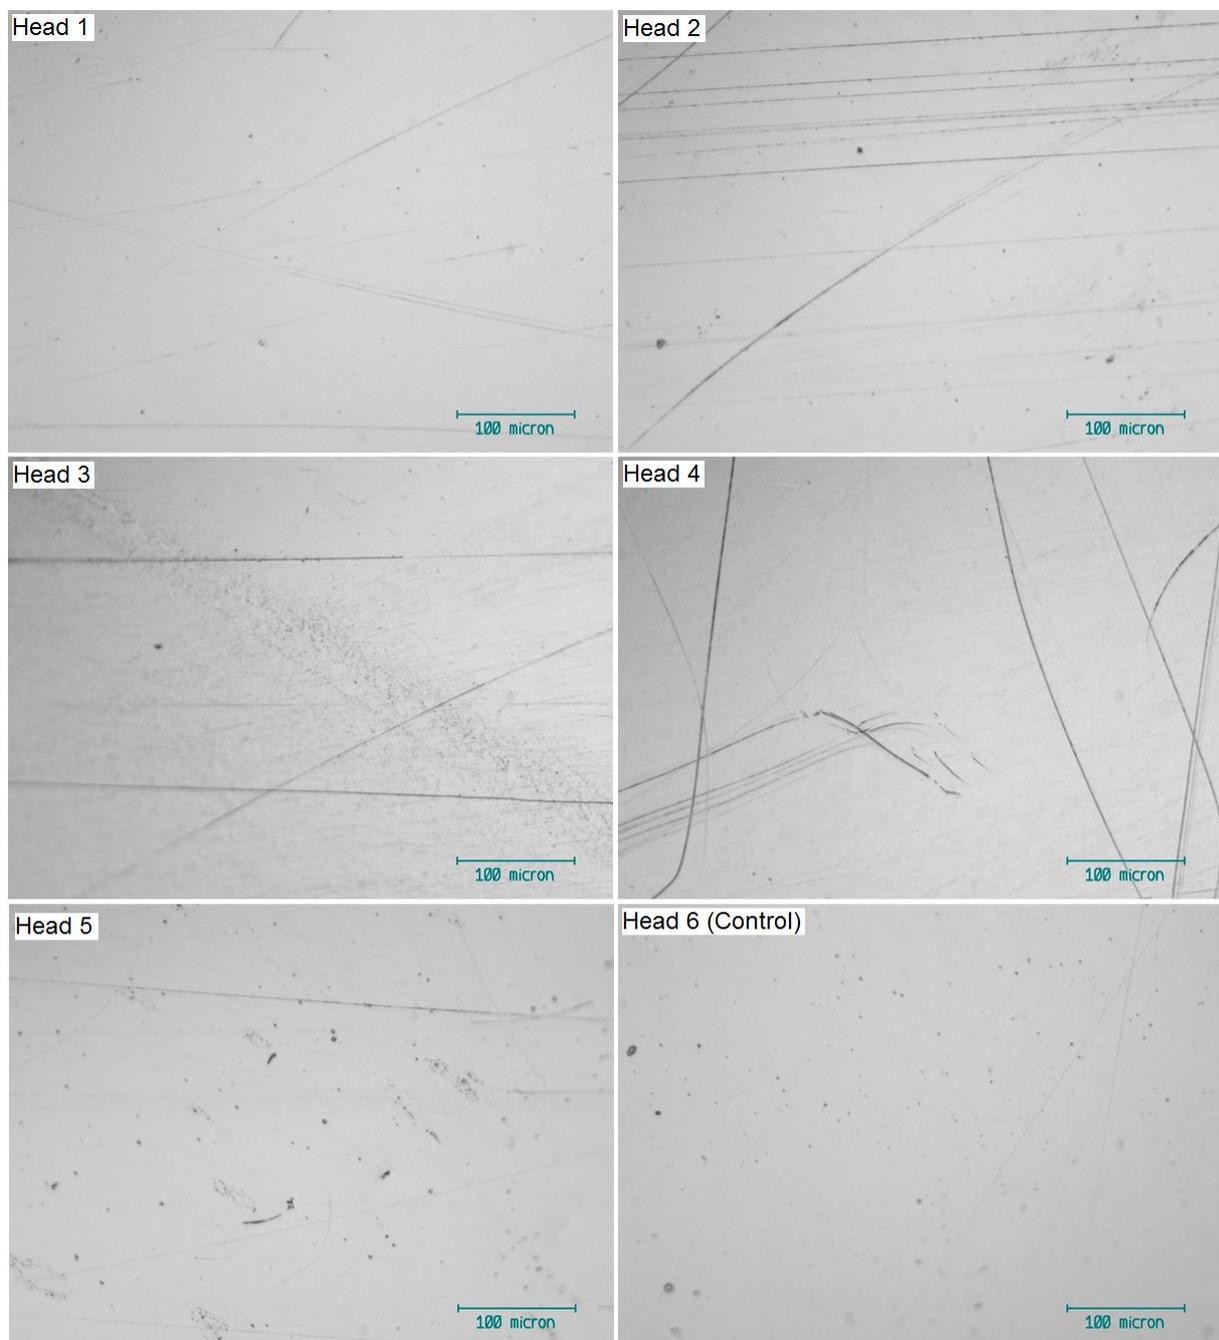
**Figure 5.28: Pole of 28 mm CoCrMo heads after 1.0 MC.**

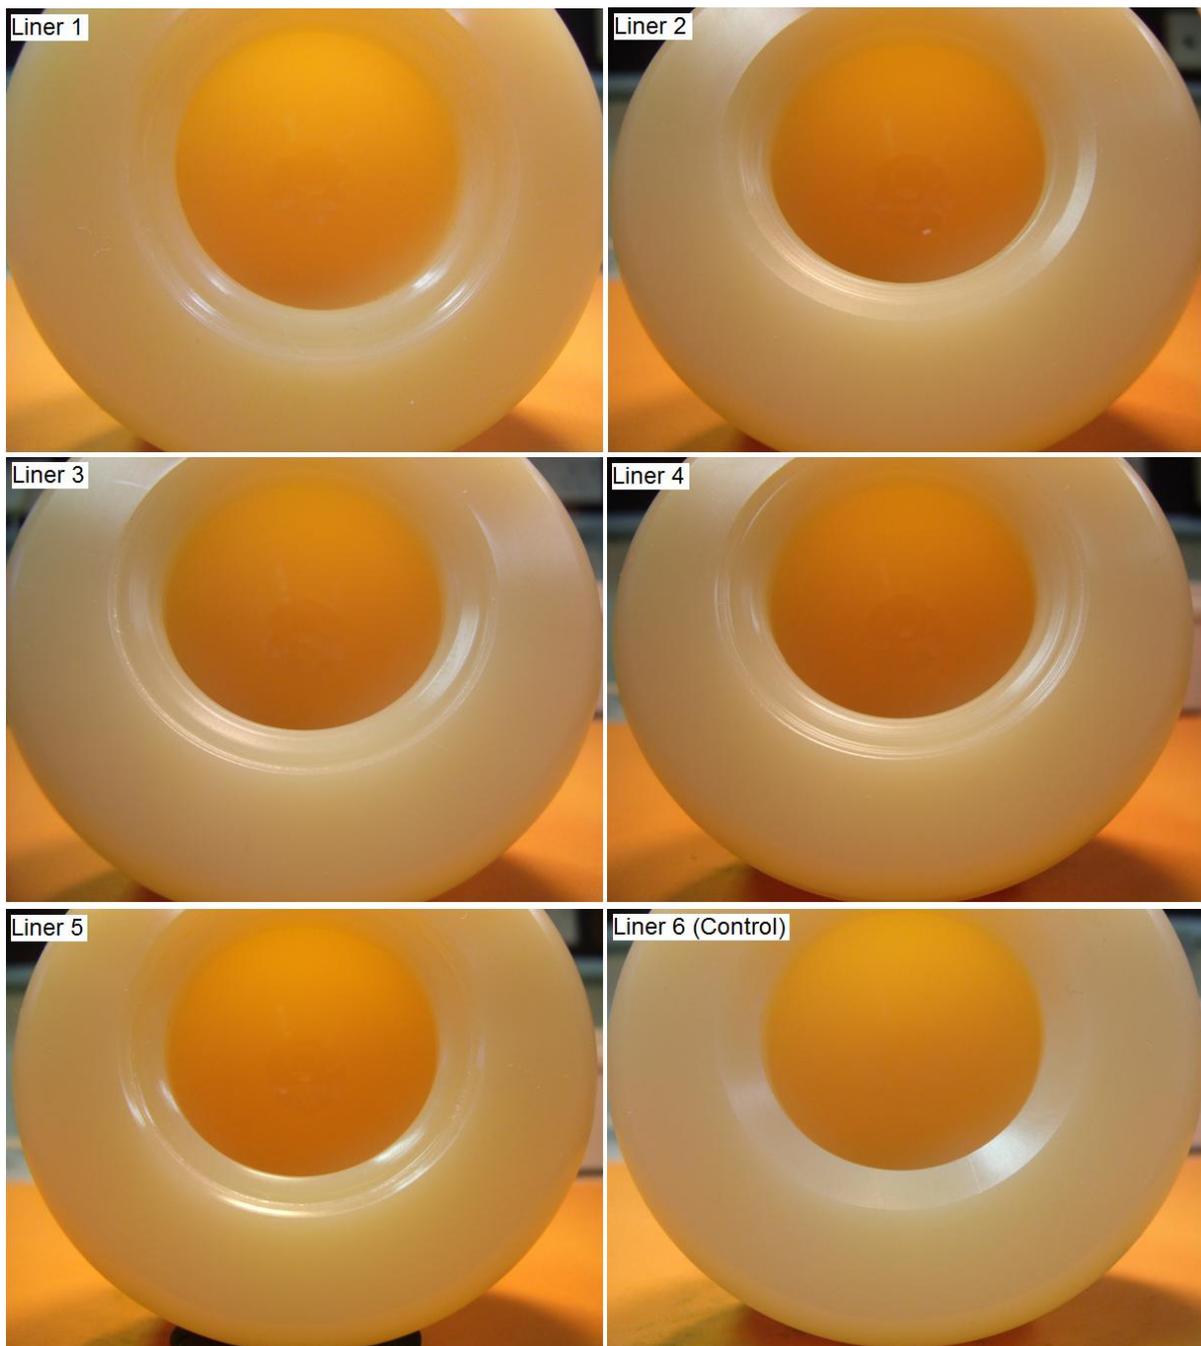
Figure 5.31: Photographs of the E1 liners at 5 MC.

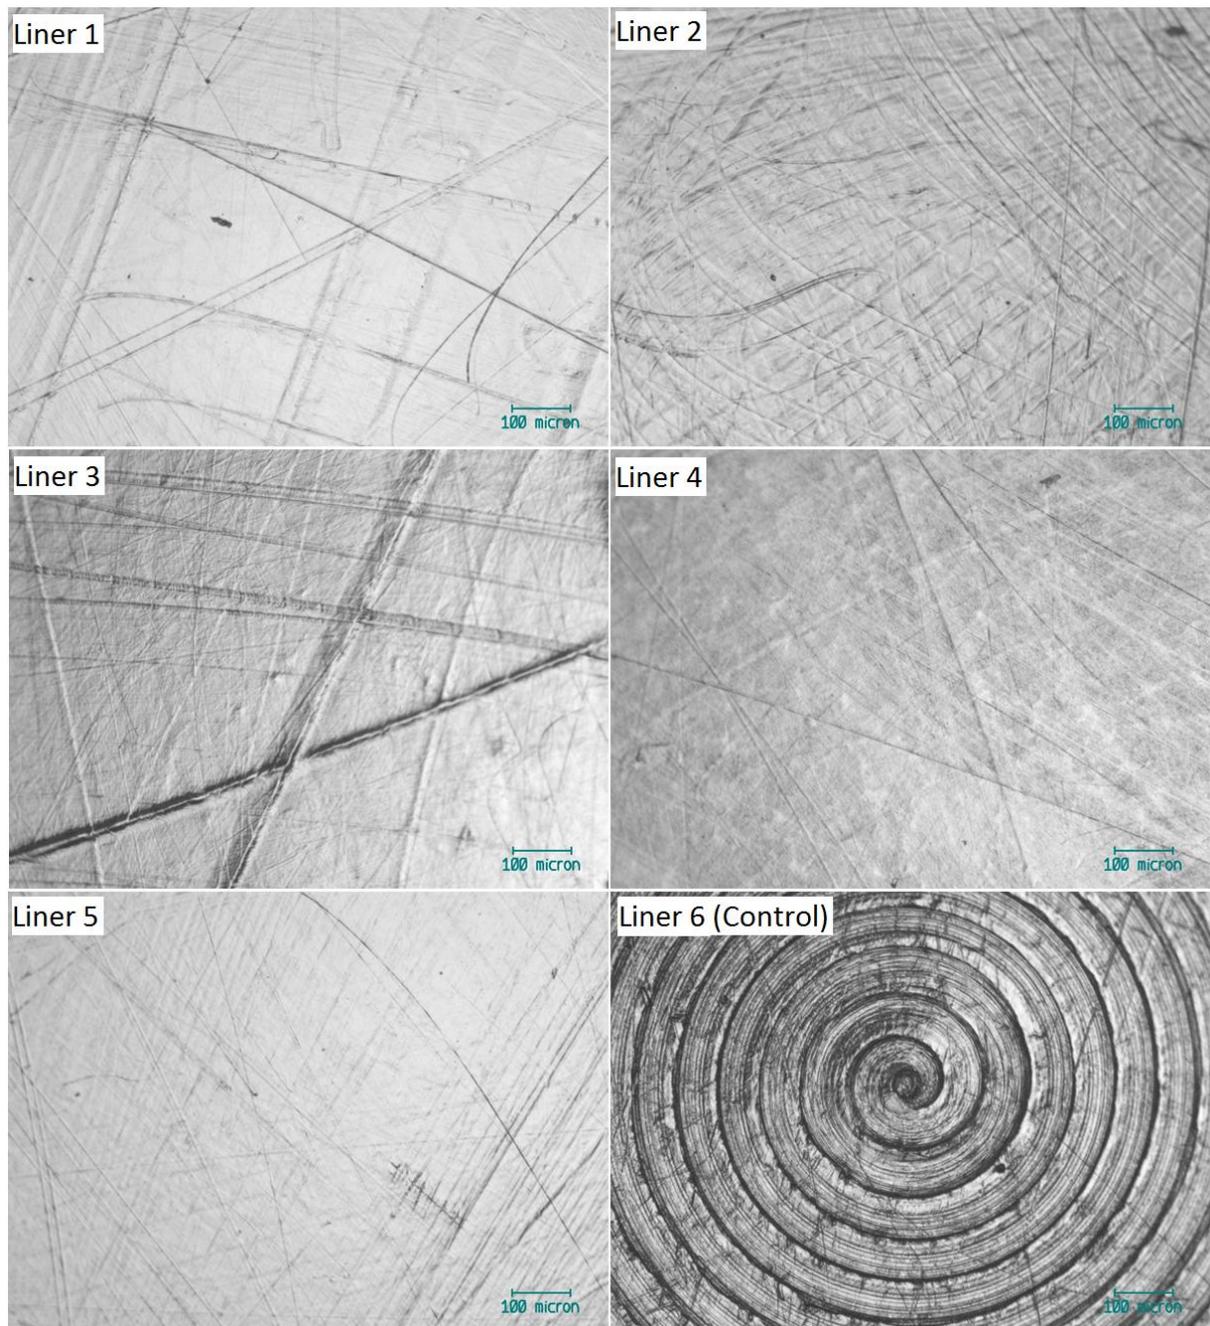
**Figure 5.51: Inner pole of E1 liners after 0.5 MC.**
