# ***In Vitro* Investigation into the use of Dual Mobility for Partial Revision of a Failed Metal Hip Resurfacing**

**Elaine Lovelady**

Thesis presented for the degree of  
Doctor of Philosophy

School of Engineering and Computing Sciences

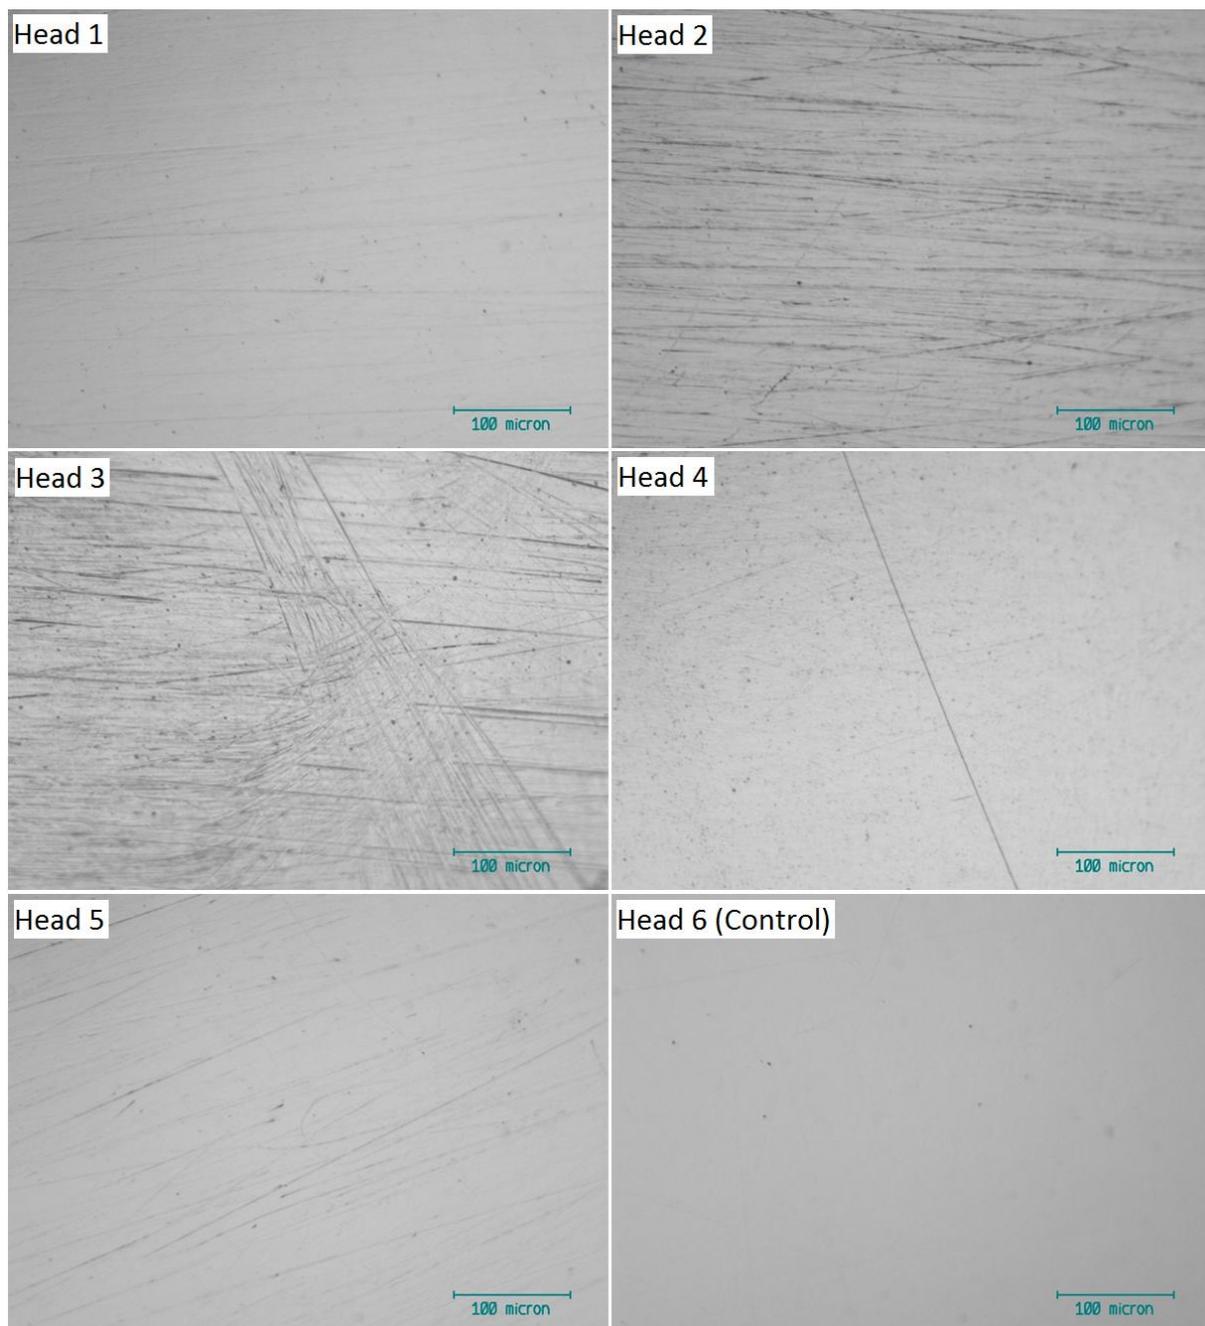
**Figure 5.58: Pole of 28 mm CoCrMo heads after 5.0 MC.**

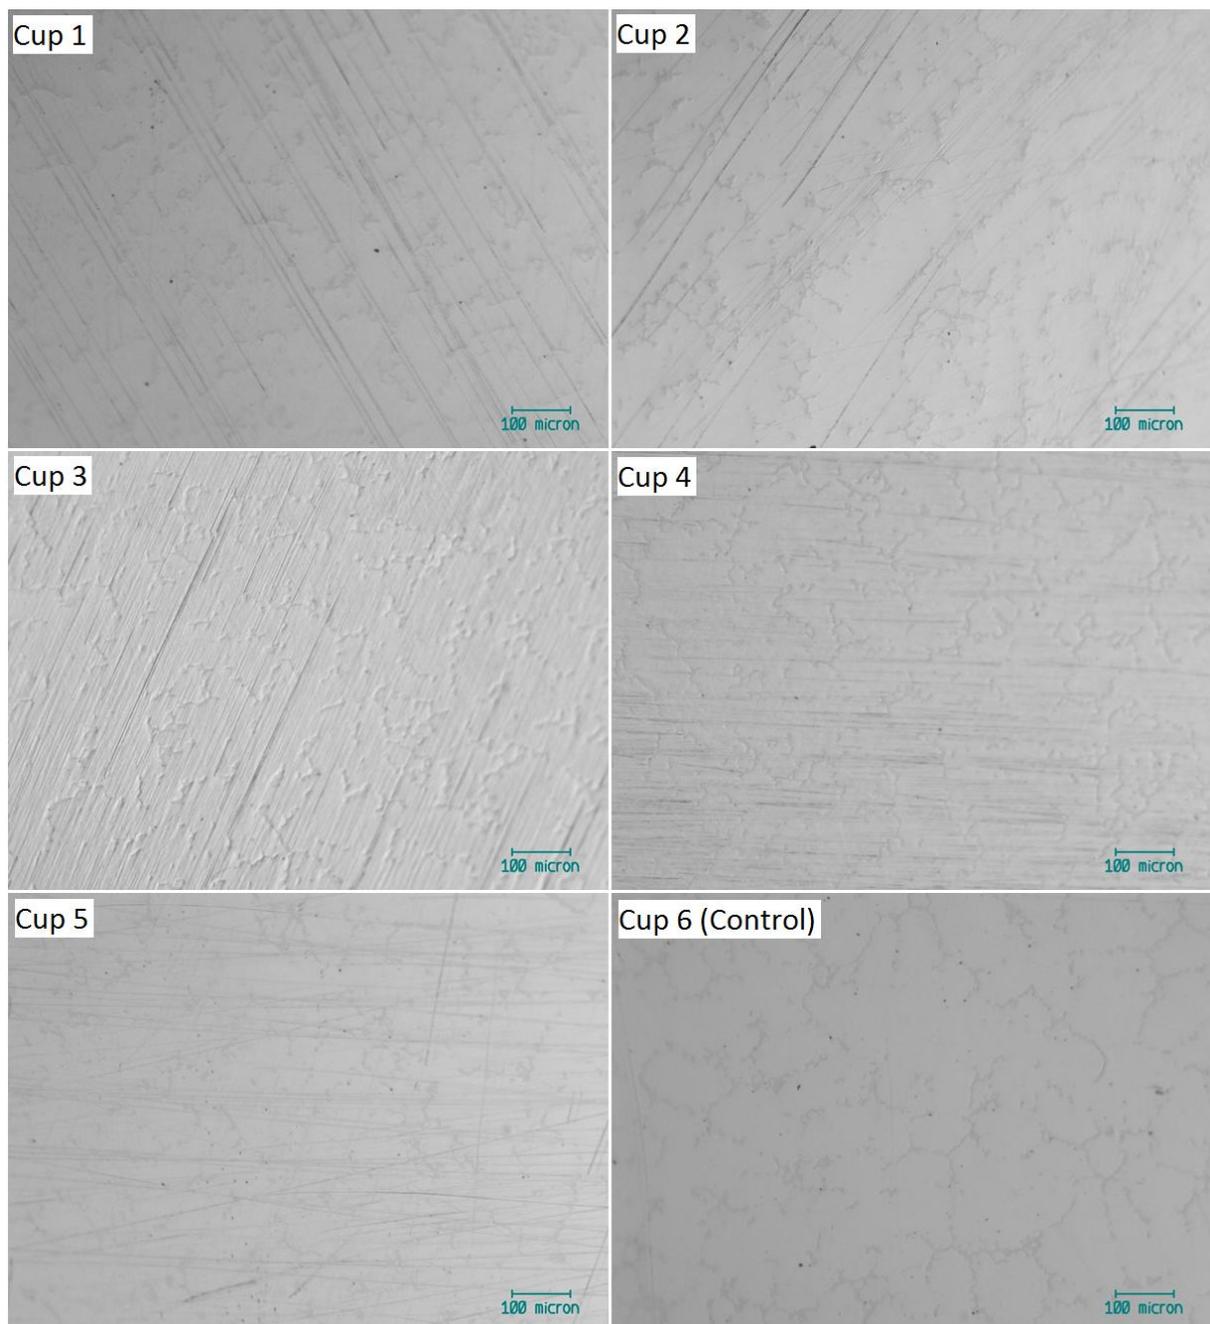
**Figure 5.59: Optical images taken within the wear patch of 60mm CoCrMo cups after 1.0 MC.**

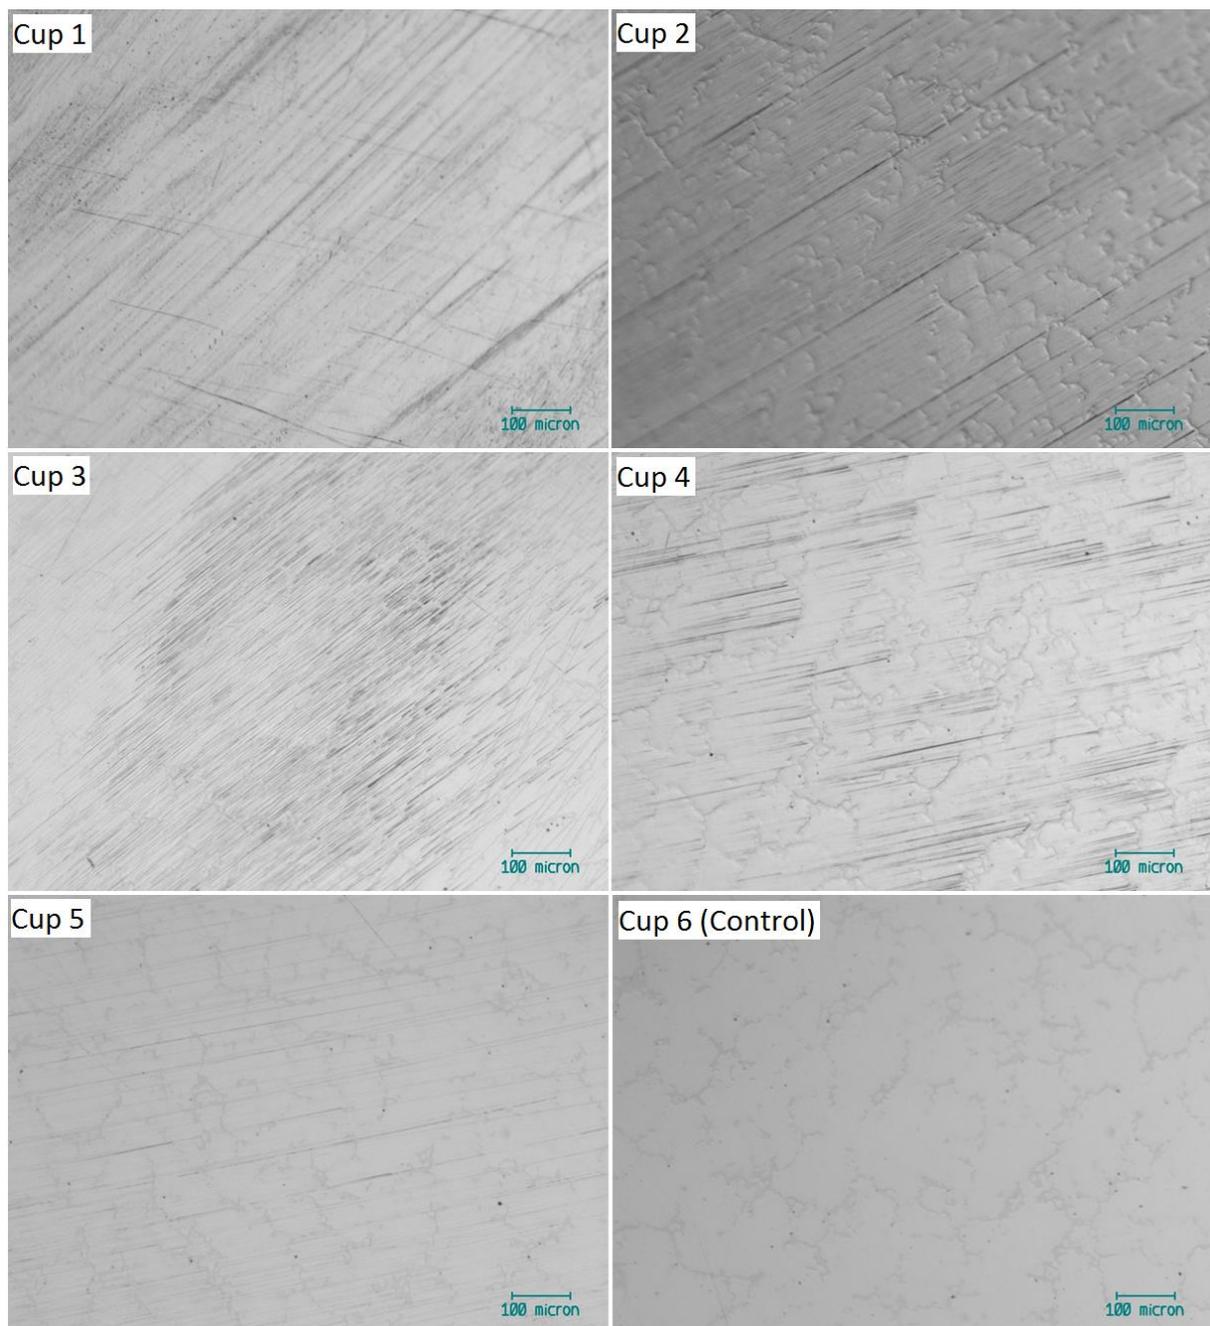
Figure 5.60: Optical images taken within the wear patch of 60mm CoCrMo cups after 5.0 MC.

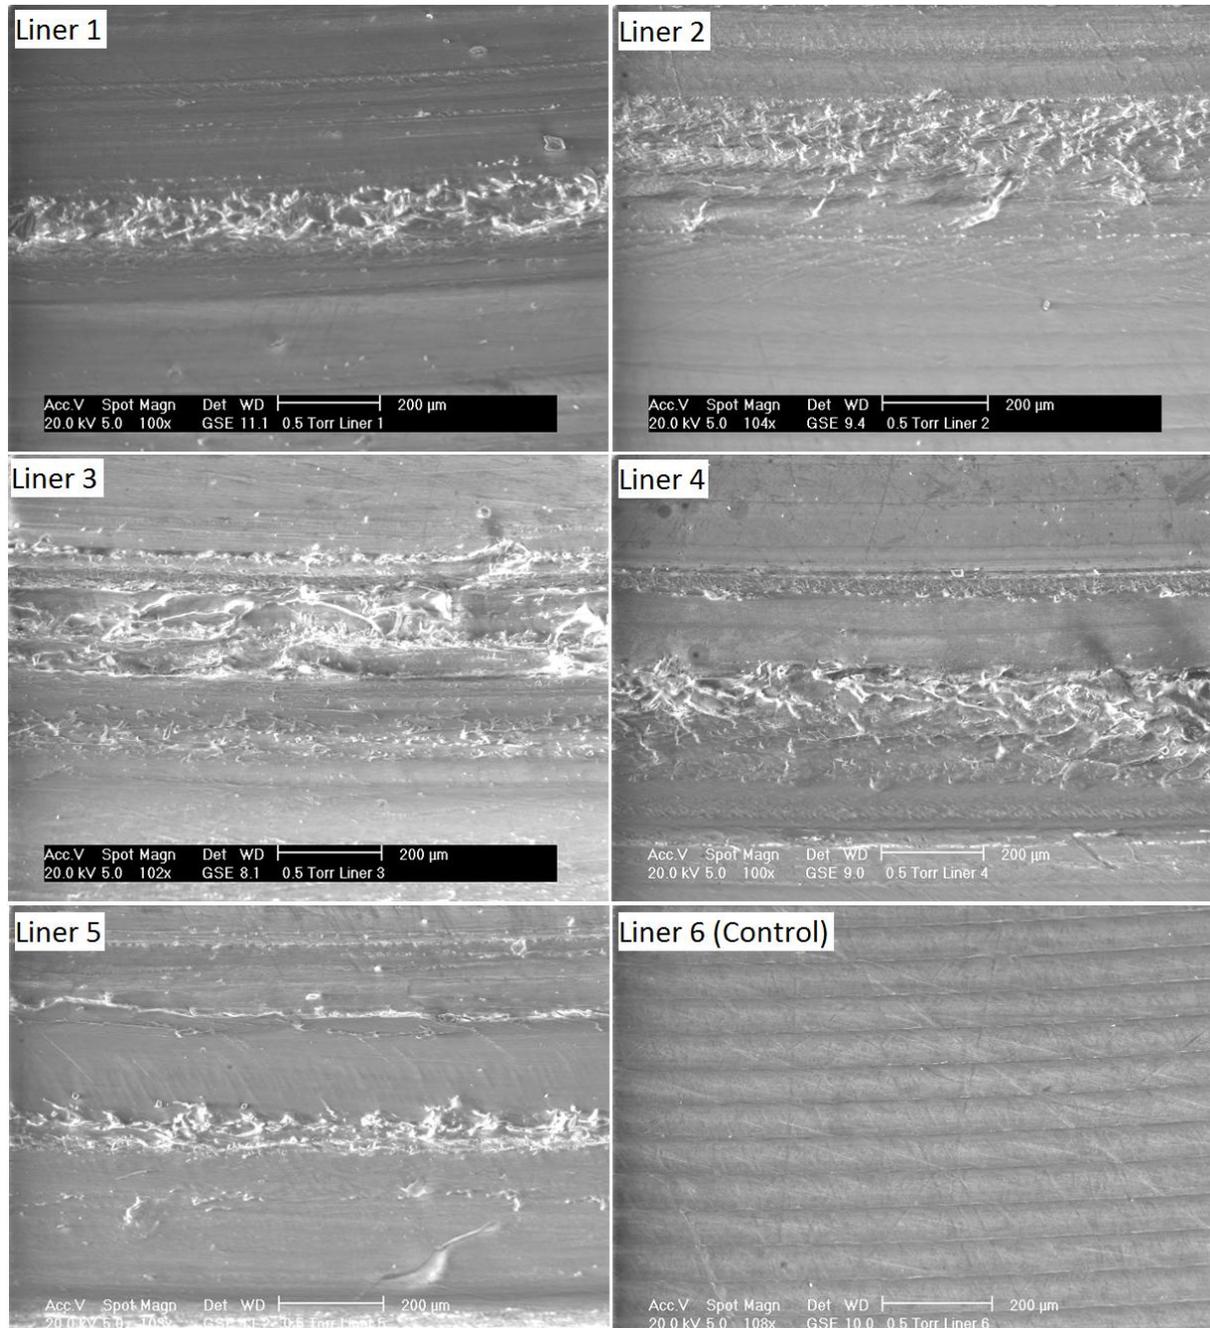
Figure 5.61: ESEM images taken around the E1 liner rim at 1.0 MC.

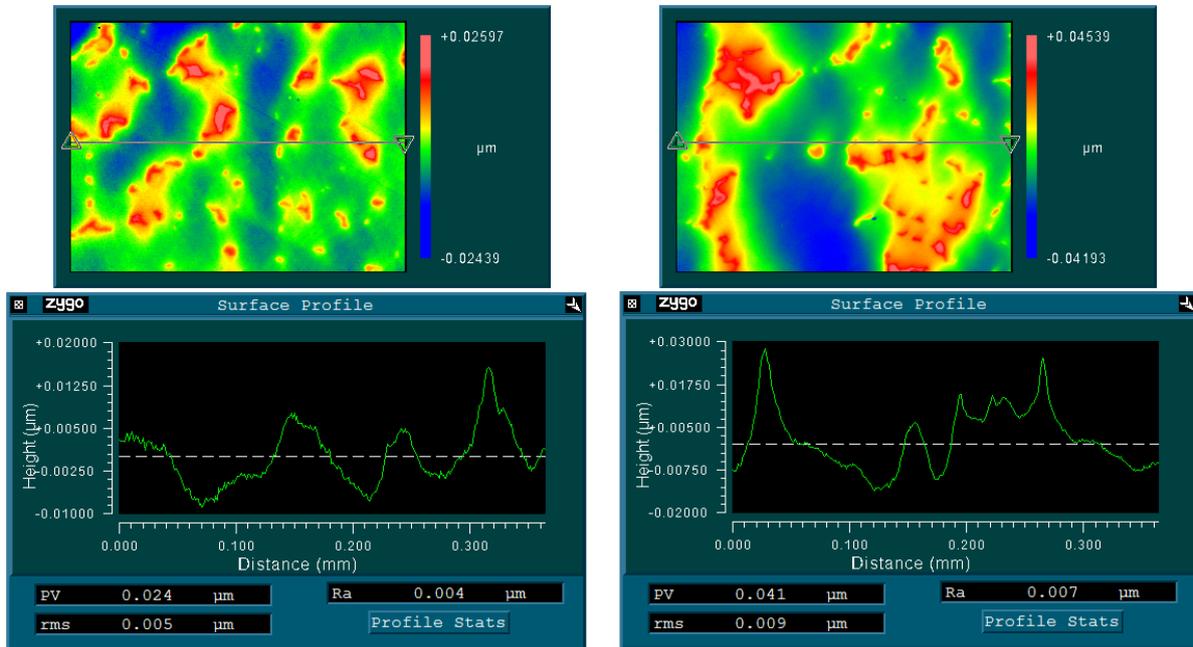
Figure 5.63: Zygo data from Cup 1 at 0 MC showing the 2D plot and the corresponding line profile of the surface.

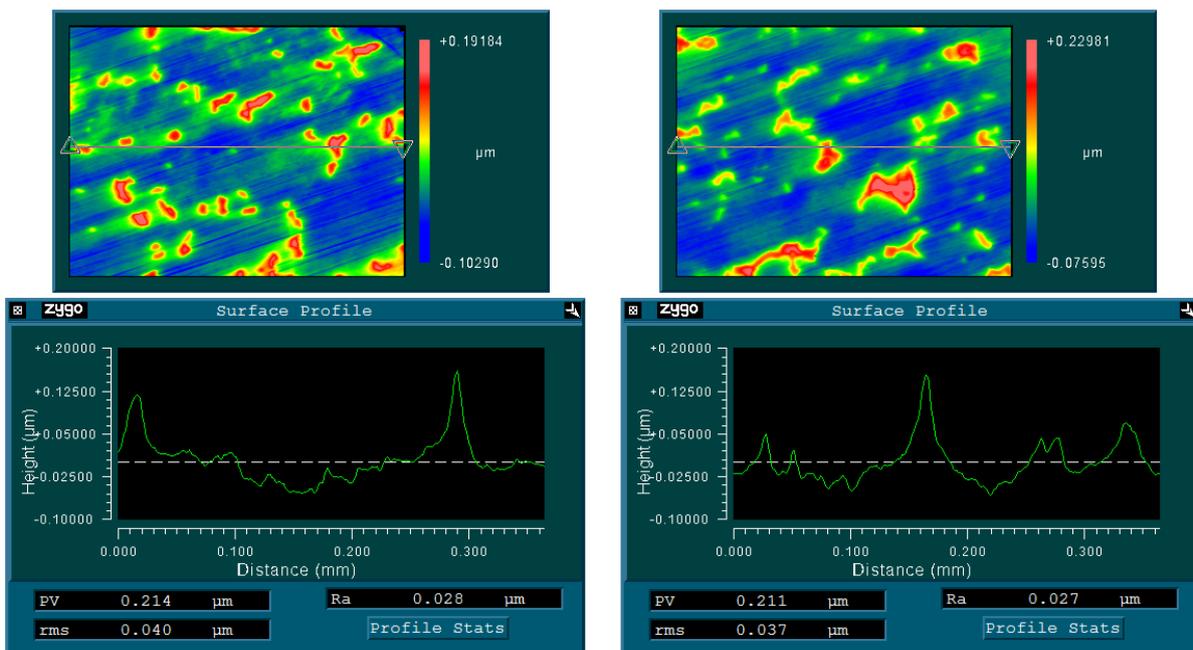
Figure 5.64: Zygo data from Cup 1 after 5 MC showing the 2D plot and corresponding line profile of the surface.

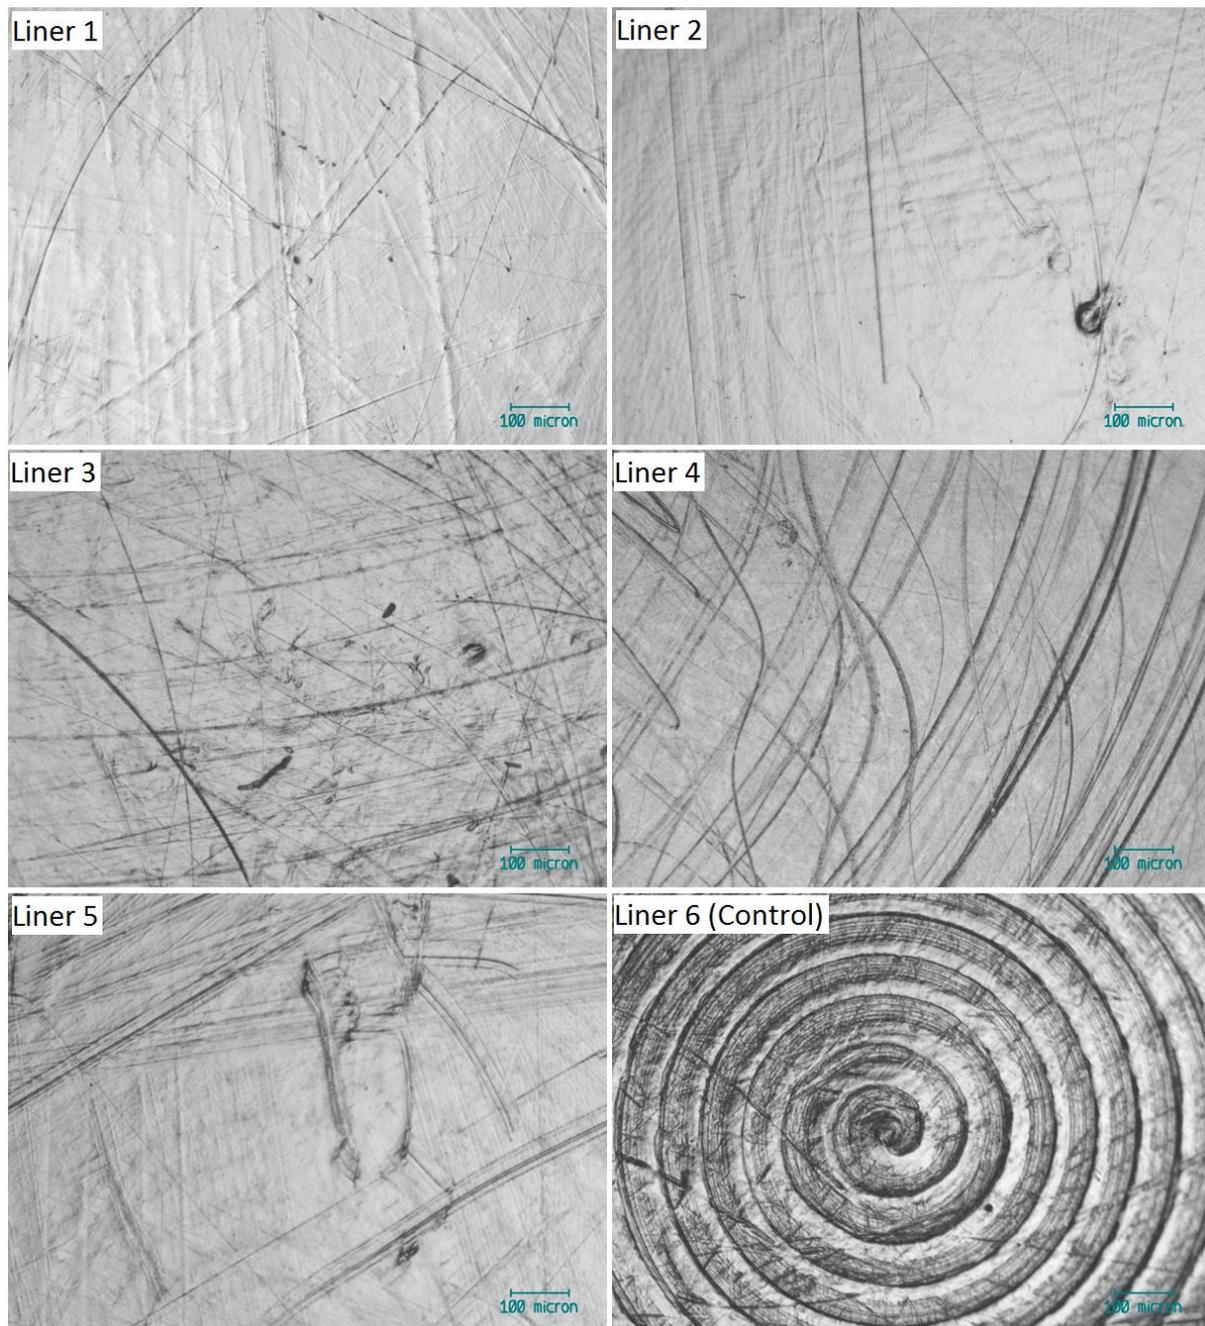
**Figure 5.79: Inner pole of E1 liners after 0.5 MC.**

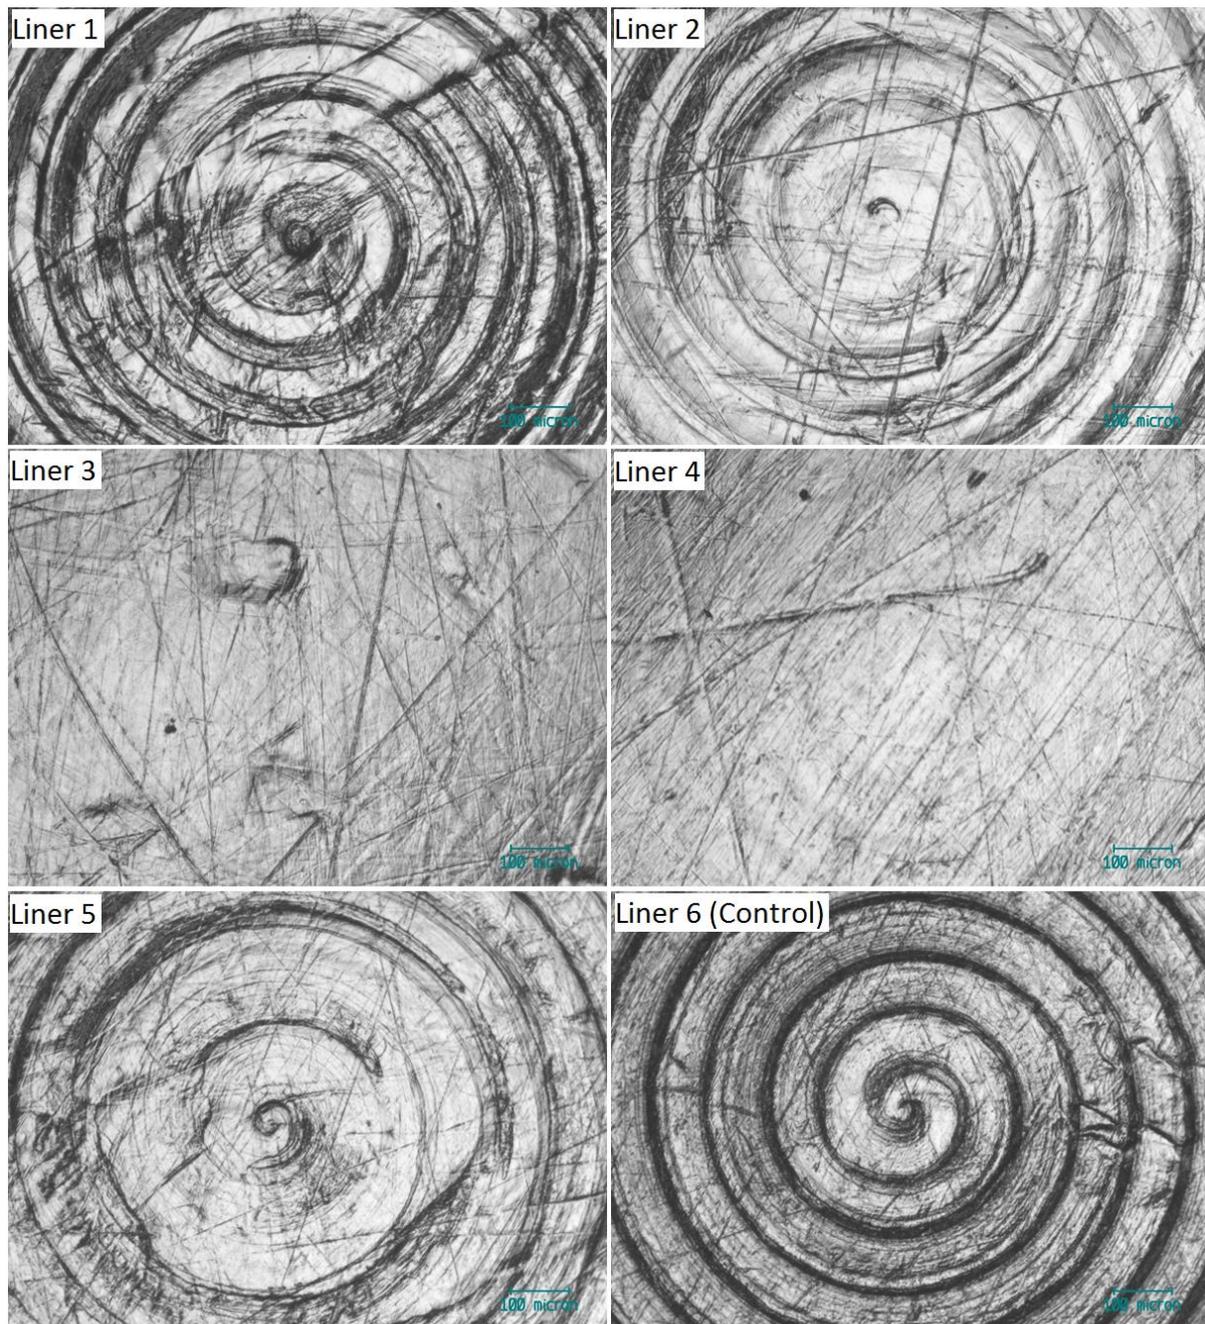
**Figure 5.80: Outer pole of E1 liners after 0.5 MC.**

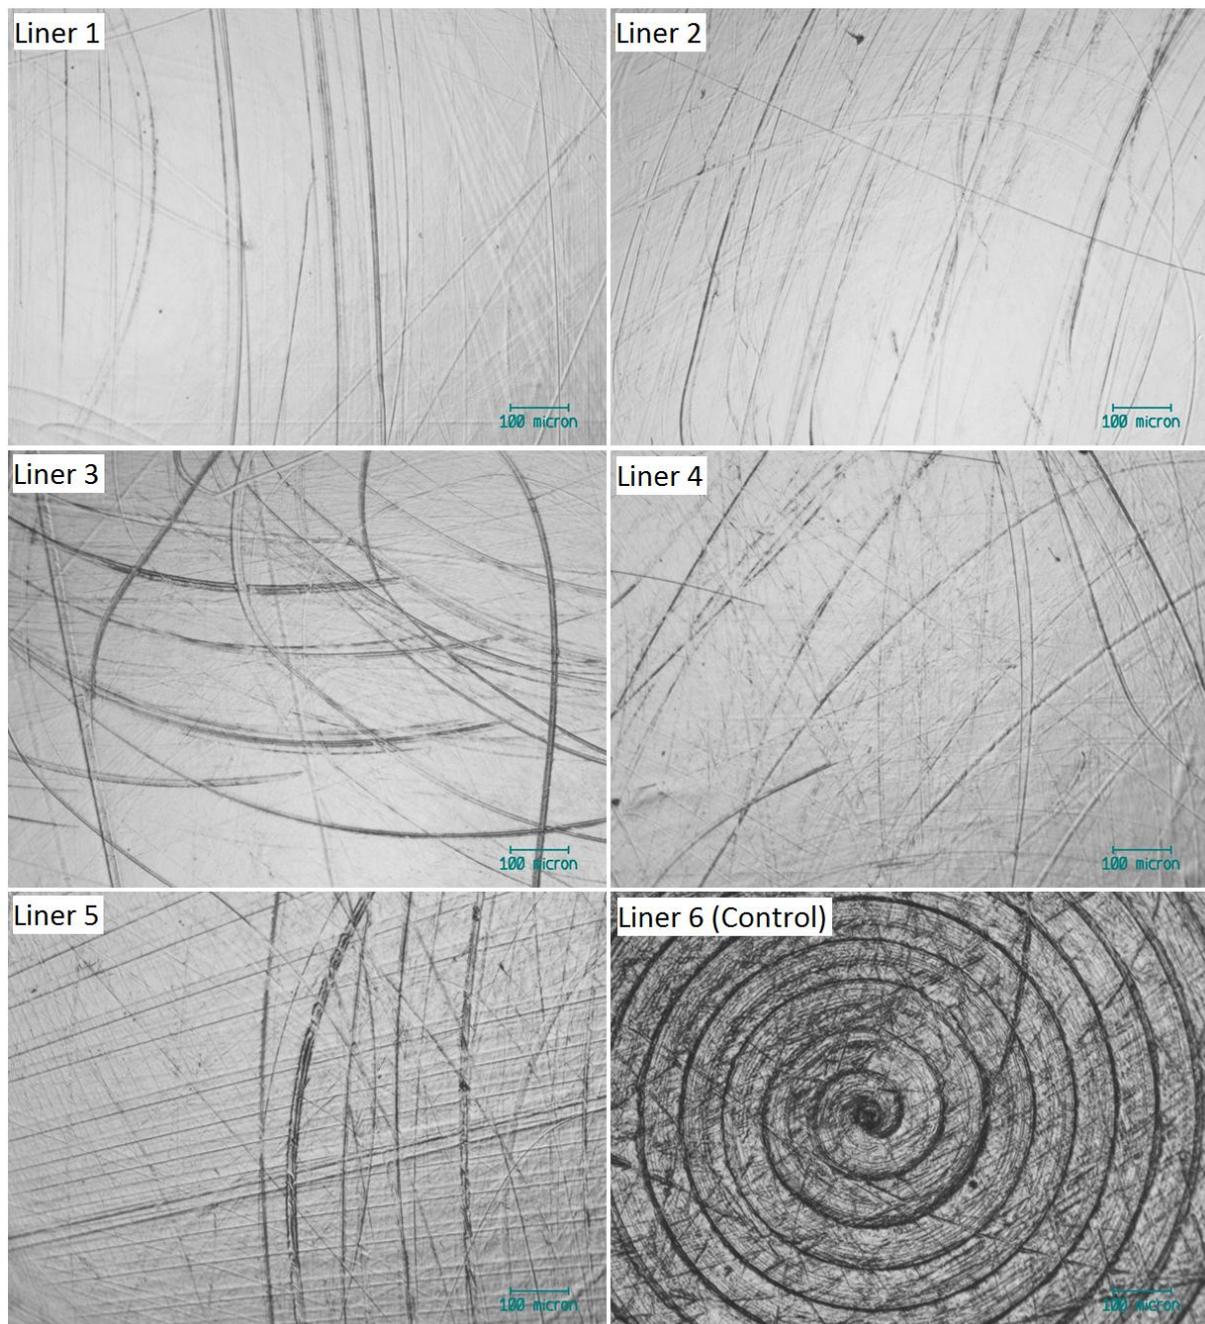
**Figure 5.81: Inner pole of E1 liners after 2.5 MC.**

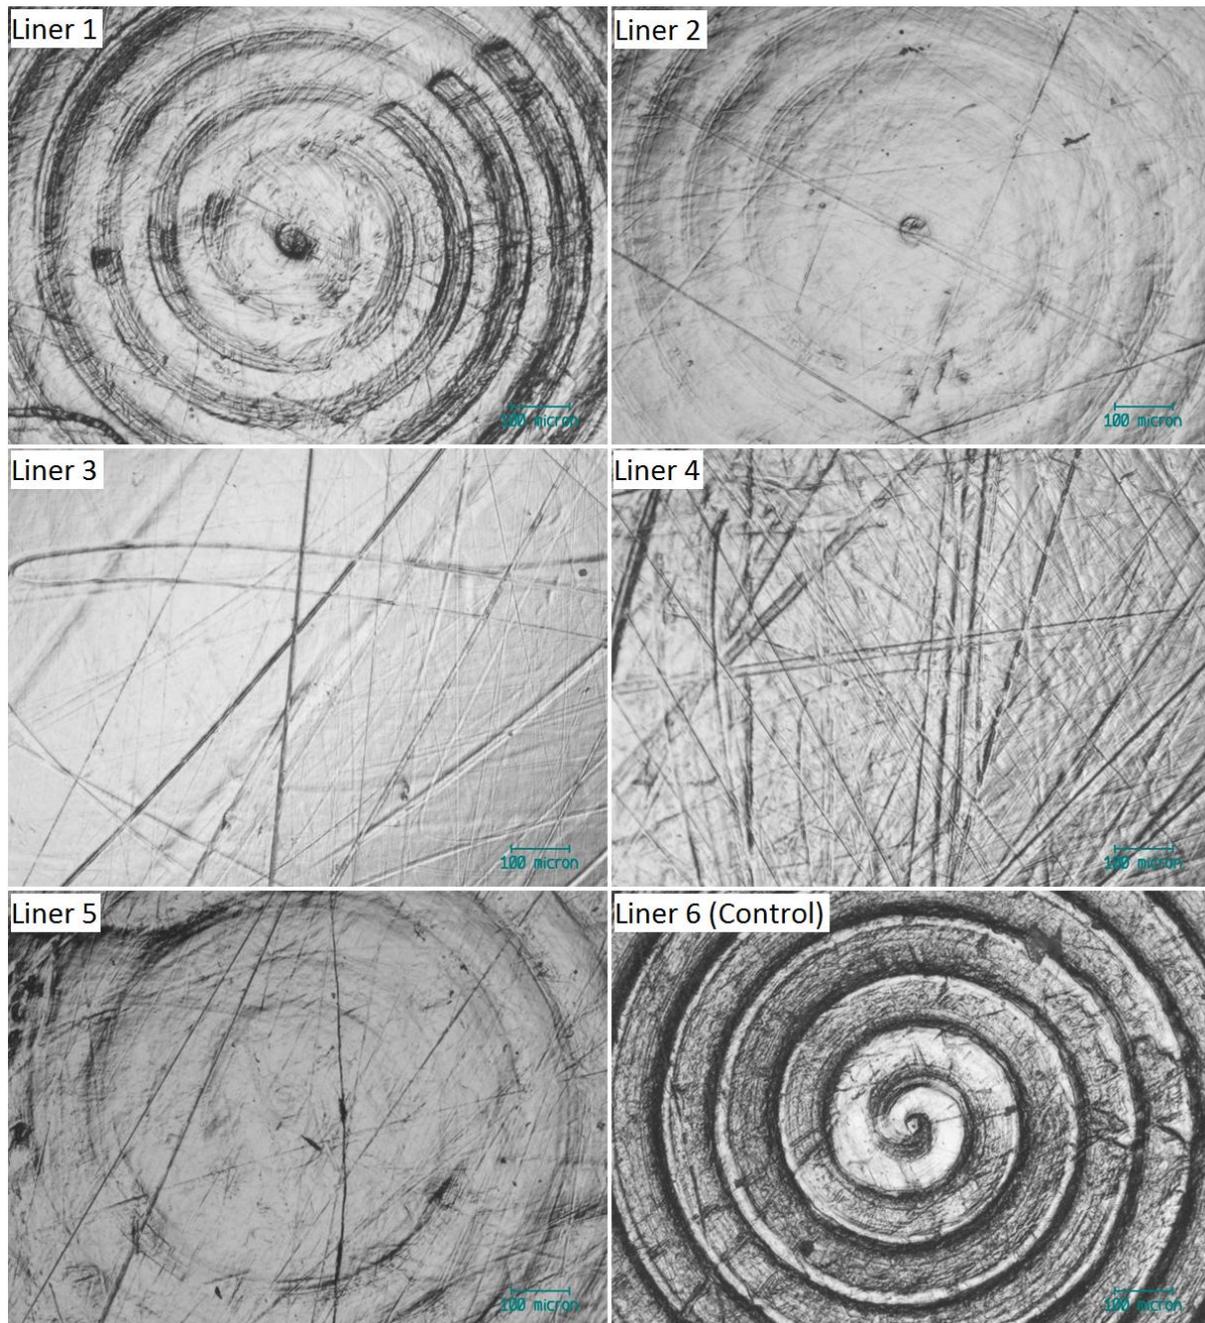
**Figure 5.84: Outer pole of E1 liners after 5.0 MC.**

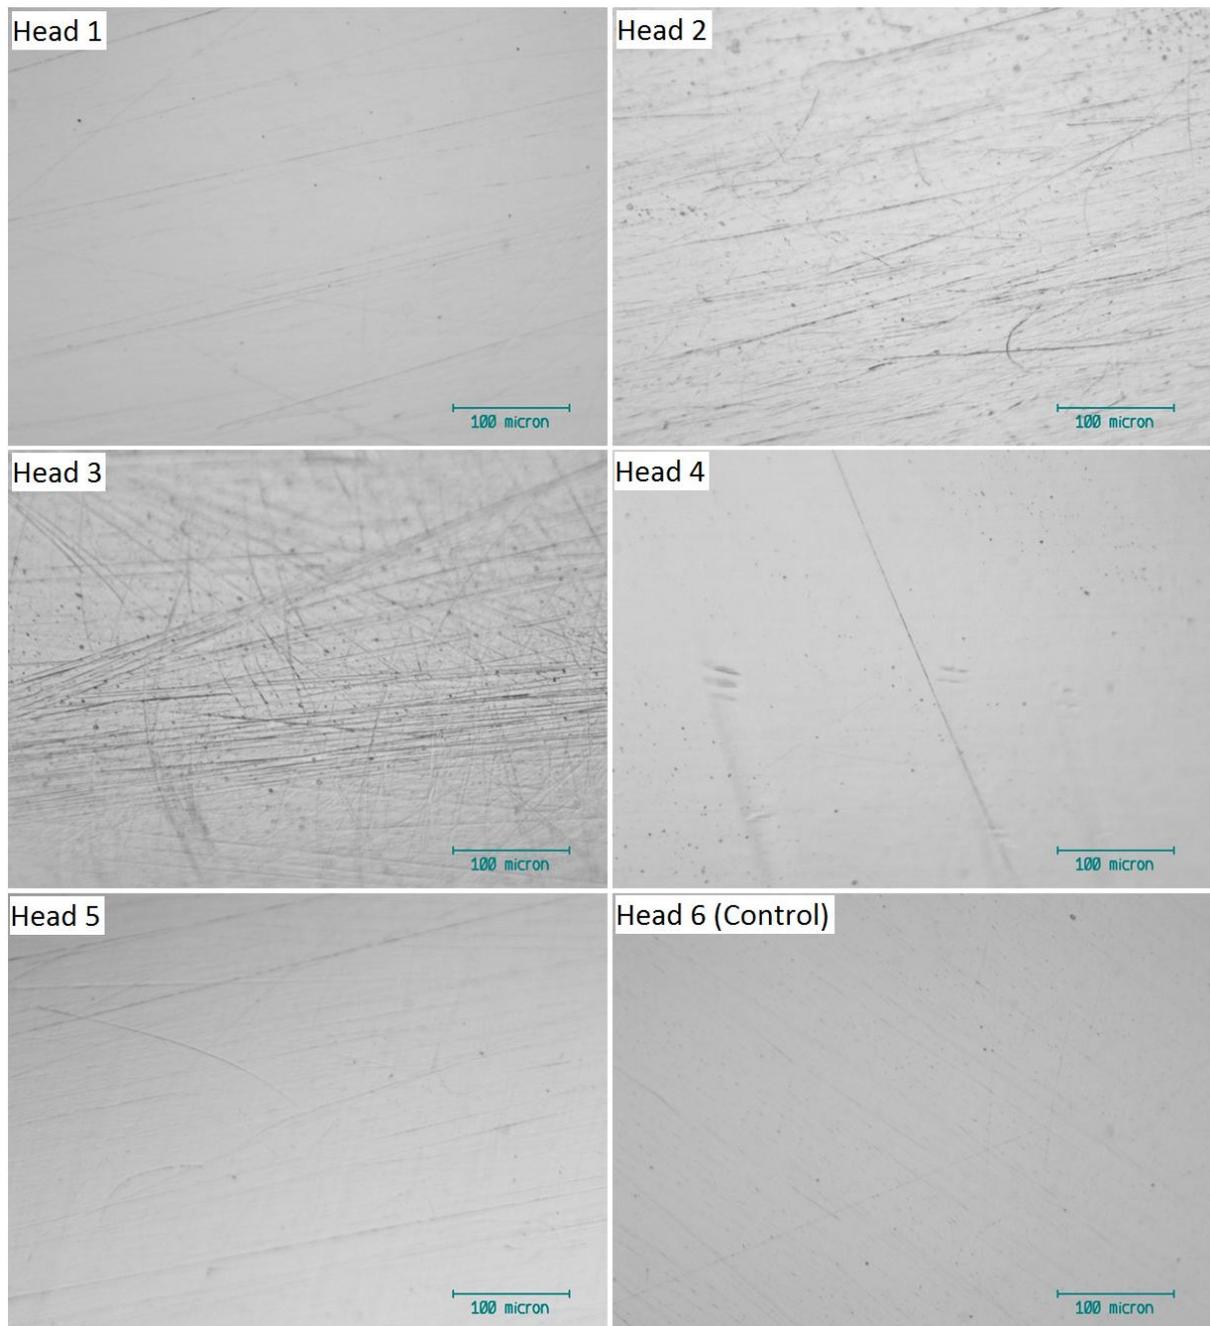
**Figure 5.85: Pole of 28 mm CoCrMo heads after 1.0 MC.**

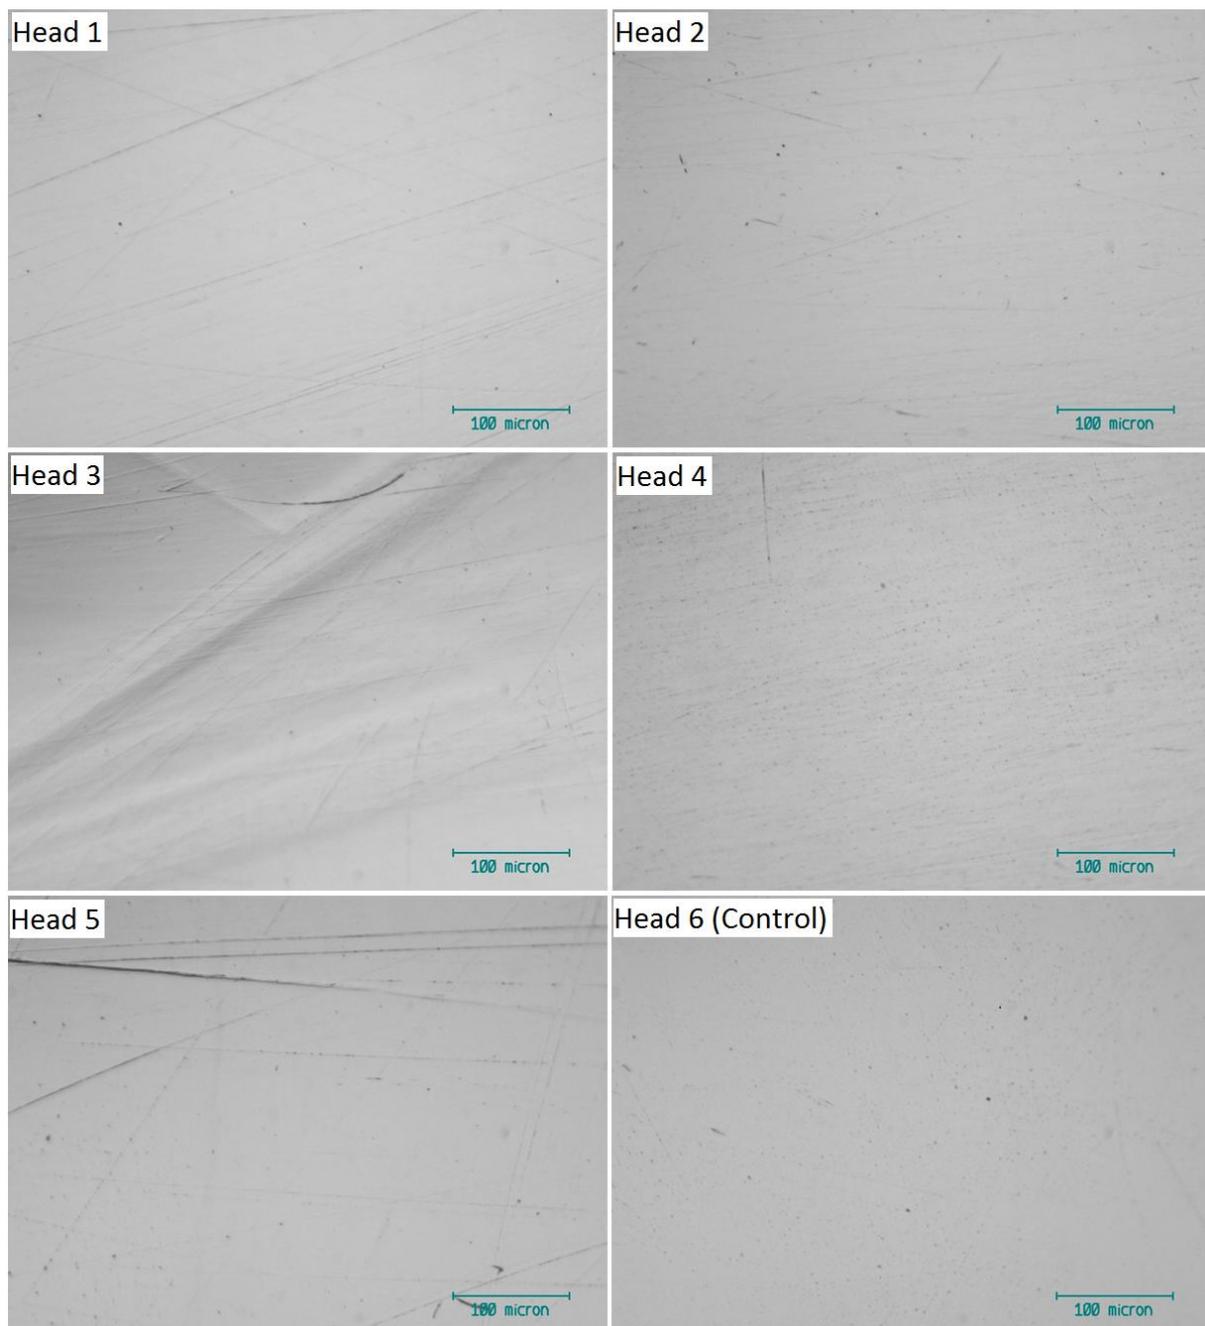
**Figure 5.86: Pole of 28 mm CoCrMo heads after 5.0 MC.**

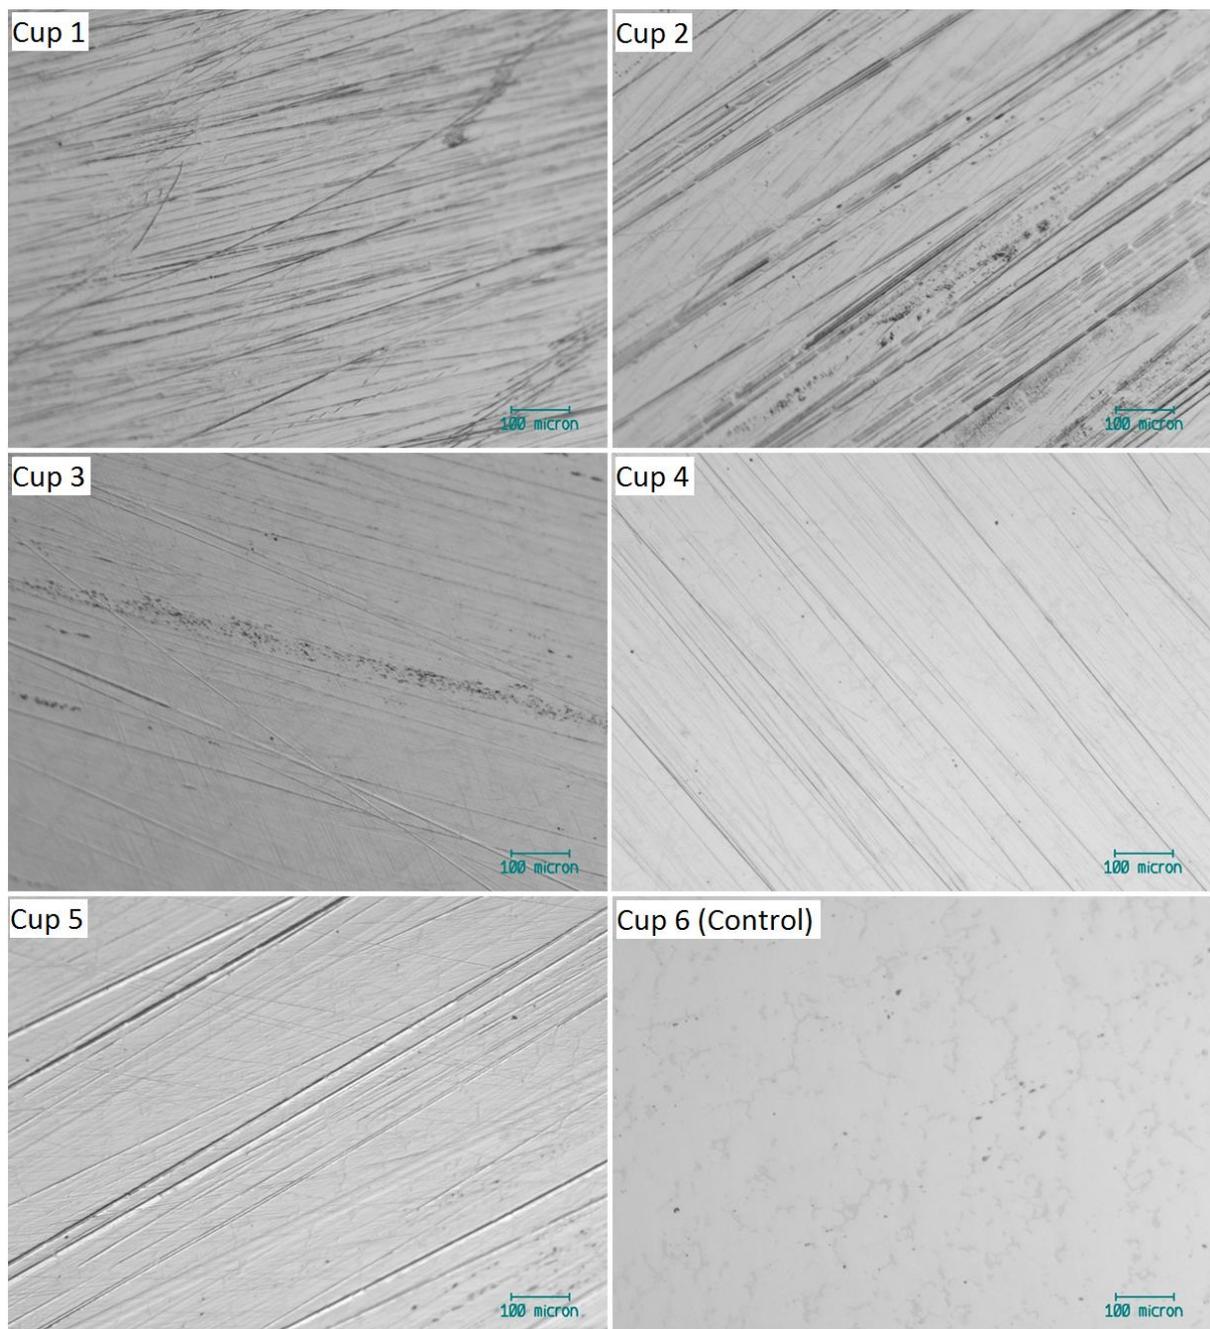
**Figure 5.87: Optical images taken within the wear patch of 60mm CoCrMo cups after 1.0 MC.**

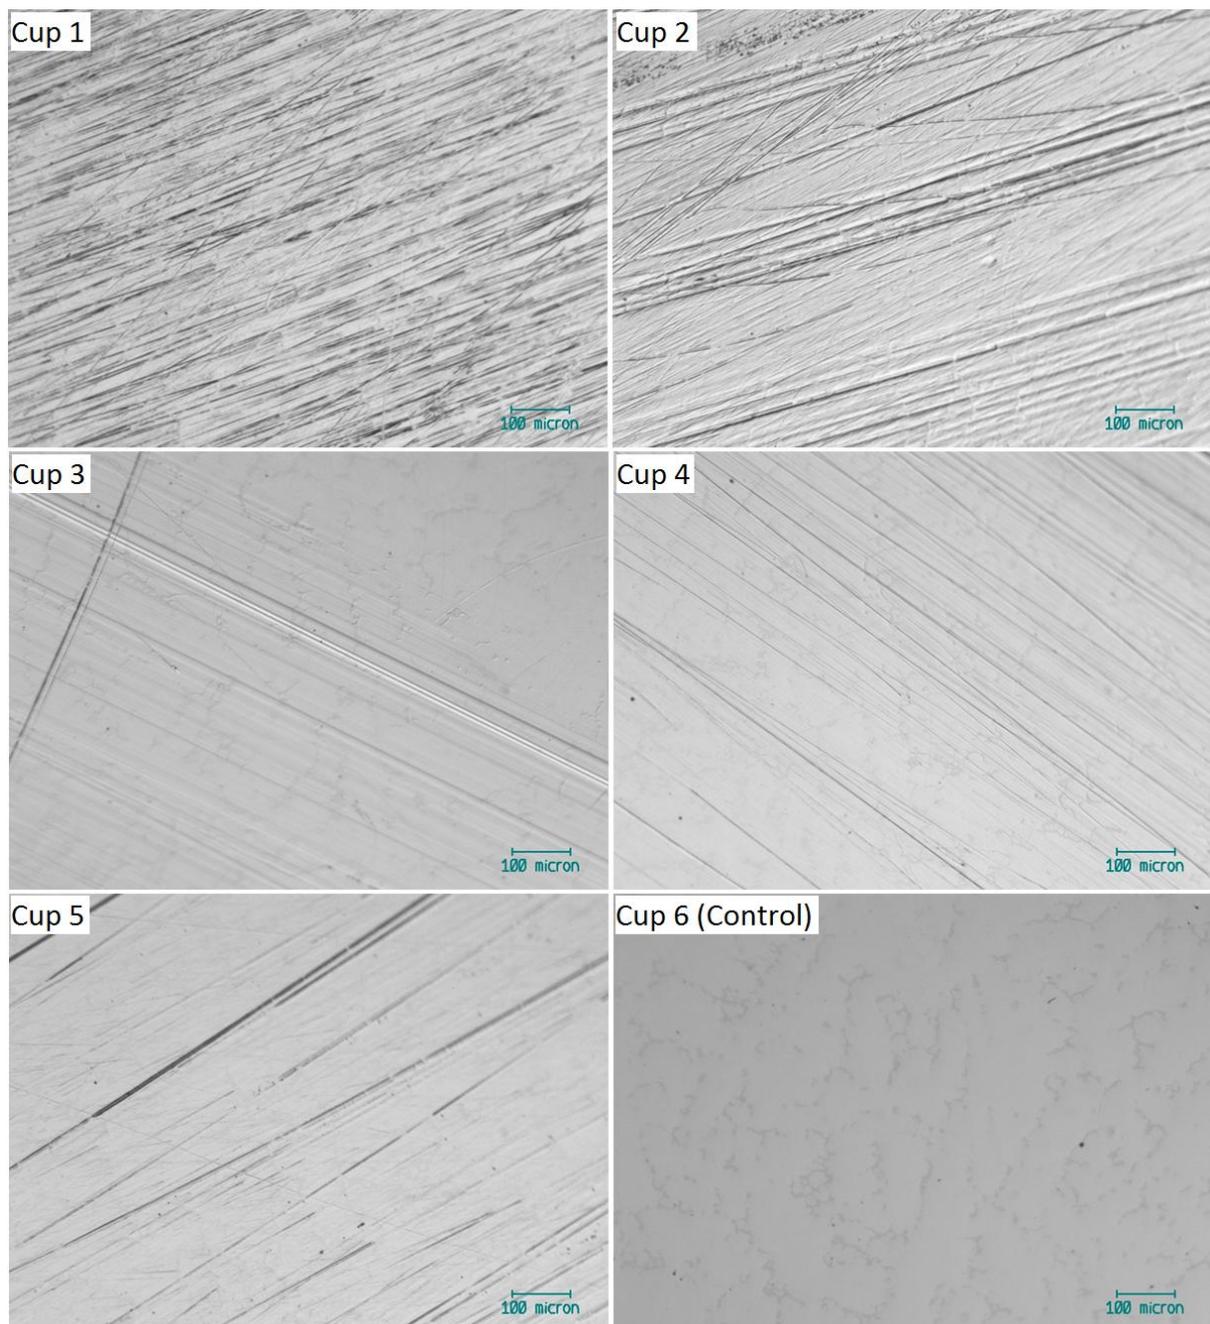
Figure 5.88: Optical images taken within the wear patch of 60mm CoCrMo cups after 5.0 MC.

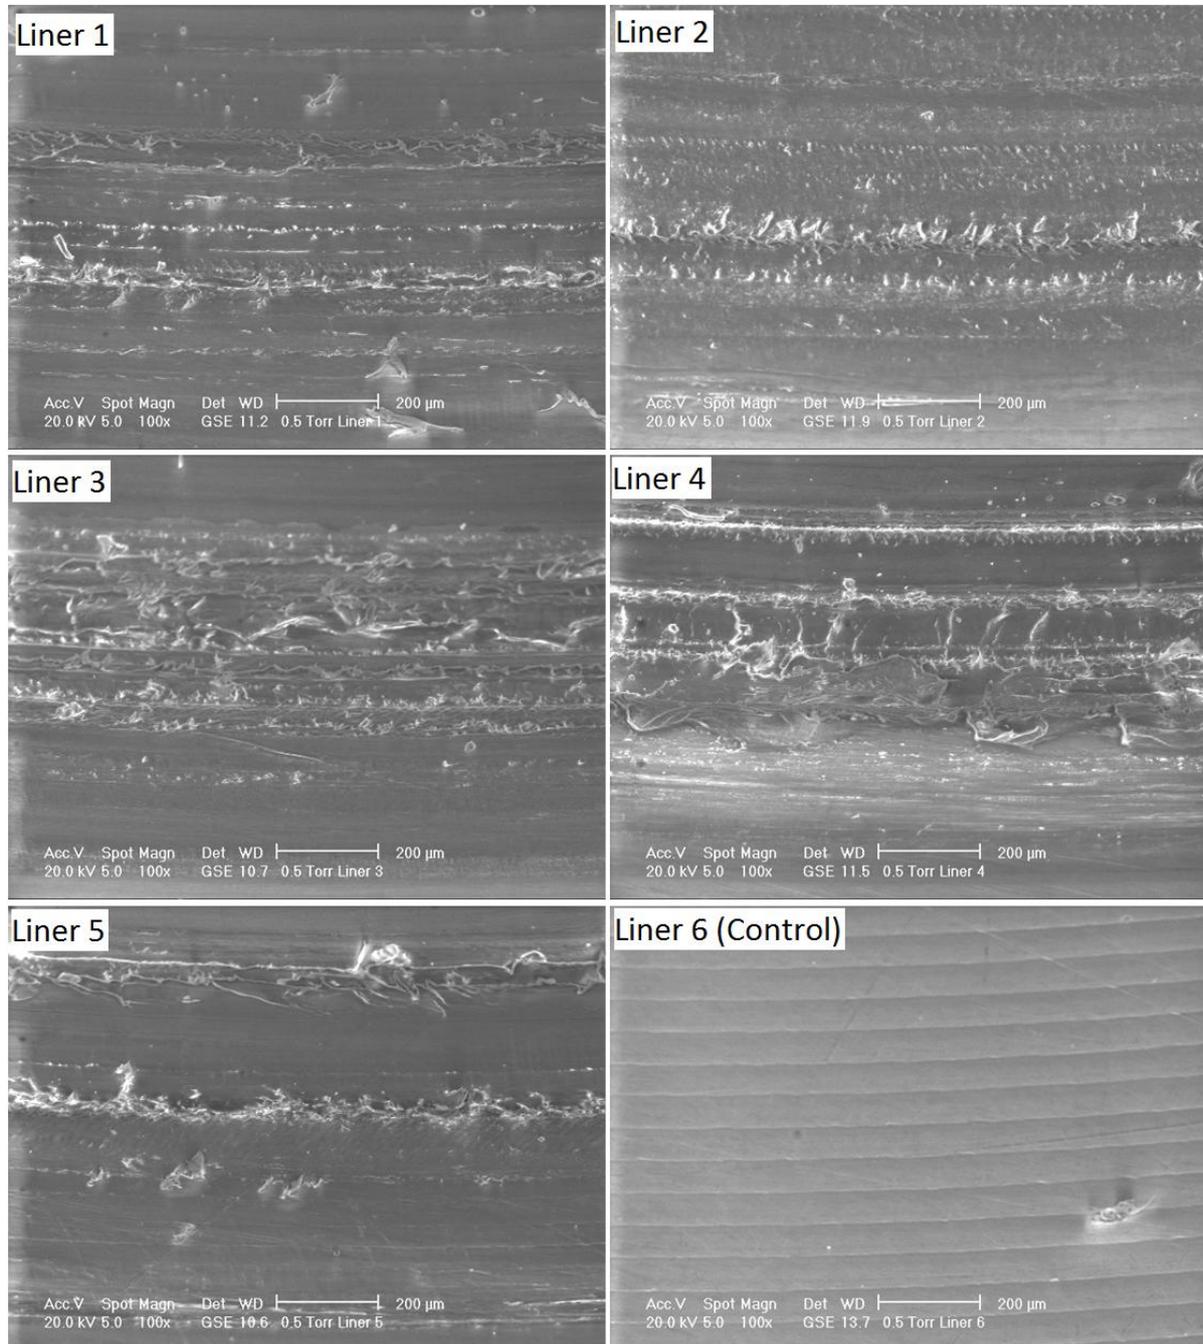
Figure 5.89: ESEM images taken around the E1 liner rim at 1.0 MC.
