# ***In Vitro* Investigation into the use of Dual Mobility for Partial Revision of a Failed Metal Hip Resurfacing**

**Elaine Lovelady**

Thesis presented for the degree of  
Doctor of Philosophy

School of Engineering and Computing Sciences

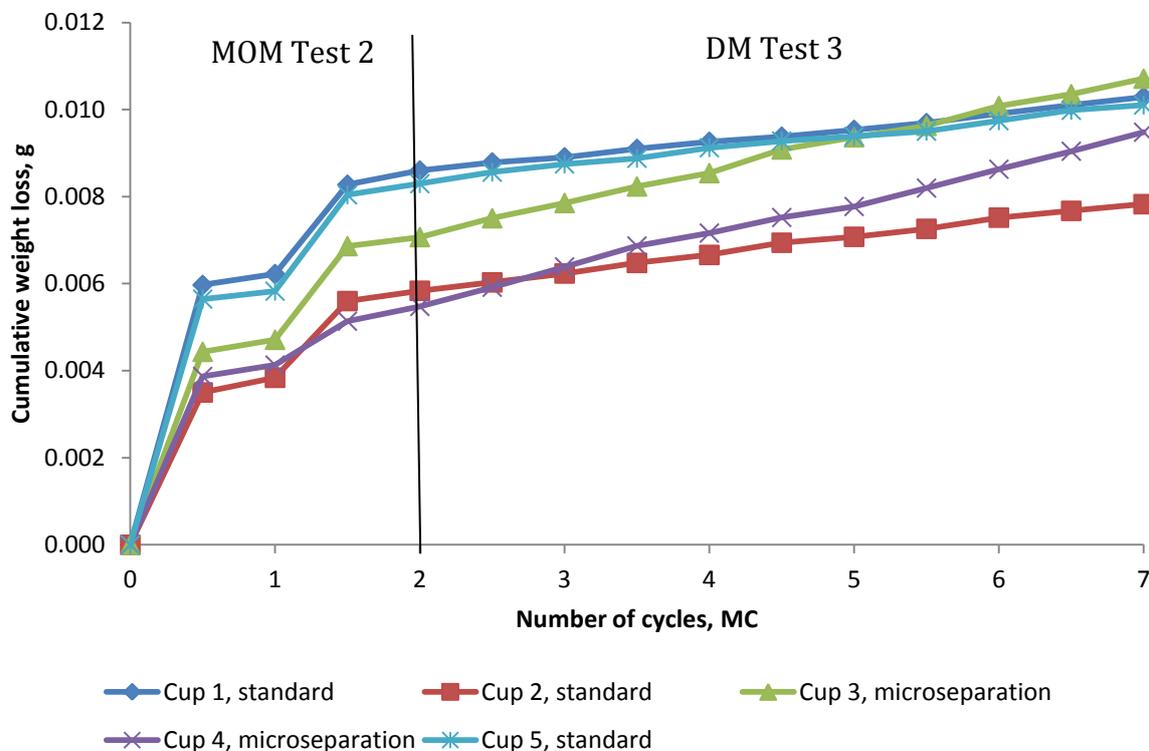
Figure 5.91: Cumulative weight loss of 60 mm CoCrMo cups throughout MOM Test 2 and DM Test 3, accounting for the load soak.

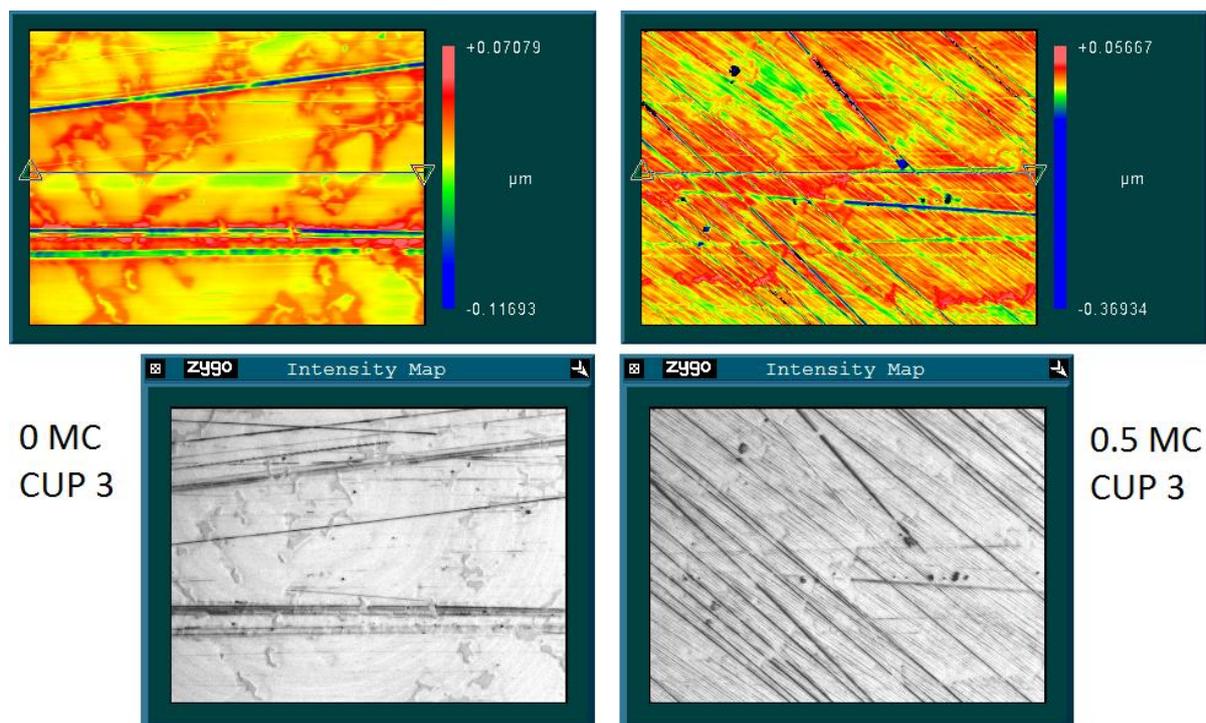
Figure 5.93: Zygo data from Cup 3 at 0 MC (left) and 0.5 MC (right) showing the 2D plot and corresponding image taken at the surface.

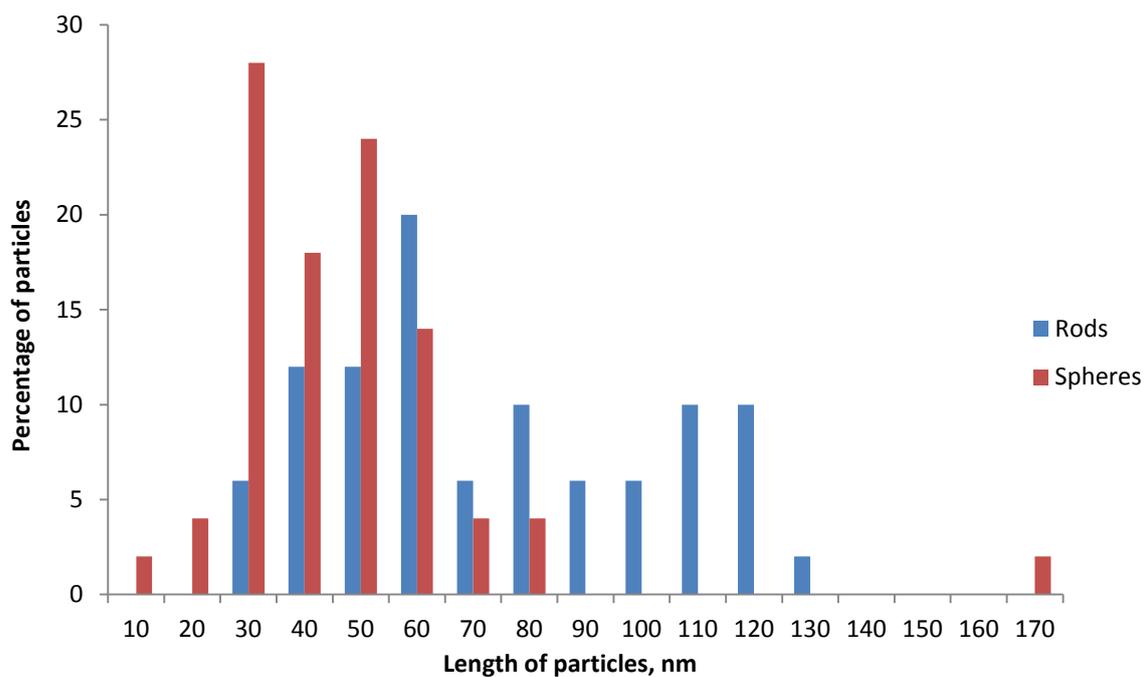
Figure 6.7: Particle distribution after 3.8 MC from Wear Condition 1.

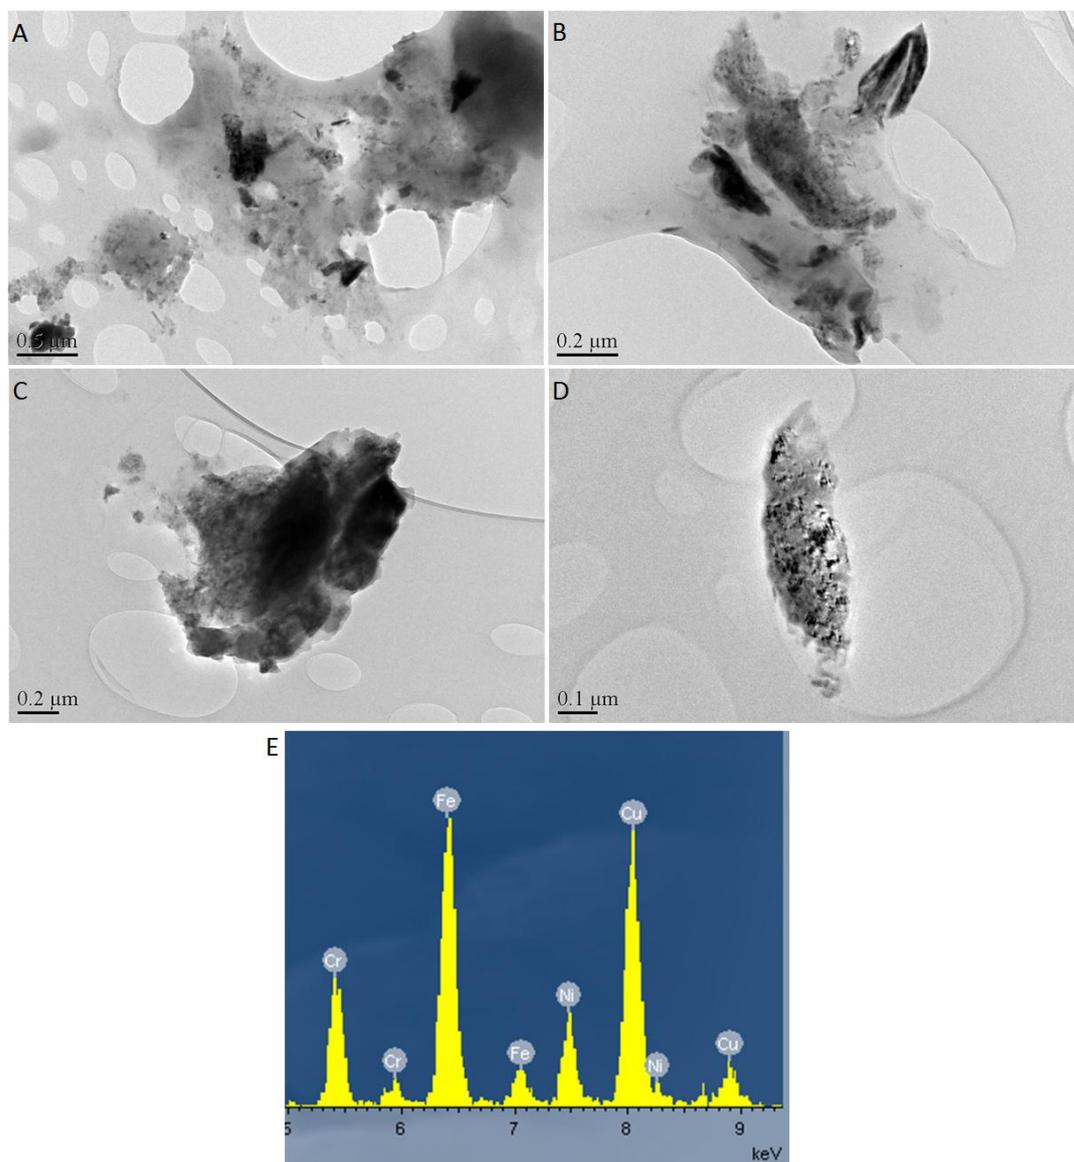
**Figure 6.14: Selection of TEM images taken of stainless steel wear particles present in DM Test samples. A: DM Test 1 (standard), B: DM Test 1 (Microseparation), C: DM Test 2 (standard), D: DM Test 3 (standard), E: EDX spectra confirming presence of Chromium, Iron and Nickel.**

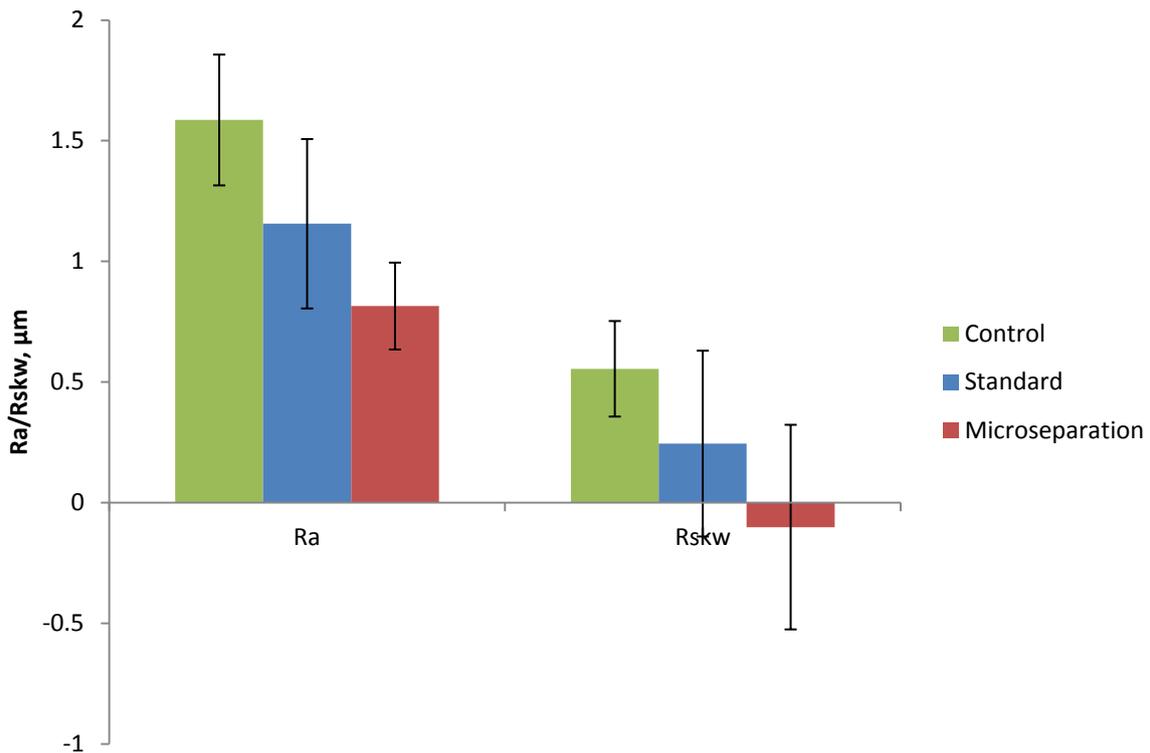
Figure 6.16: Zygo data taken from around the head stems at the end of dual mobility testing.

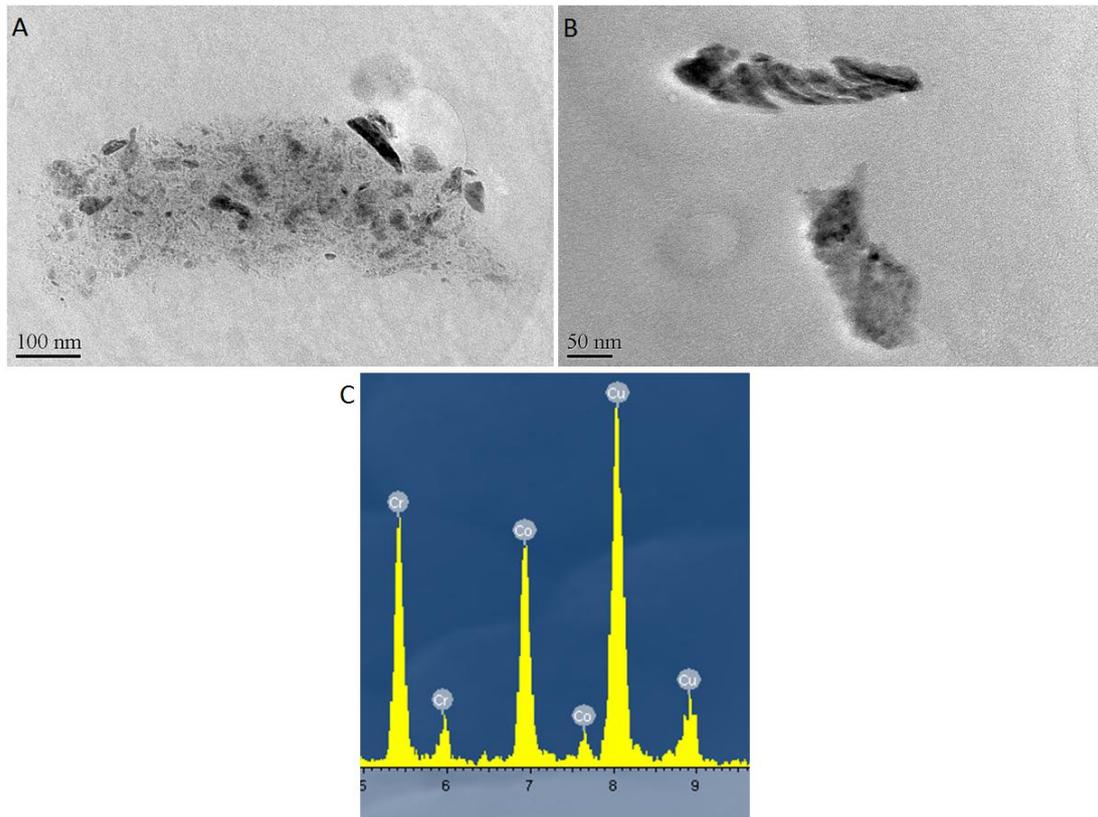
**Figure 6.17: A and B: TEM images of CoCr particles found in serum from DM Test 2 (microseparation) C: EDX spectra confirming presence of CoCr.**

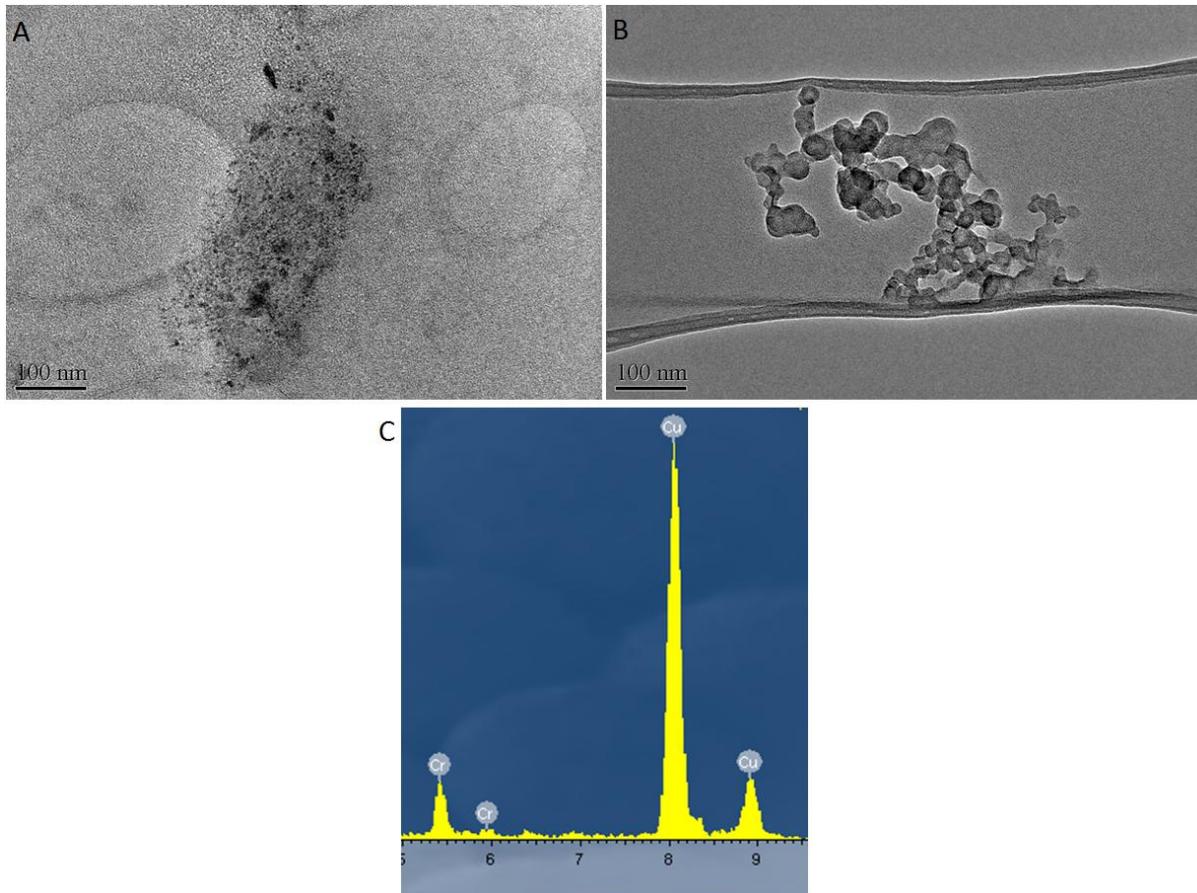
**Figure 6.19: A: TEM image from DM Test 2 (microseparation), B: TEM image from DM Test 3 (microseparation) C: EDX spectra confirming presence of Cr.**

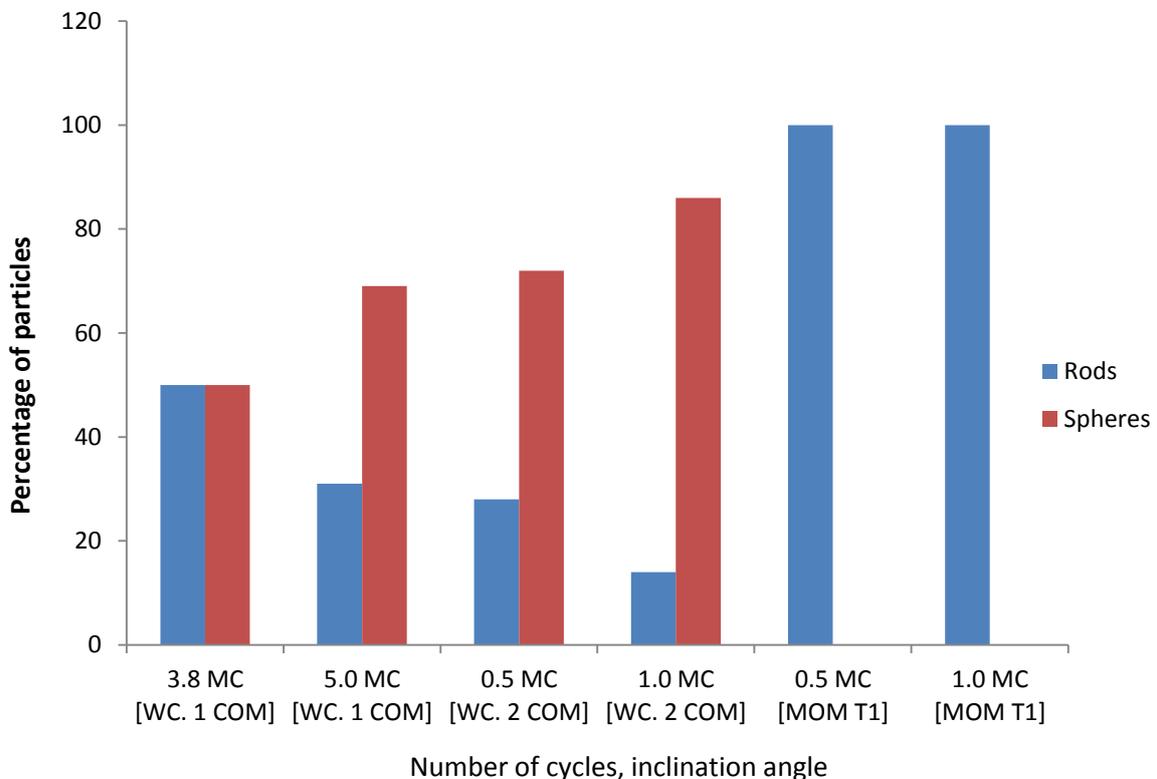
**Figure 6.21: Ratio of rod-like particles to spherical particles in all digested samples from the COM studies and MOM Test 1.**

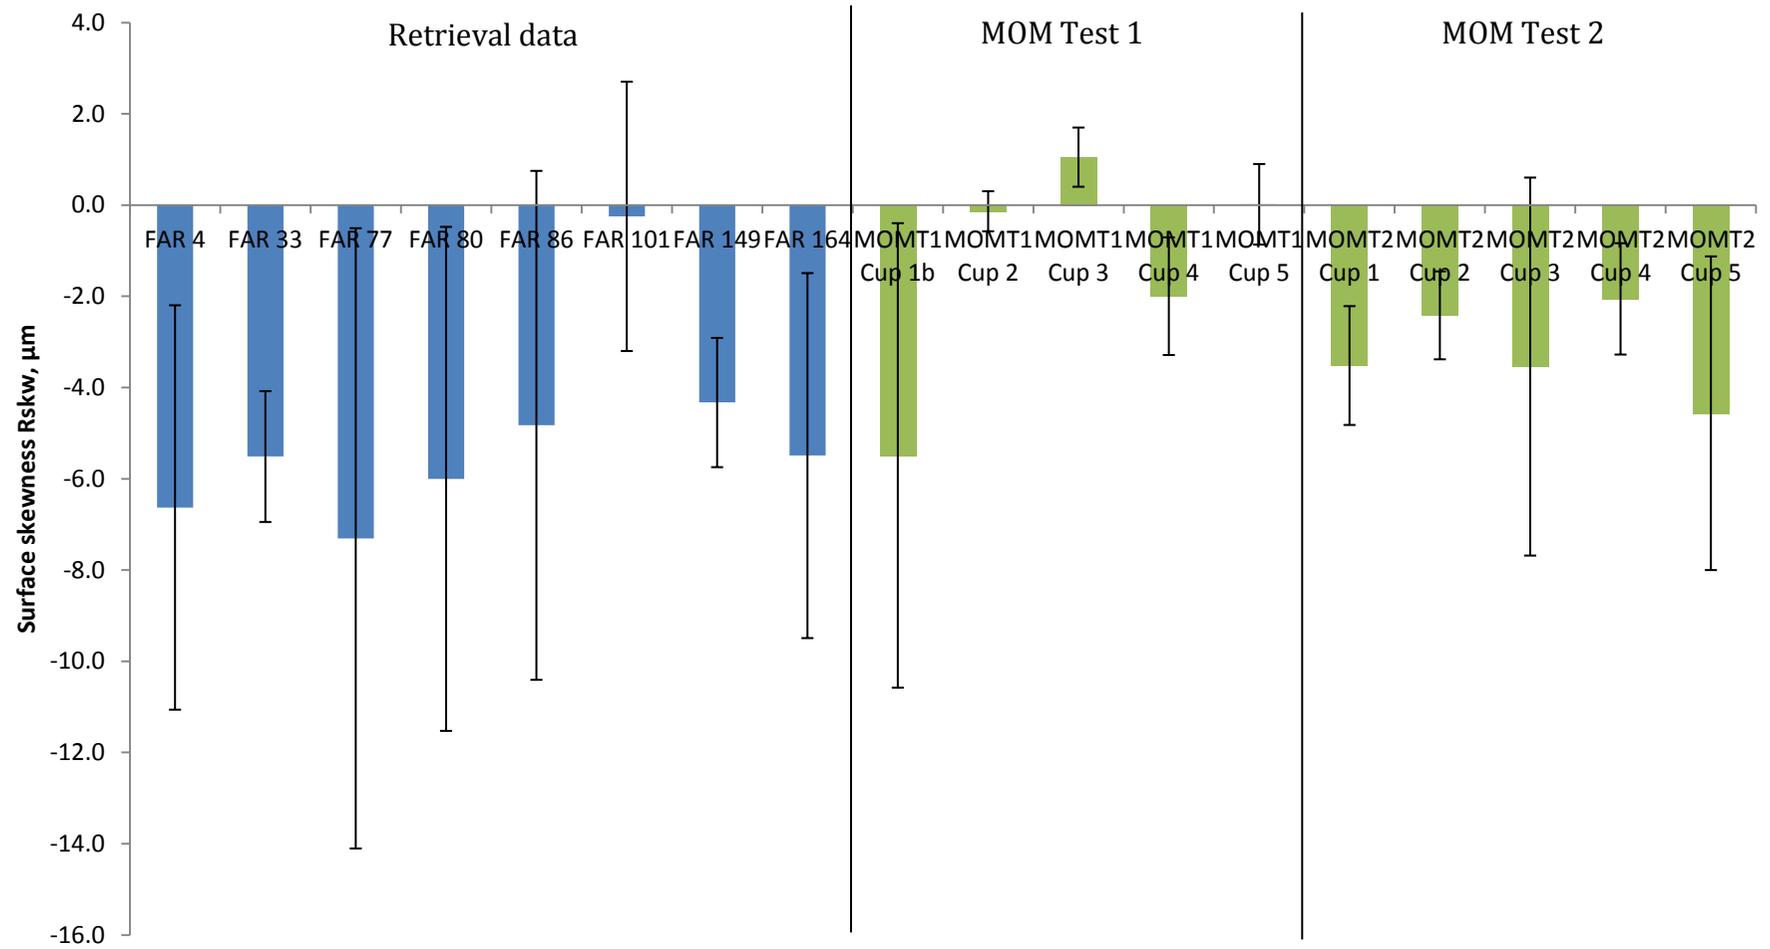
Figure 7.2: Comparison of zygo Rskw data from retrieved CoCrMo cups (blue) with CoCrMo cups from MOM T1 and T2 (green).

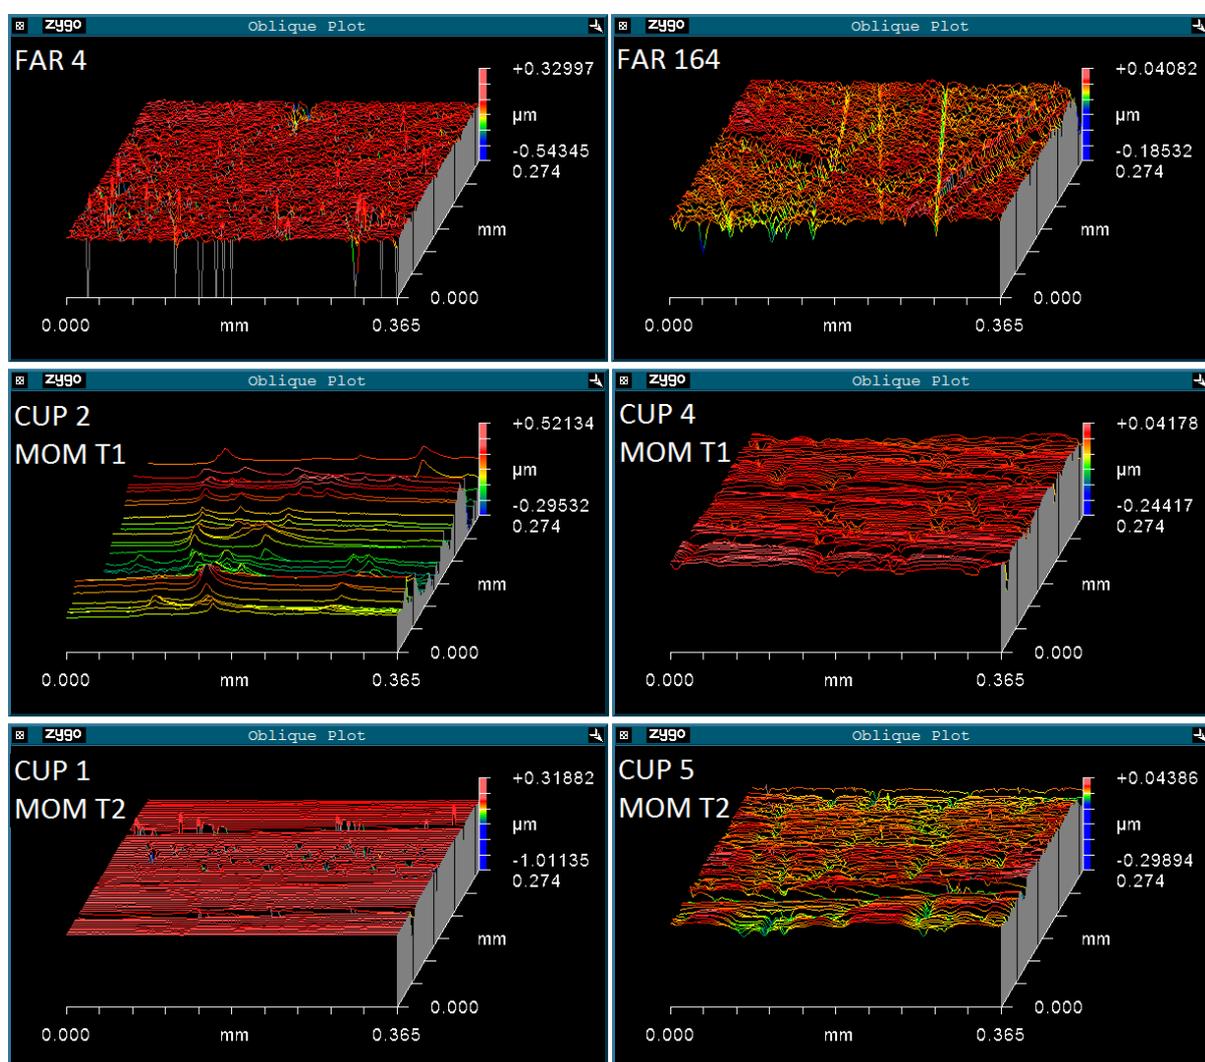
Figure 7.3: Comparison of surface profiles from retrieved CoCrMo cups with the CoCrMo cups at the end of MOM T1 and T2.

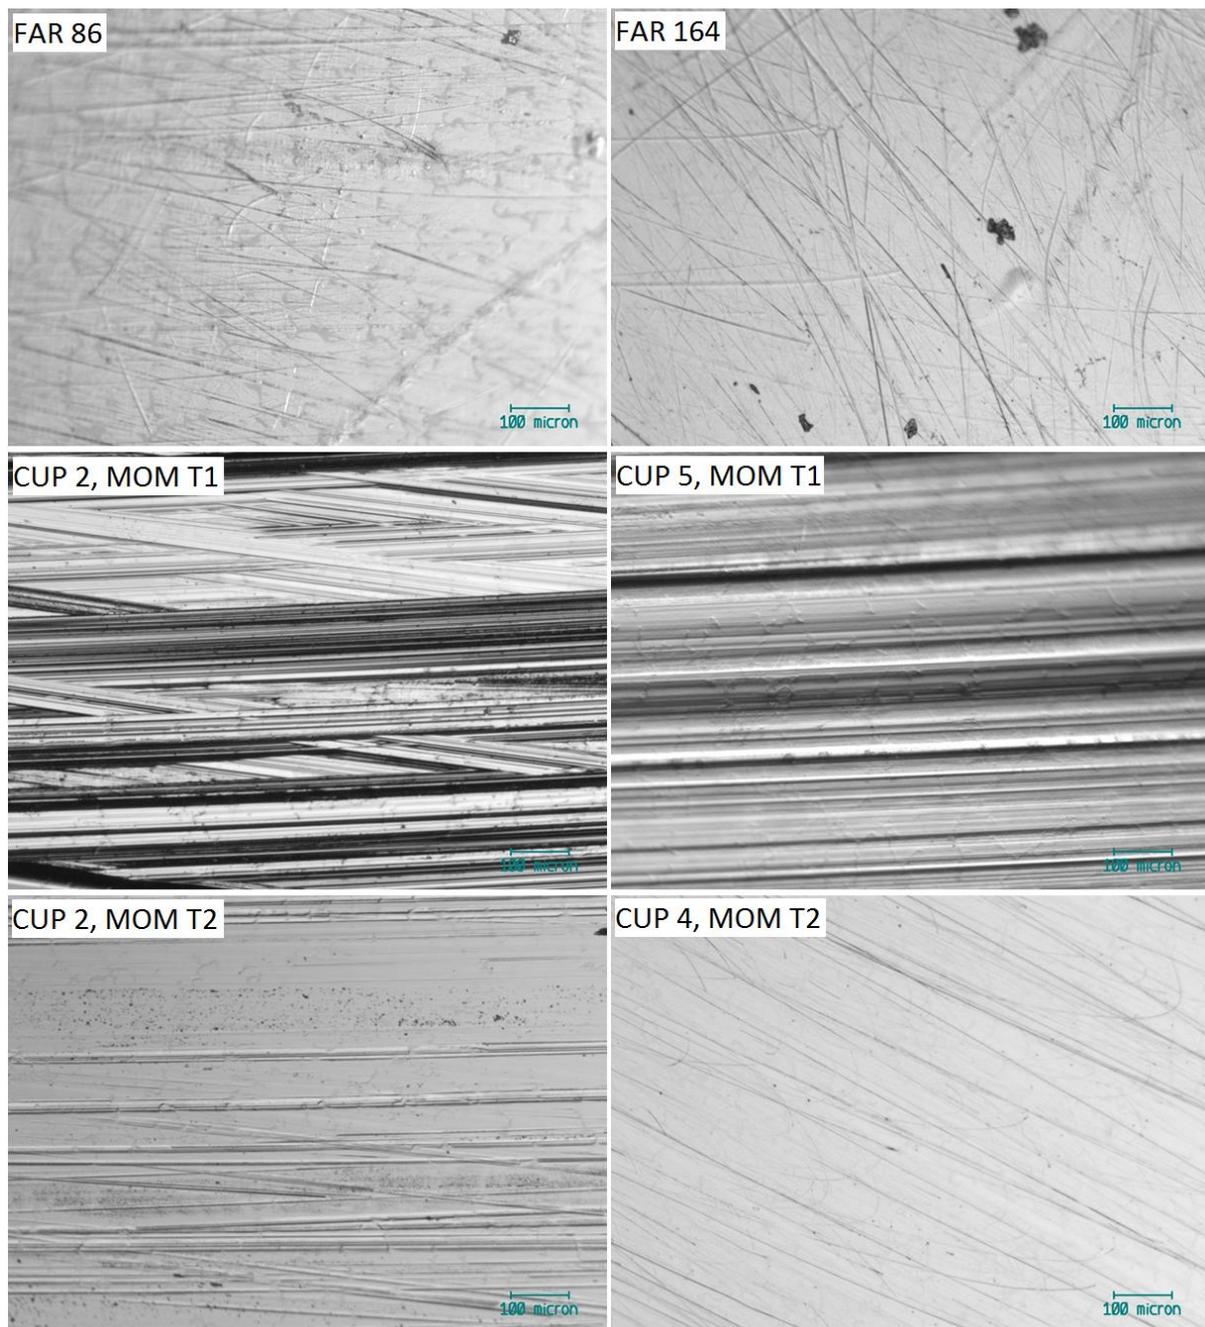
**Figure 7.4: Optical images taken within the wear patch of retrieved CoCrMo cups in comparison to the CoCrMo cups at the end of MOM T1 and T2.**

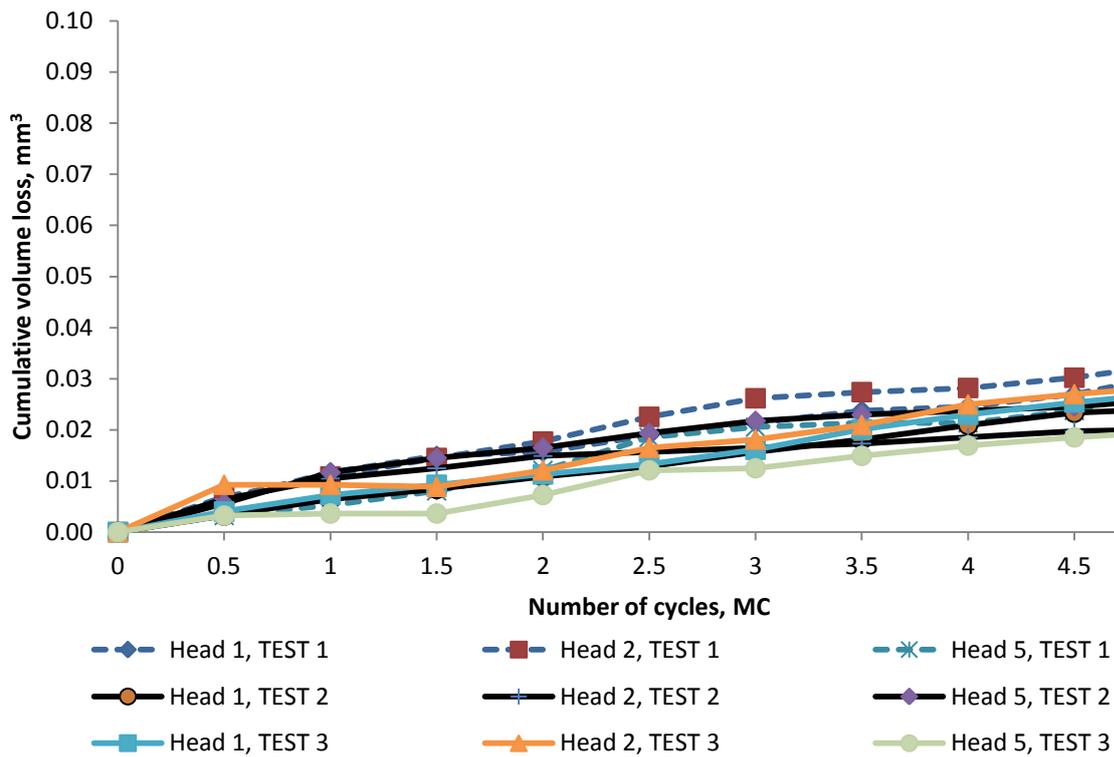
Figure 7.5: Cumulative volume loss of 28 mm CoCrMo heads in all dual mobility tests under standard conditions, accounting for the load soak.

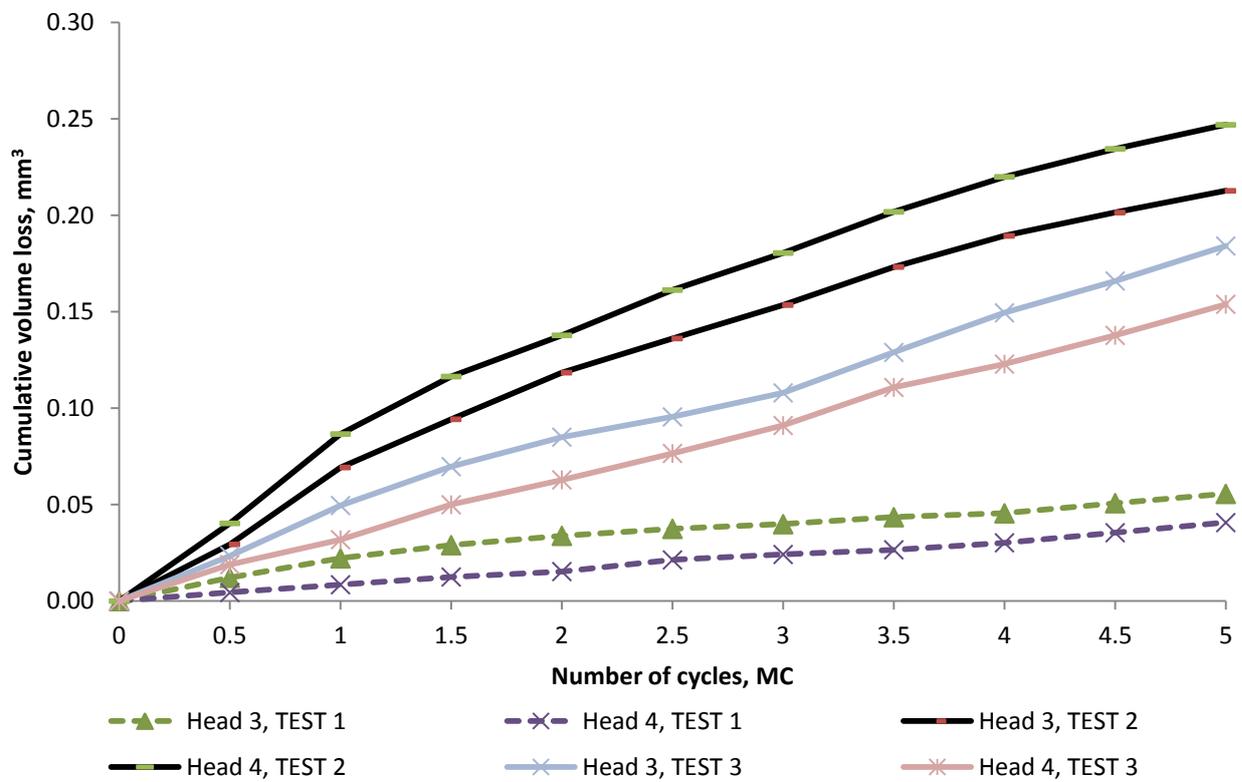
Figure 7.6: Cumulative volume loss of 28 mm CoCrMo heads in all dual mobility tests under microseparation conditions, accounting for the load soak.

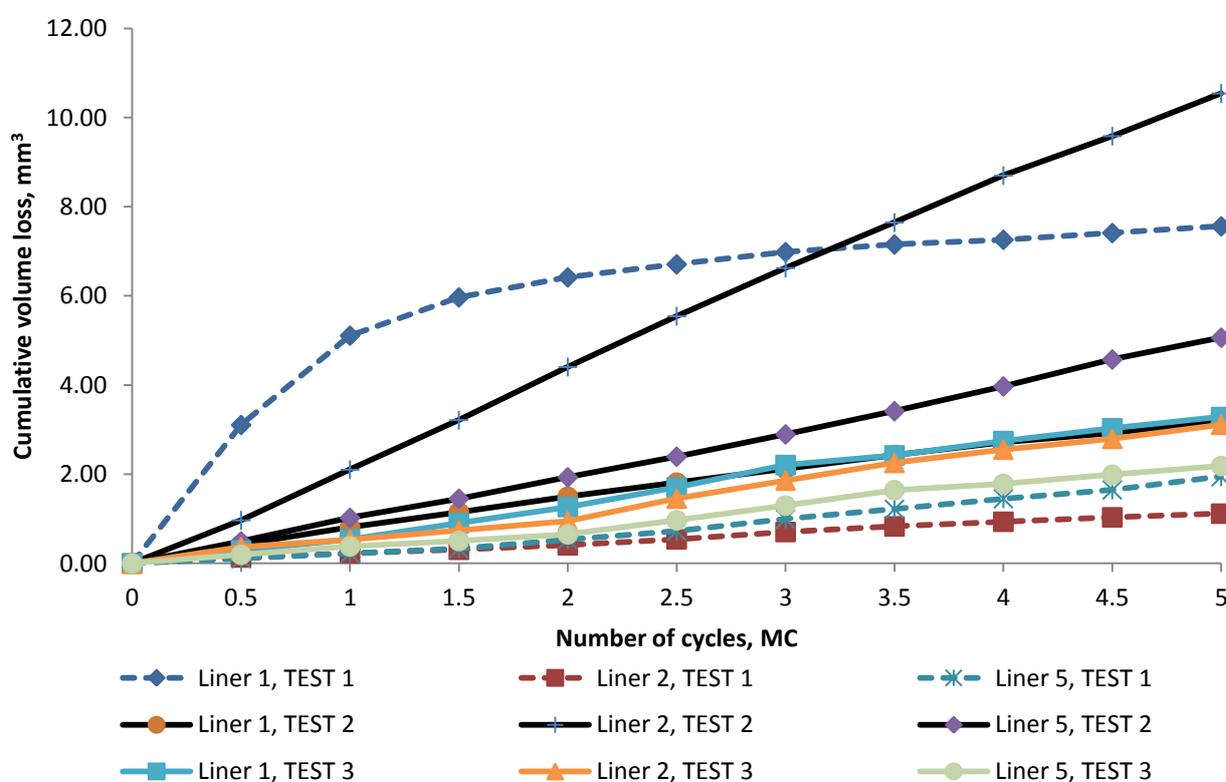
Figure 7.7: Cumulative volume loss from E1 liners in all dual mobility tests under standard conditions, accounting for the load soak.

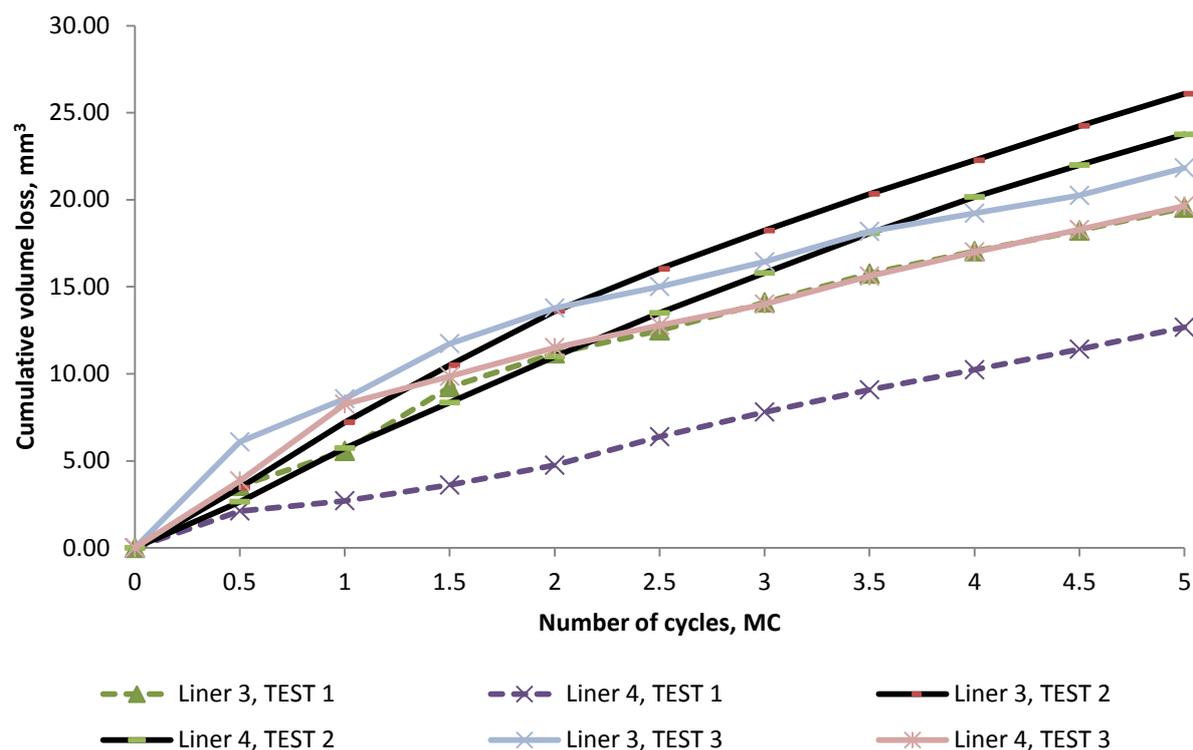
**Figure 7.8: Cumulative volume loss from E1 liners in all dual mobility tests under microseparation conditions, accounting for the load soak.**

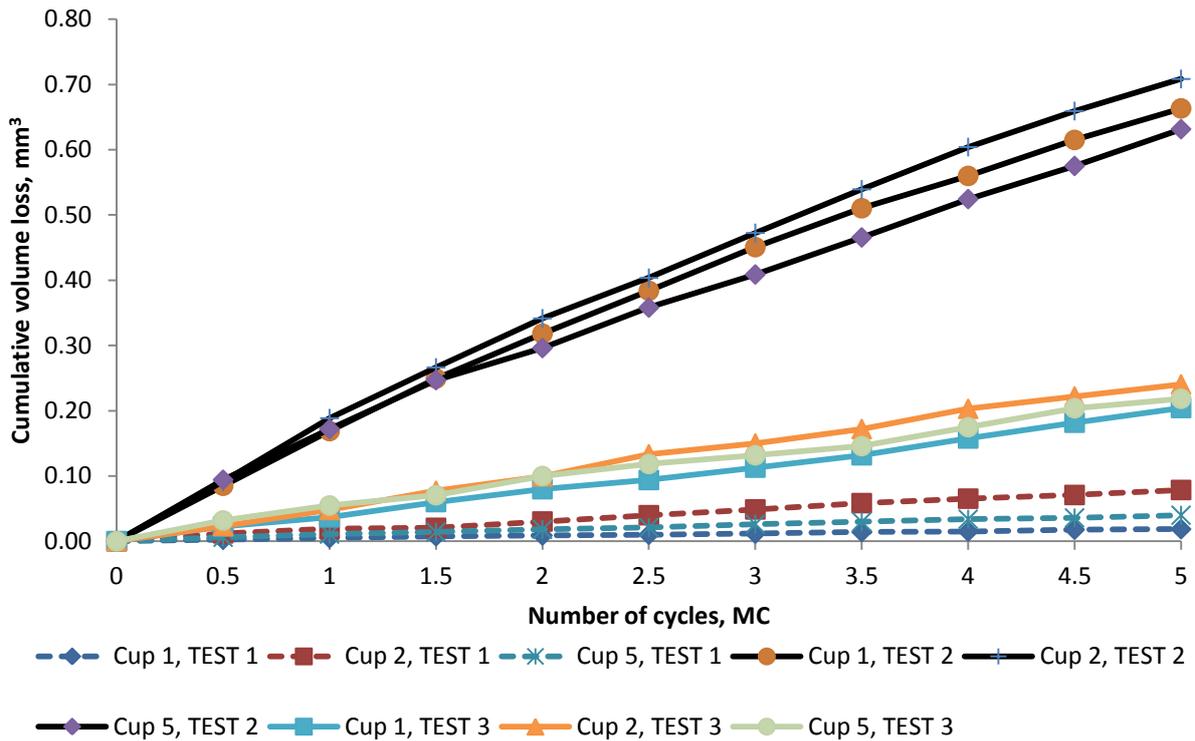
Figure 7.9: Cumulative volume loss of 60 mm CoCrMo cups in all dual mobility tests under standard conditions, accounting for the load soak.

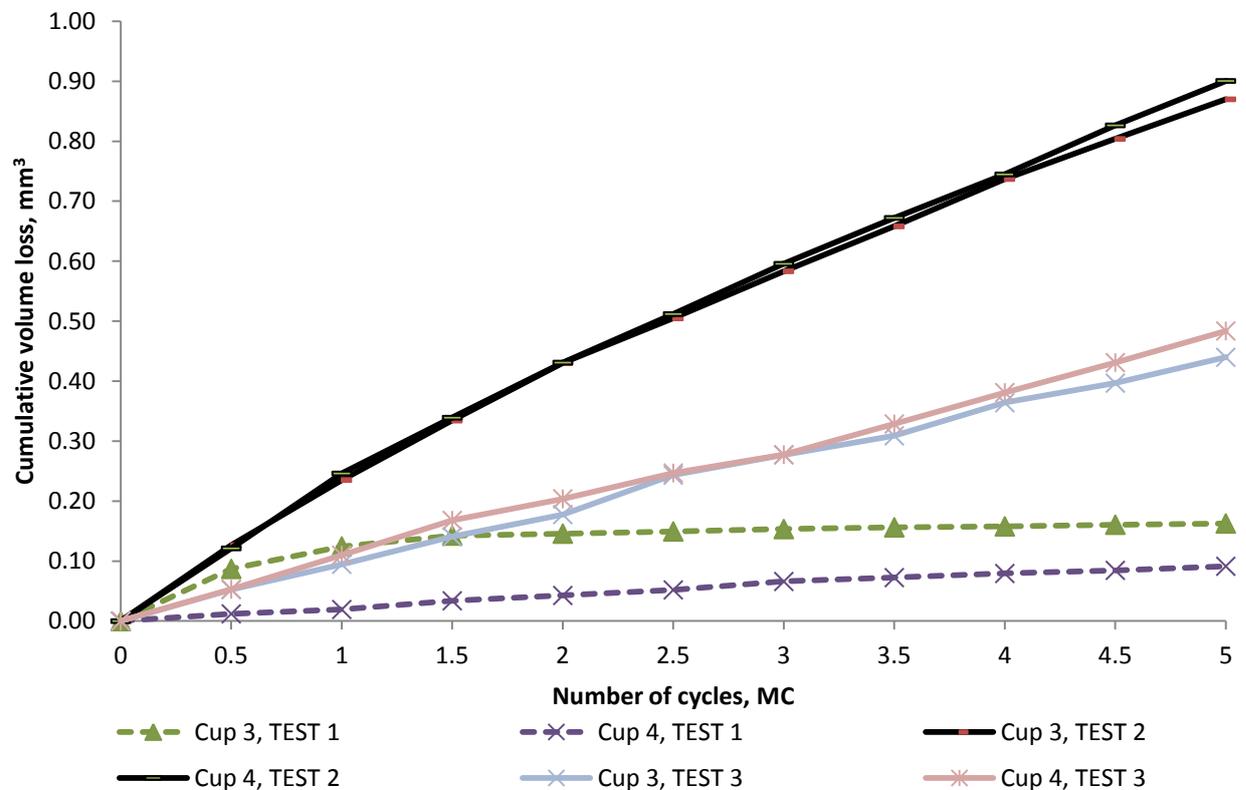
Figure 7.10: Cumulative volume loss of 60 mm CoCrMo cups in all dual mobility tests under microseparation conditions, accounting for the load soak.

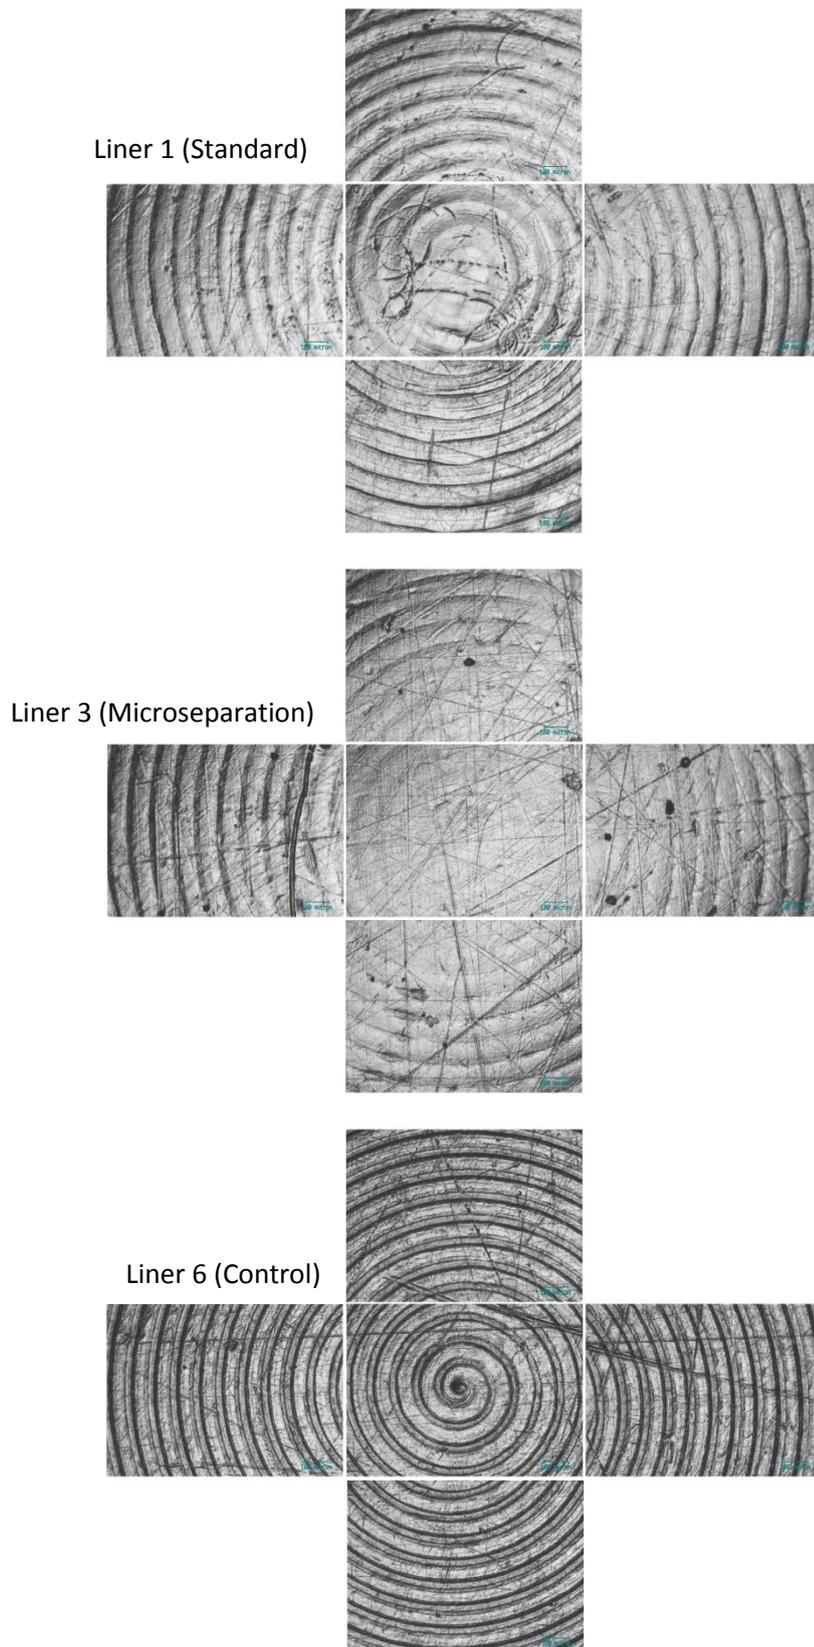
**Figure 7.11: Optical images taken from around the pole of the E1 liners in Dual Mobility Test 1: Worn cups from MOM Test 1 vs. dual mobility heads.**

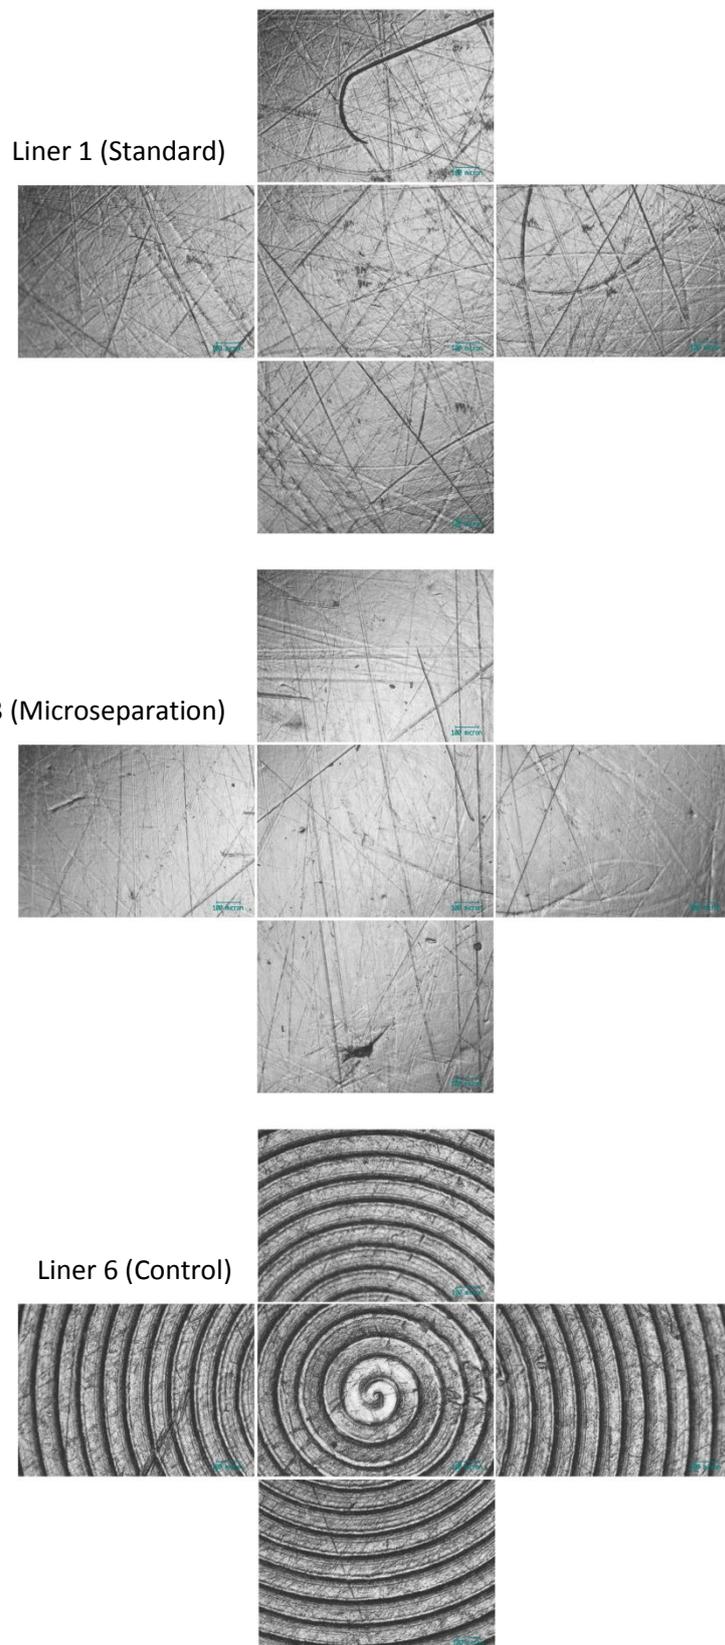
**Figure 7.12: Optical images taken from around the pole of the E1 liners in Dual Mobility Test 2: Unworn cups vs. dual mobility heads.**

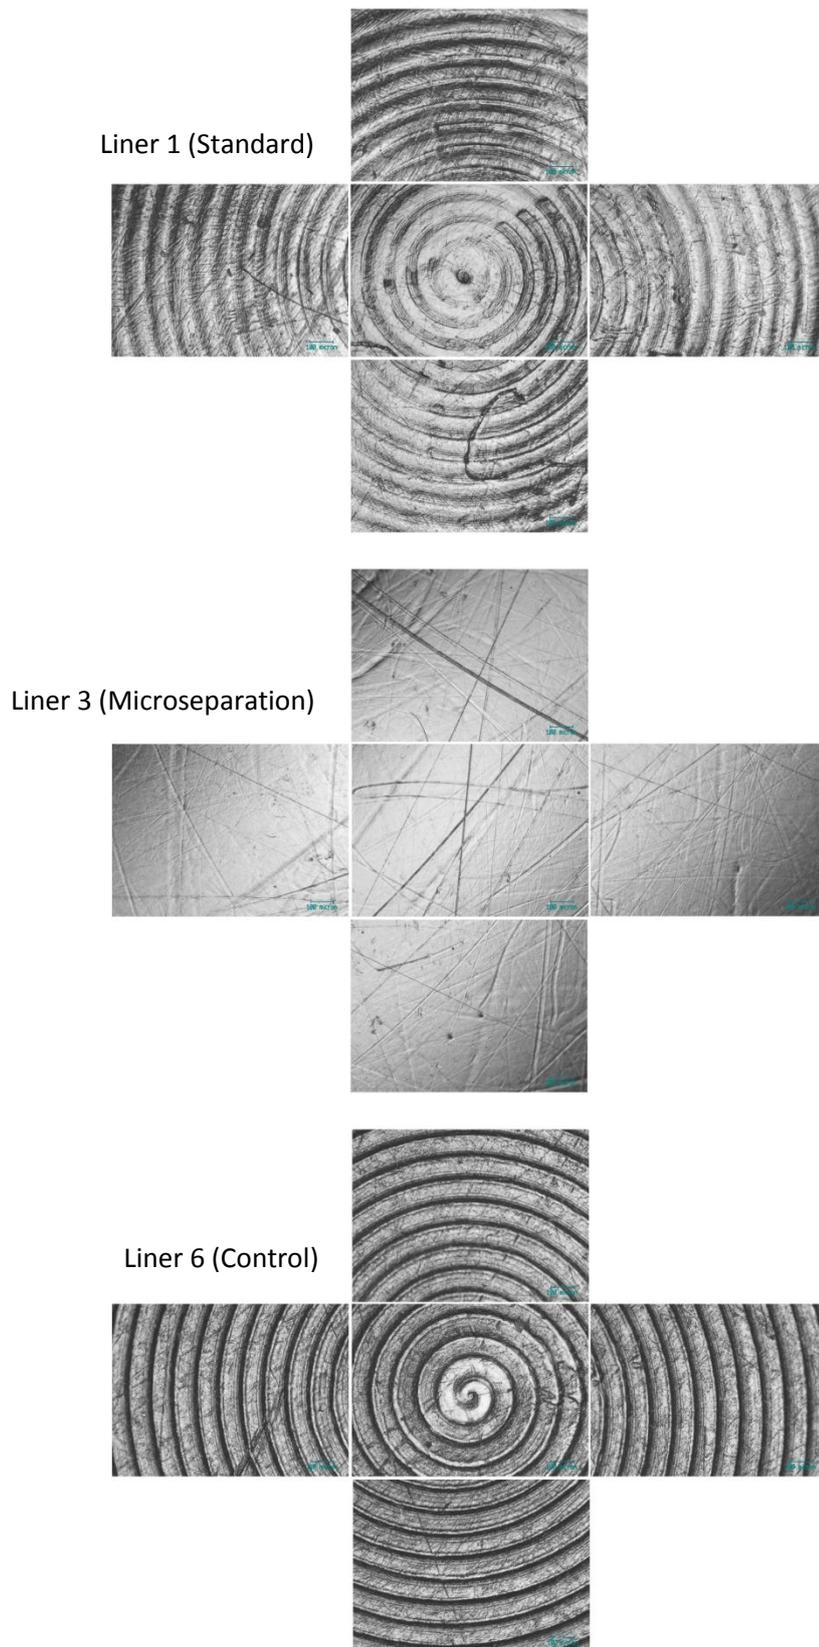
**Figure 7.13: Optical images taken from around the pole of the E1 liners in Dual Mobility Test 3: Worn cups from MOM Test 2 vs. dual mobility heads.**
