# ***In Vitro* Investigation into the use of Dual Mobility for Partial Revision of a Failed Metal Hip Resurfacing**

**Elaine Lovelady**

Thesis presented for the degree of  
Doctor of Philosophy

School of Engineering and Computing Sciences

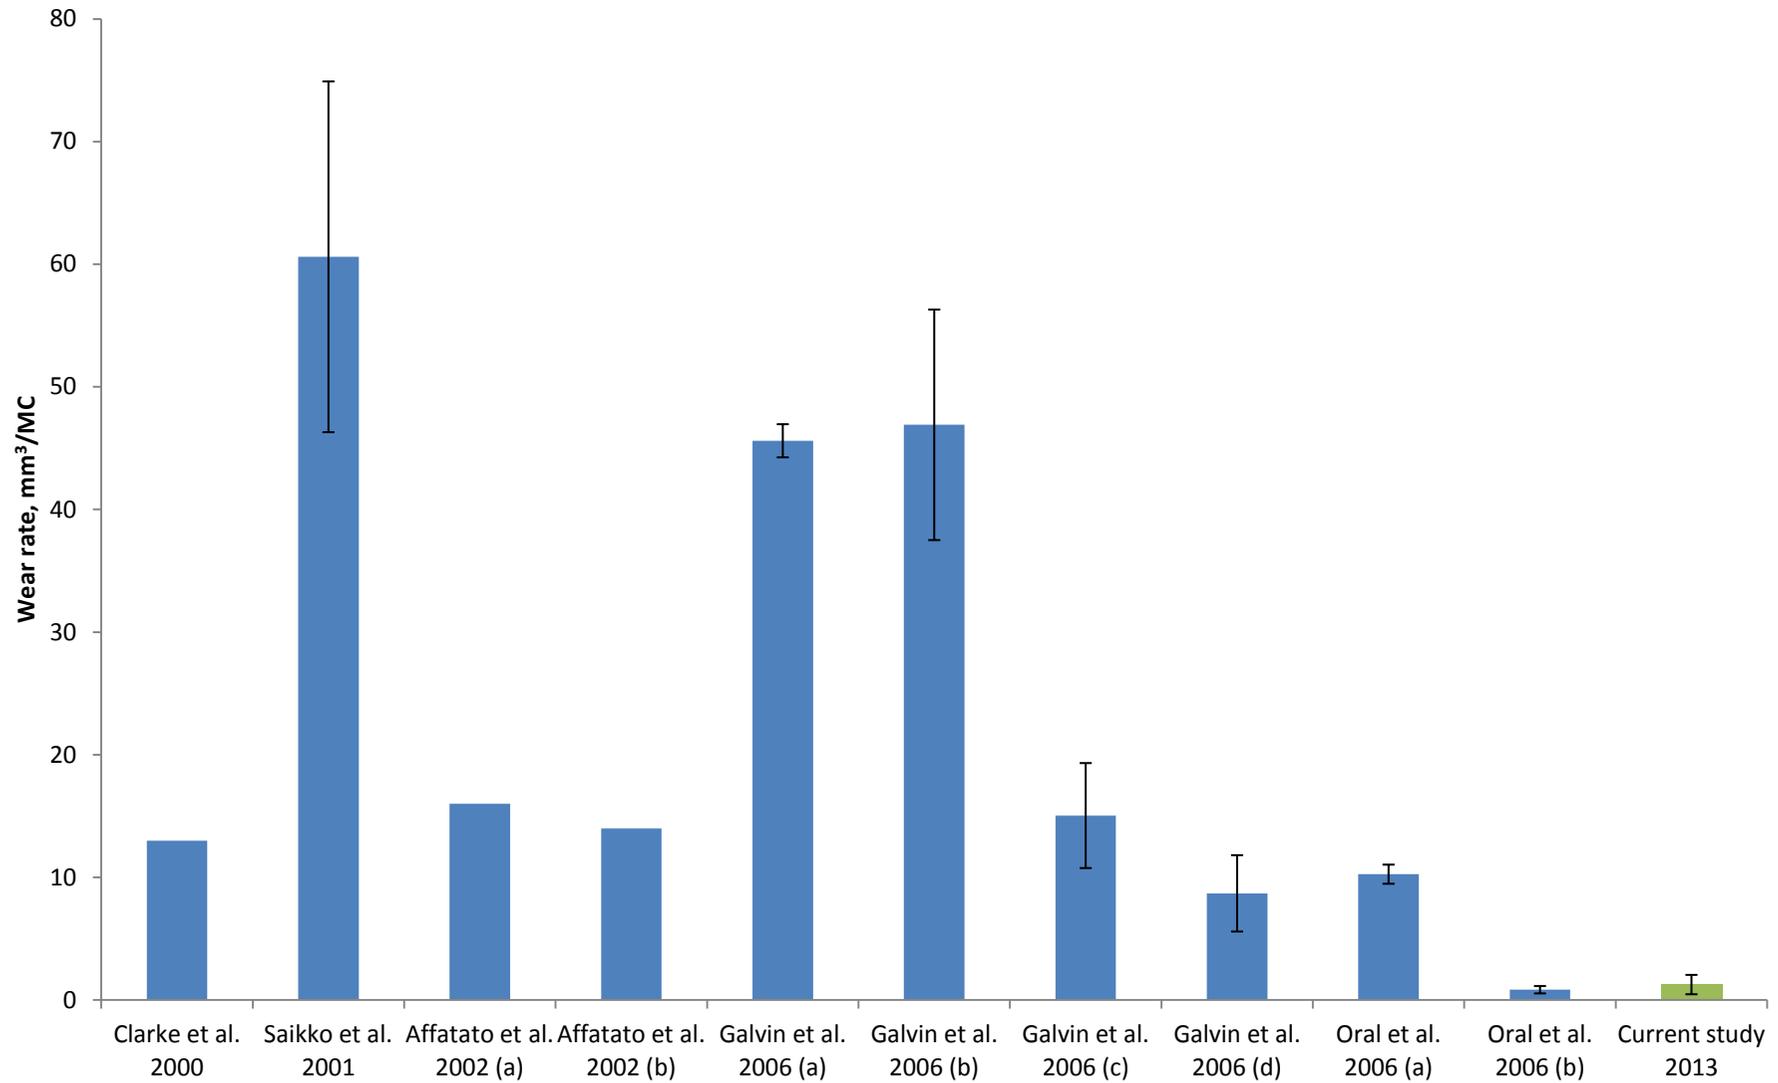
Figure 7.15: Comparison of previous *in vitro* testing of 28 mm CoCrMo heads against single articulation UHMWPE bearings with the current DM study.
