Early ecclesiastical sites in the northern isles and Isle of Man: An archaeological field survey

EARLY ECCLESIASTICAL SITES
IN THE
NORTHERN ISLES
AND
ISLE OF MAN:
AN ARCHAEOLOGICAL
FIELD SURVEY

VOLUME 2: GAZETTEER & ILLUSTRATIONS

Thesis presented by Christopher Edmund Lowe for
the degree of Doctor of Philosophy in the
University of Durham.

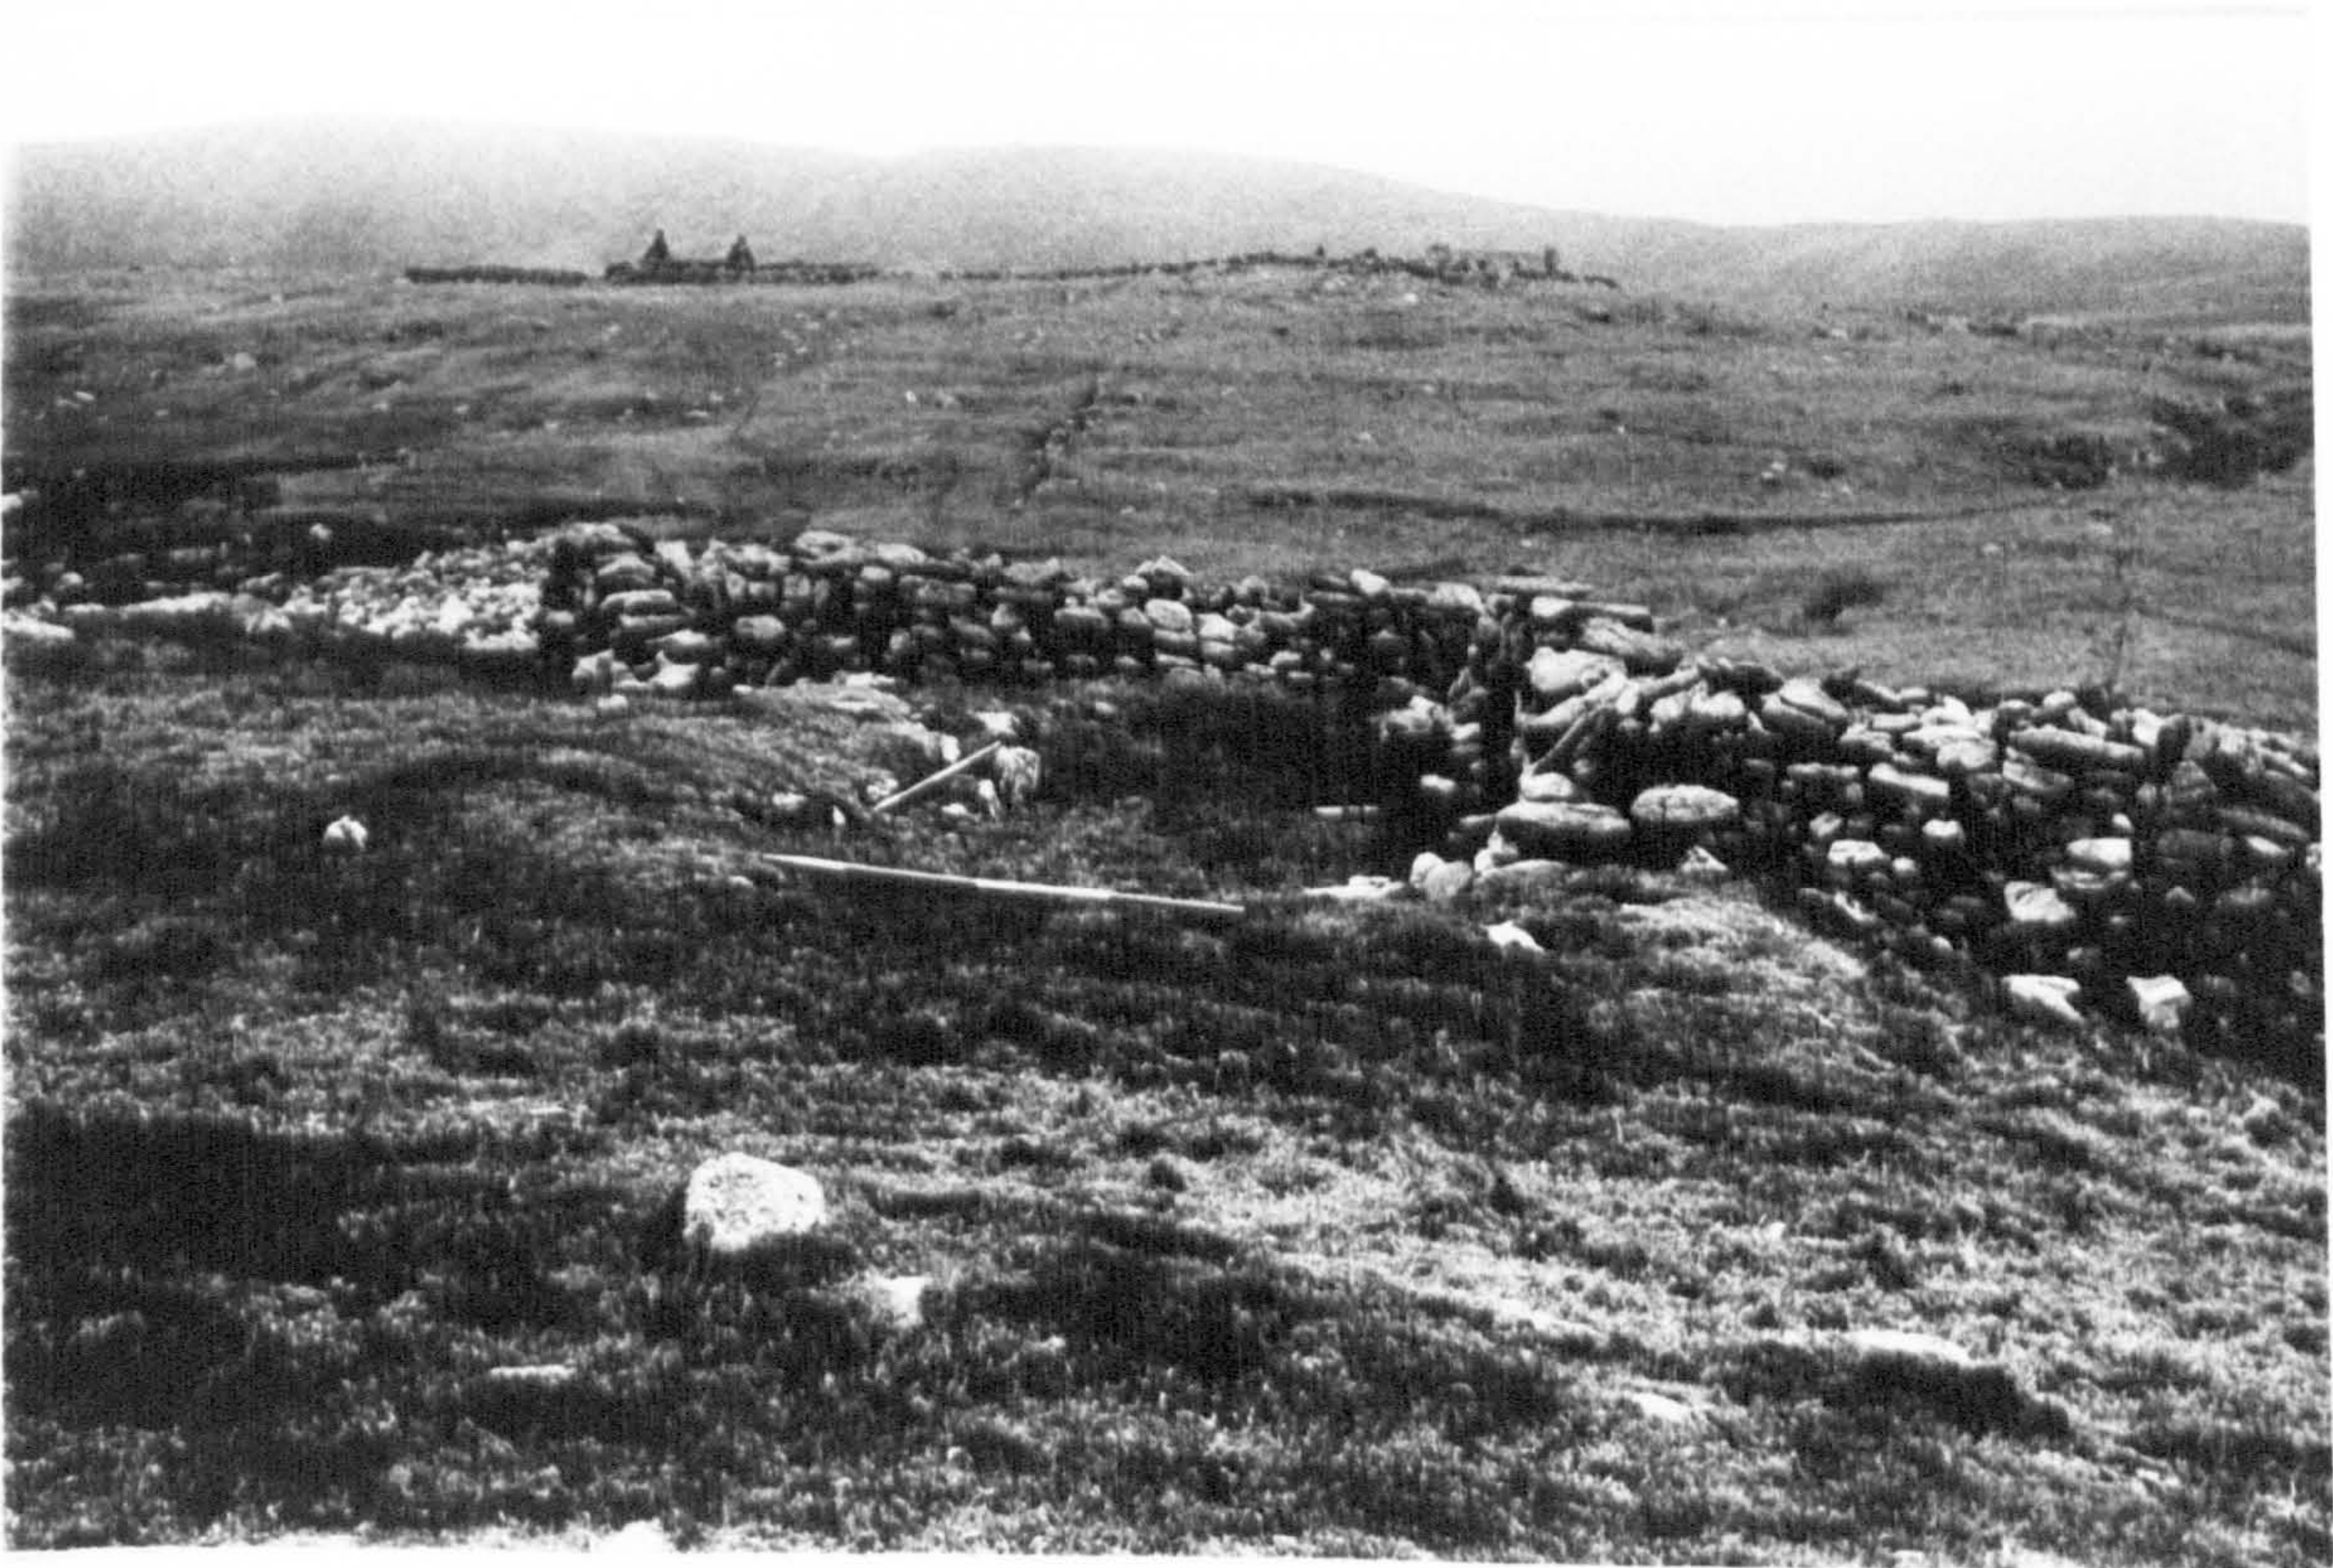
b) Kirkaby chapel (UNST 14) facing E: foundation of bench
visible against N wall of nave; enclosure bank visible
in foreground
