Assessing the importance of river bank erosion for fine sediment delivery to Bassenthwaite Lake

Jonathan Hopkins

Thesis for M. Sc. (by research)

Durham University, Department of Geography

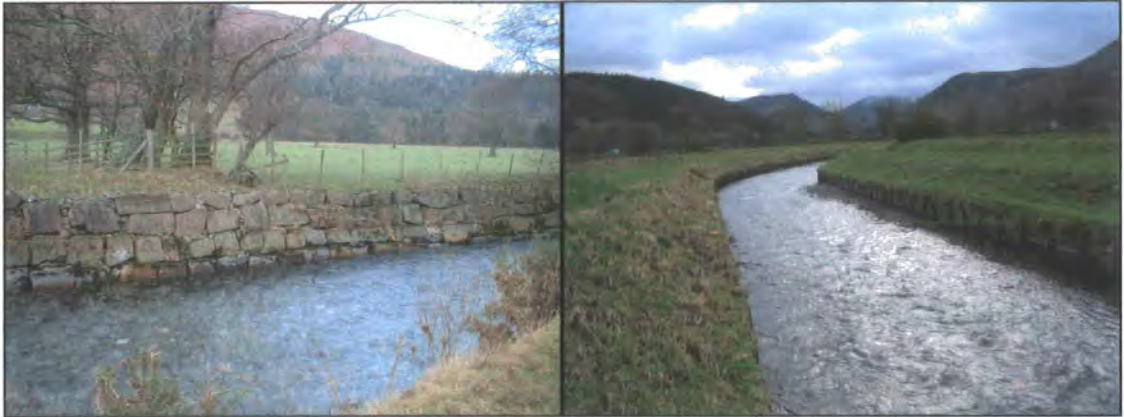
Figure 2.5: Channel regulation on Newlands Beck, showing channel straightening and bank heightening and reinforcement using (left) boulder revetments (NY 238 221) and (right) wooden revetments at Newlands Bridge (NY 240 263).

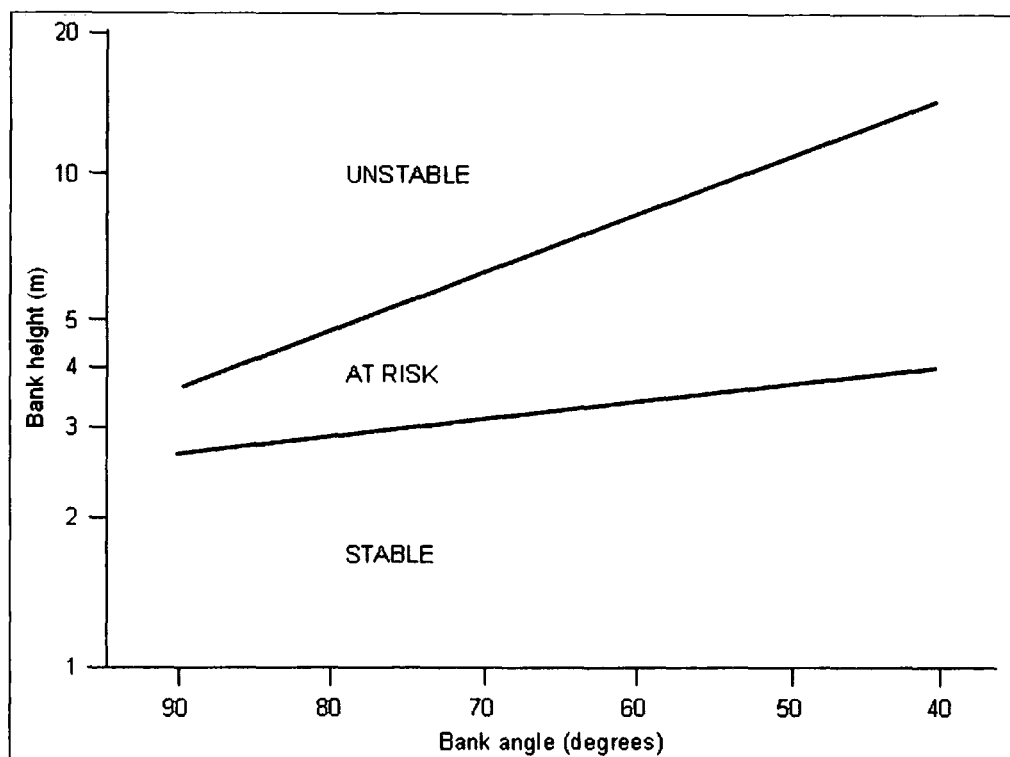
Figure 2.13: An example of slope-stability analyses, suggesting critical bank heights for river banks at certain angles. Adapted from Simon and Hupp (1987).

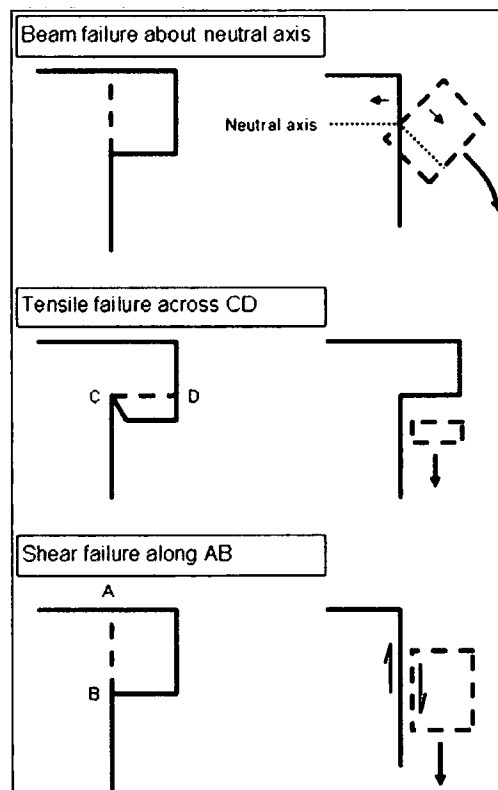
Figure 2.15: Mechanisms of cantilever failure: beam failure, tensile failure and shear failure. Adapted from Thorne and Tovey (1981).

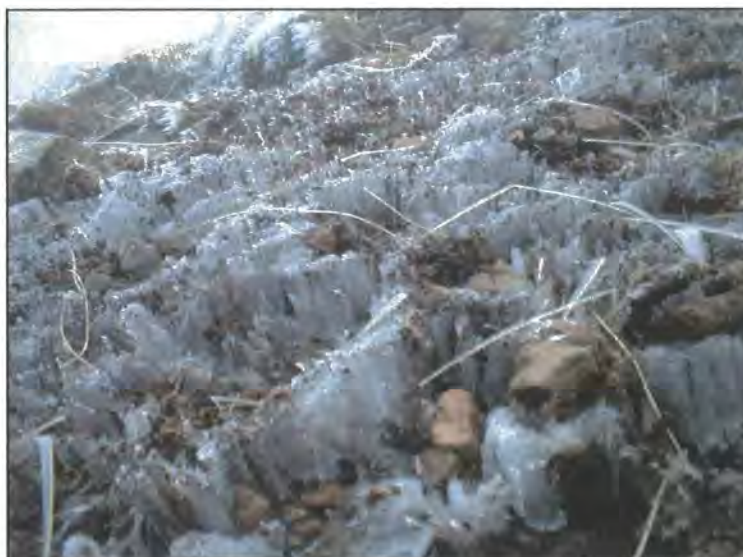
Figure 2.18: Needle ice observed on bare in the upland Bassenthwaite catchment on 26th December 2006. The crystals in the photograph were around 50 mm in length.

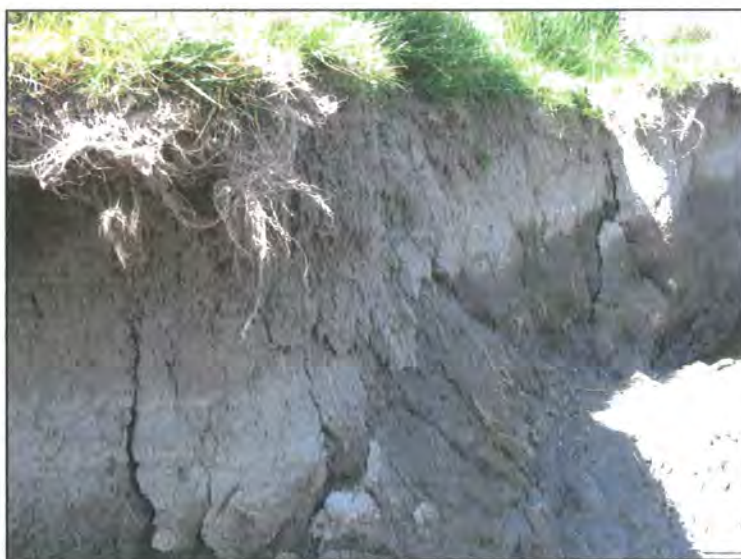
Figure 2.19: A desiccated river bank on the River Derwent near Bassenthwaite Lake, showing a dry and crumbly upper bank with deep cracks in the upper bank surface.

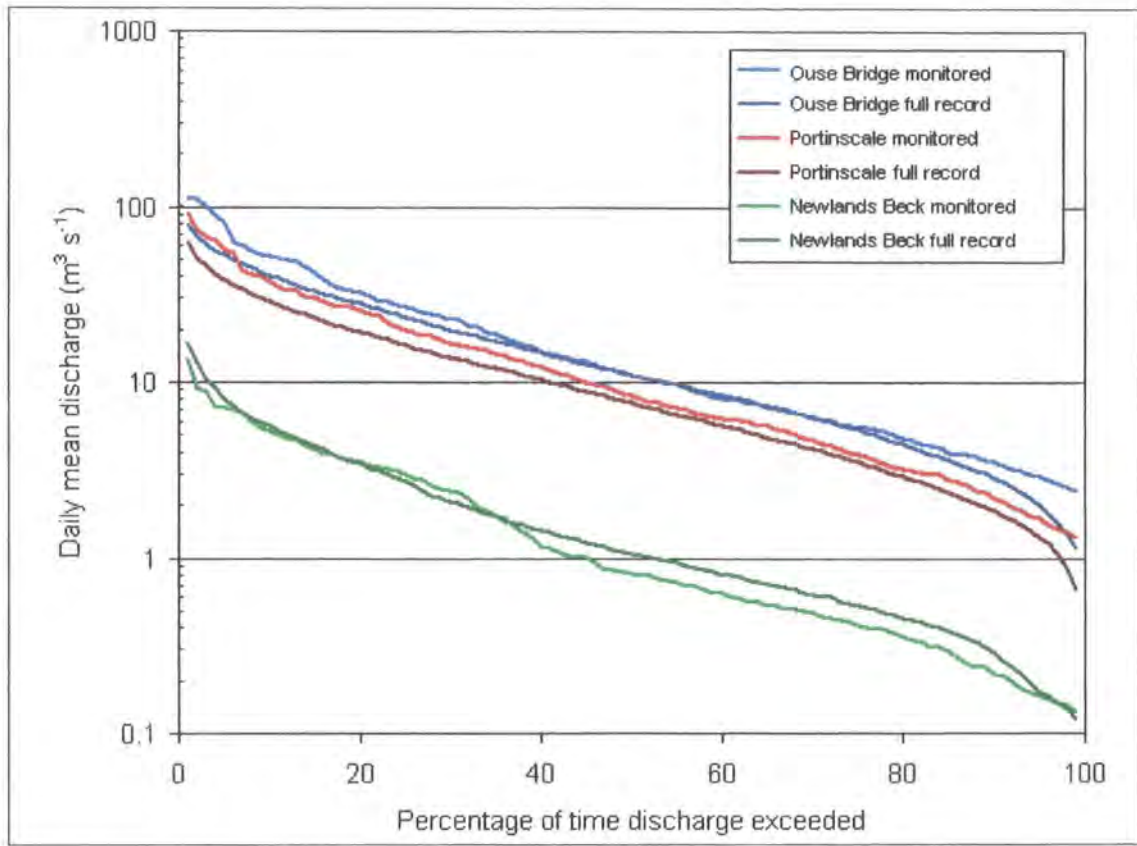
Figure 3.5: Flow duration curves for the gauging stations at Ouse Bridge, Portinscale and Newlands Beck, for both the main turbidity monitoring period (April-November 2006) and the full discharge record at the stations (Ouse Bridge and Portinscale 1976-present, Newlands Bridge 2004-present). Discharge data provided by the Environment Agency.

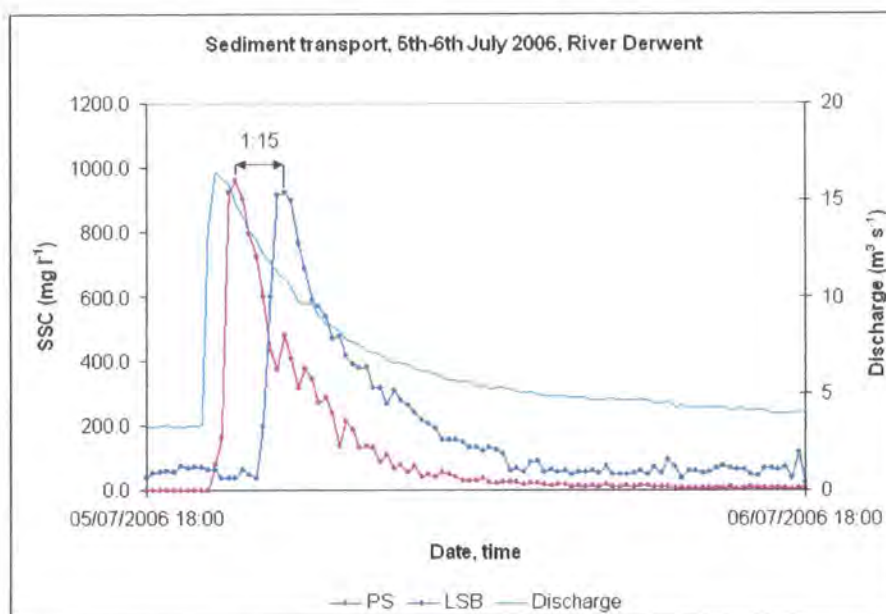
Figure 4.7: A large suspended sediment pulse observed between the 5th and 6th July 2006 at Portinscale and Low Stock Bridge. The discharge values (peak: $16.4 \text{ m}^3 \text{ s}^{-1}$) and sediment transport peaks at Portinscale and Low Stock Bridge are shown, as is the lag time (1 hour 15 minutes) between the peak sediment transport at the monitoring stations.

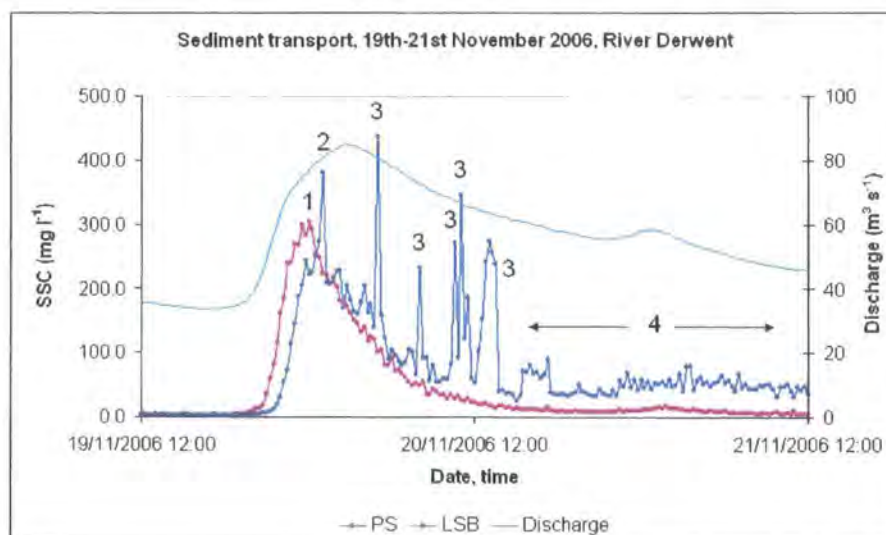
Figure 4.8: Suspended sediment transfers on the River Derwent at Portinscale and Low Stock Bridge, 19th-21st November 2006. As with Figures 4.9 and 4.10 below, numbers on the graph are referred to in the text in Section 4.1.3.4.

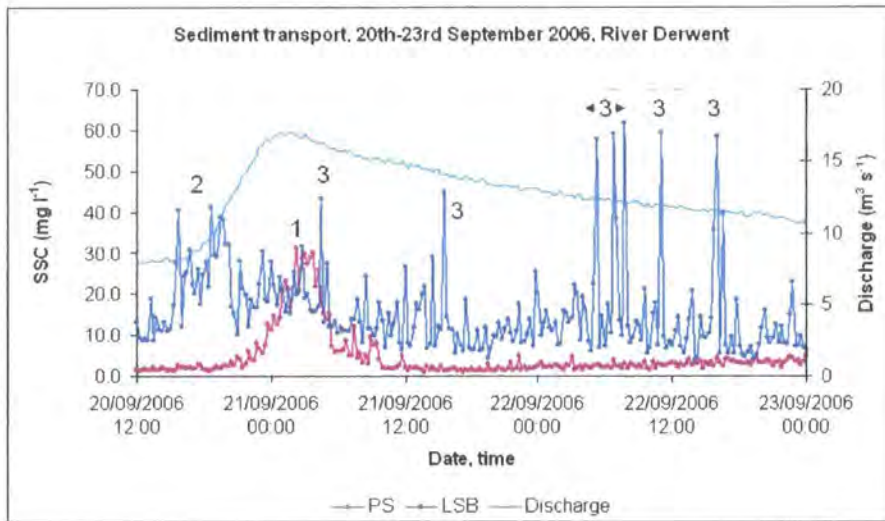
Figure 4.9: Suspended sediment transfers on the River Derwent at Portinscale and Low Stock Bridge, 20th-23rd September 2006.

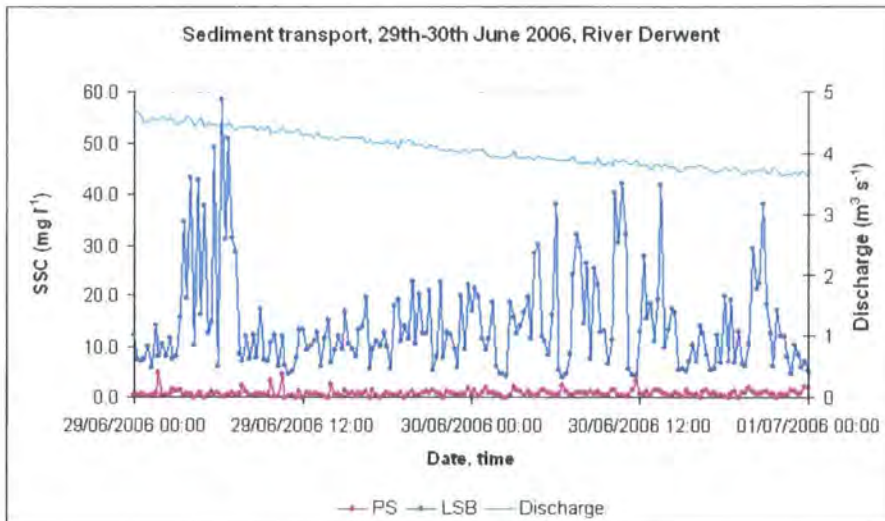
Figure 4.10: Suspended sediment transfers on the River Derwent at Portinscale and Low Stock Bridge, 29th-30th June 2006.

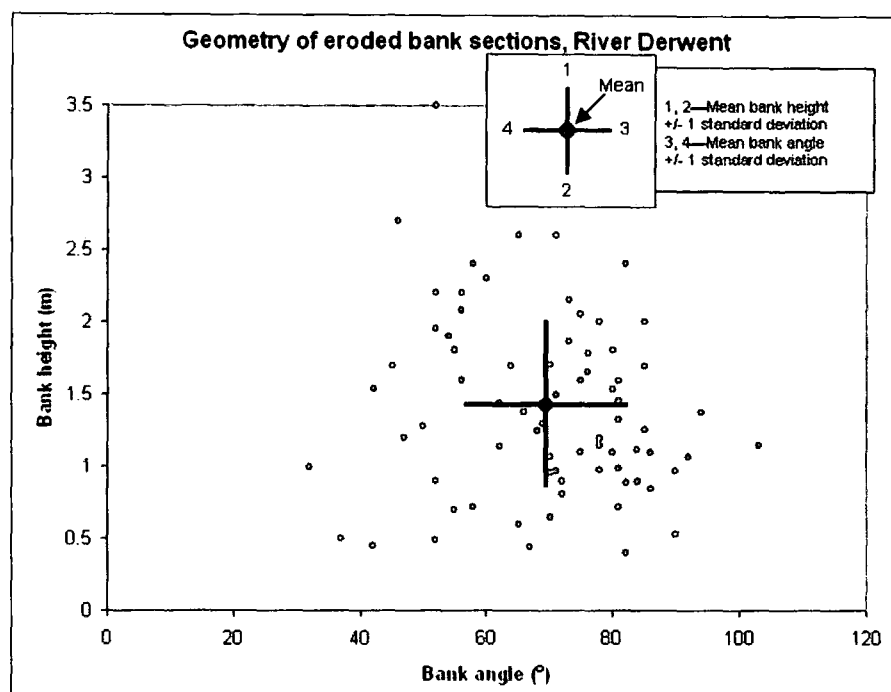
Figure 4.16: The geometry of eroded bank sections measured on the River Derwent, showing average geometry and centroids.

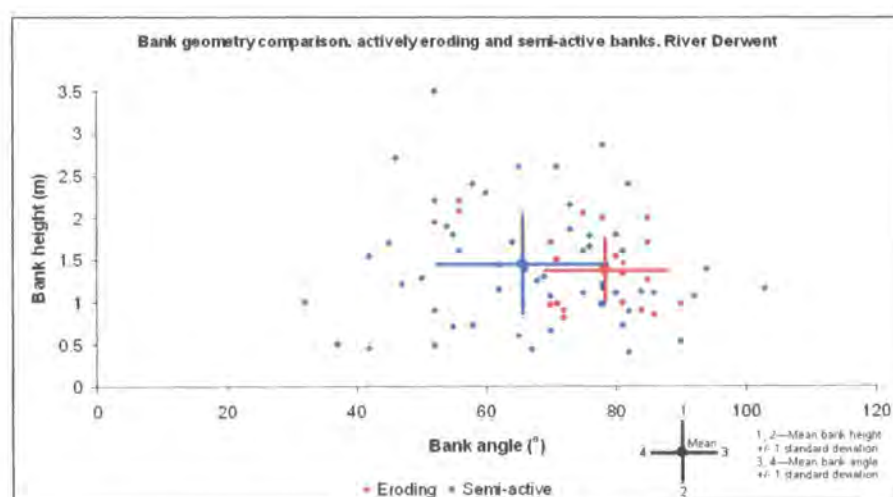
Figure 4.17: Geometry comparison of presently actively eroding and semi-active banks profiles showing average geometry with centroids for both categories.

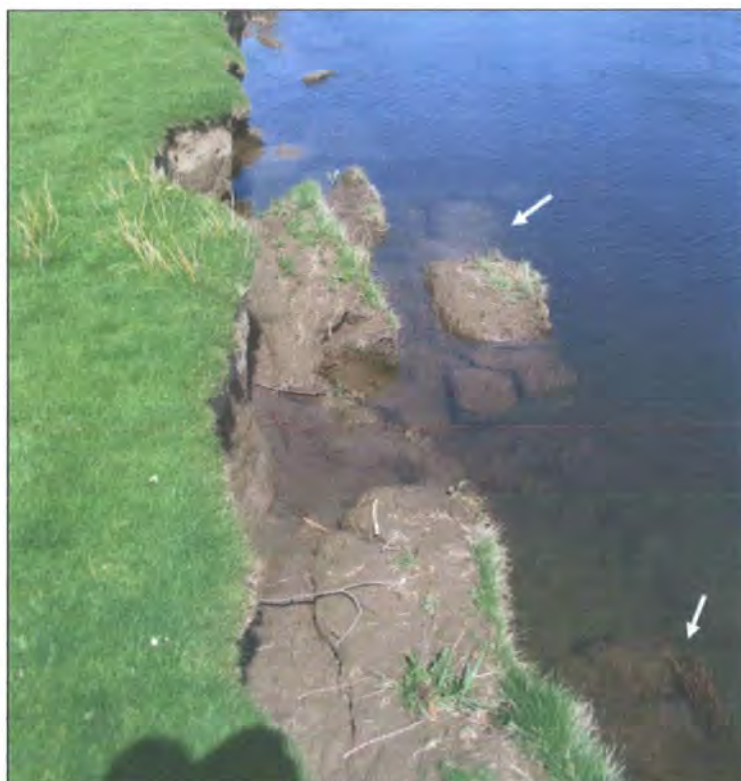
Figure 4.28: Unvegetated, intact blocks (indicated by white arrows) lying in the river channel below more recent failures at bank 6 (flow direction: away from photograph).

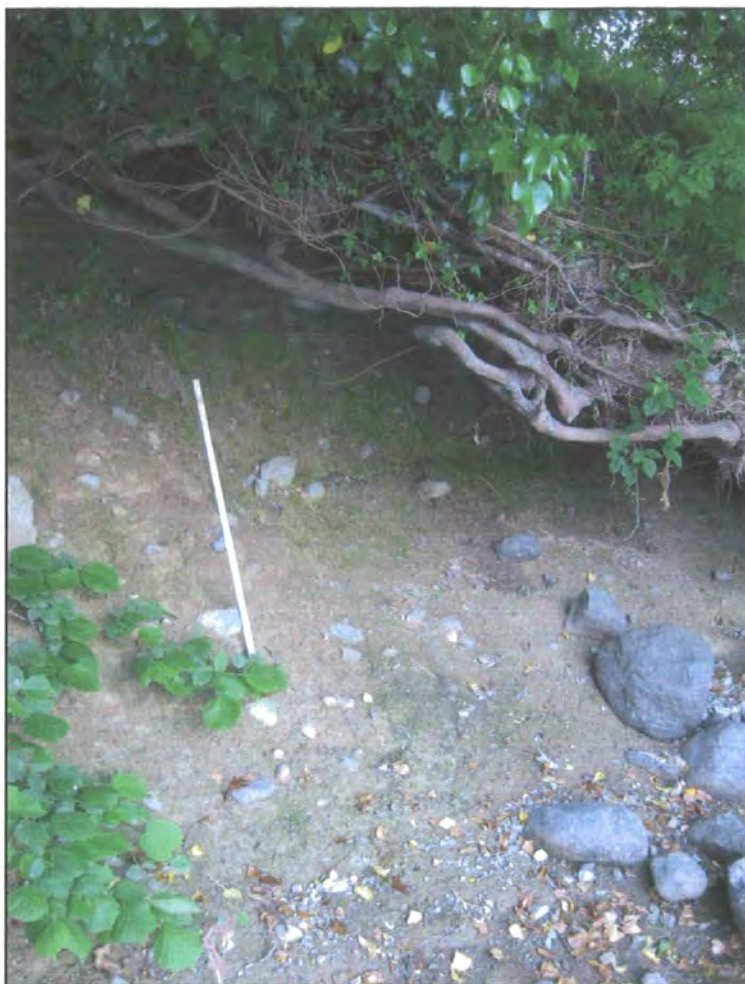
Figure 4.29: High (3.5 m) but presently stable river bank near Portinscale (NY 252 238), with metre ruler for scale. The dense vegetation roots at the overhang and the highly cohesive till on the lower, exposed bank face have prevented active erosion of this bank.

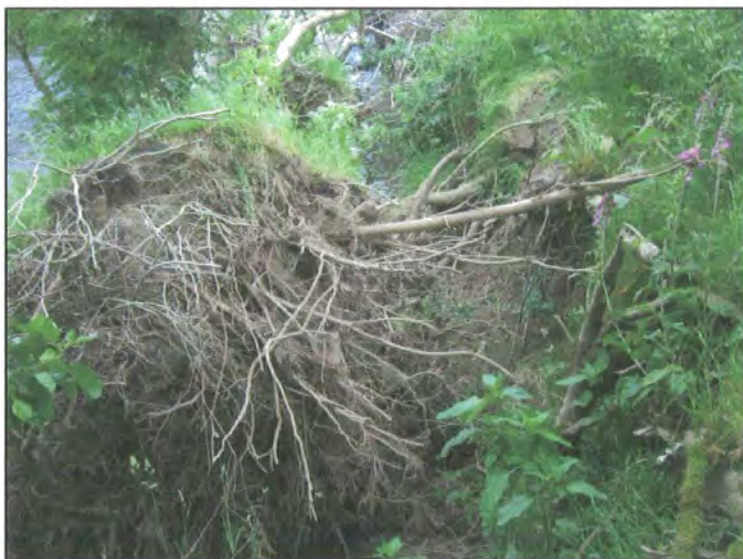
Figure 4.31: Collapsed bank-top tree at NY 247 251, showing a considerable amount of material removed from the bank attached to the roots, and a steep bank face left exposed by the removal of the material.

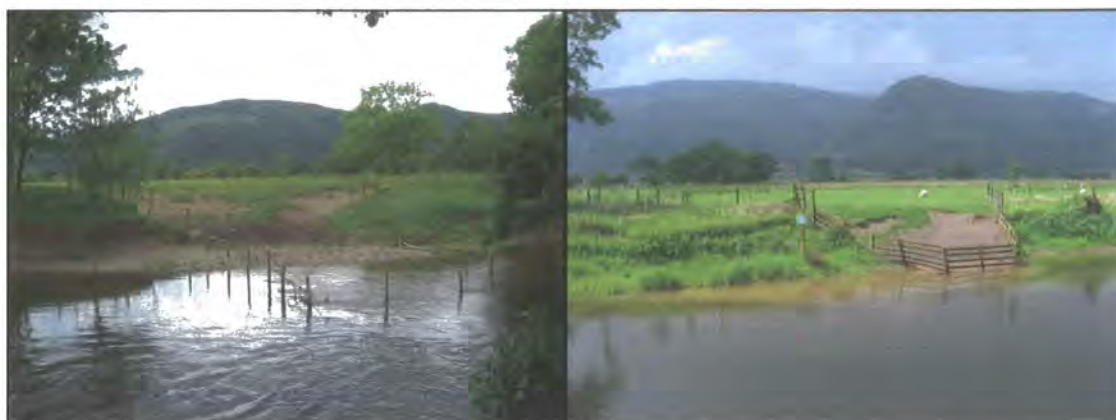
Figure 4.32: Large poaching scars: (left) near High Stock Bridge (NY 244 257), (right) near Low Stock Bridge (NY 244 257). Note the diversion of fencing into the river channel to allow grazing animals access to the water.
