*The detection of hydrogen induced cracking in welded and seamless steel pipes using acoustic emission and ultrasonic techniques*

THE DETECTION OF HYDROGEN INDUCED CRACKING  
IN WELDED AND SEAMLESS STEEL PIPES USING  
ACOUSTIC EMISSION AND ULTRASONIC TECHNIQUES

G A Raine, F.Inst. NDT.TEng (CEI)

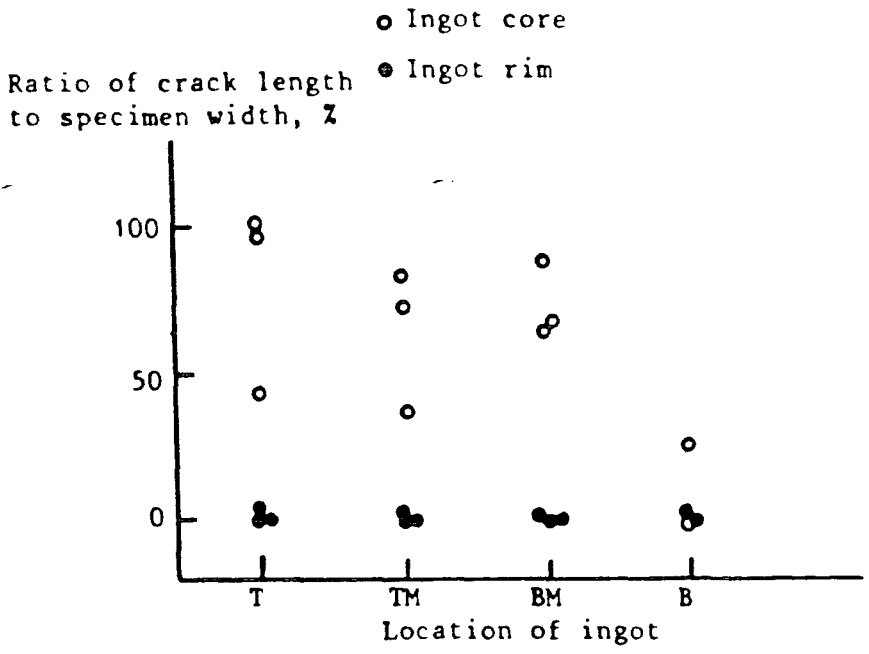
FIG. 11

INFLUENCE OF SAMPLING LOCATION ALONG LENGTH OF INGOT  
ON HIC SUSCEPTIBILITY OF PLATE  
AFTER IKEDA ET AL<sup>23</sup>

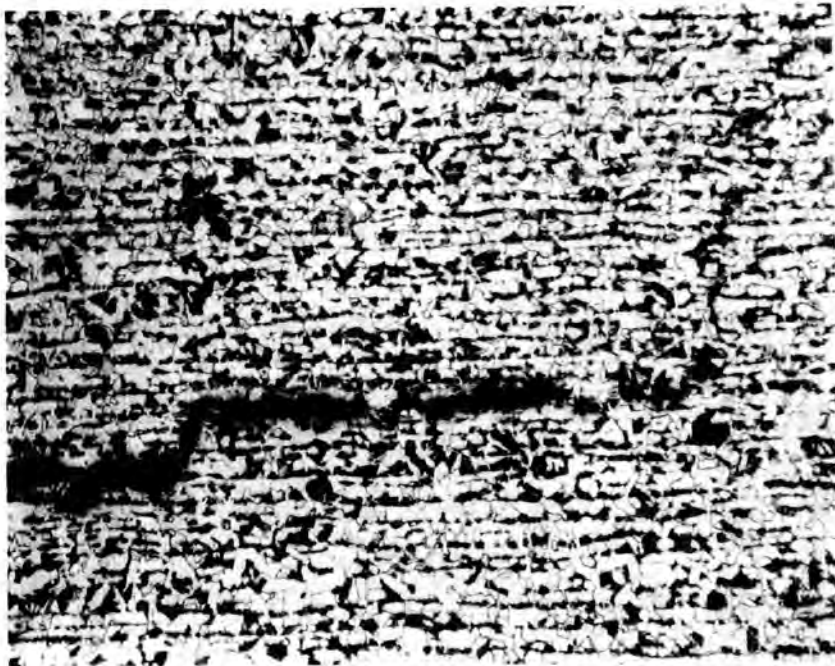
Figure 107  
Metallographic section of pipe section 3 showing  
the extent of the banding x 100
