THE CONSTRUCTION

OF

HADRIAN'S WALL

DOCTOR OF PHILOSOPHY UNIVERSITY OF DURHAM DEPARTMENT OF ARCHAEOLOGY

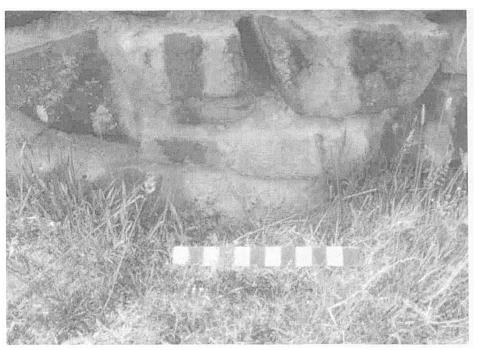
Plate 1 Lime from consolidation mortar leached out over facing stones, Peel Gap tower (1996)

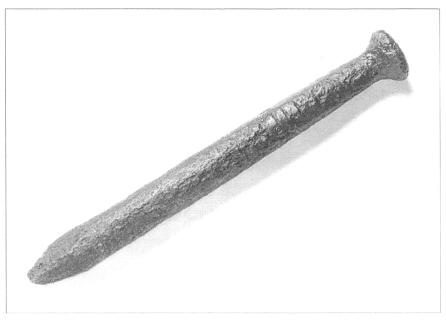
Plate 3 Mallet-headed ?Roman punch from Mumrills (photograph National Museums of Scotland)

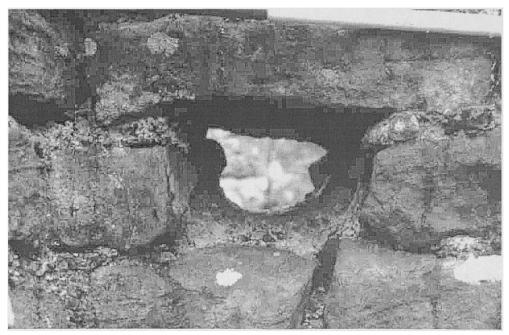
a. Putlog hole, wall 10

Impressions in the mortar inside the putlog holes give clear evidence of the size and form of putlogs used (see plate 9 overleaf). The majority were round poles 4" (100mm) diameter, with occasional use of split poles to give half-round putlogs up to 6" (150mm) wide by up to $4\frac{1}{2}$ " (110mm) (see fig. 9.5).⁵⁵³ The putlog holes go through the walls, but both mortar impressions and the position of core stones indicate that the putlogs were not always continuous poles but rather went something less than half way through the wall, giving a bearing of 12-18" (300-450mm).

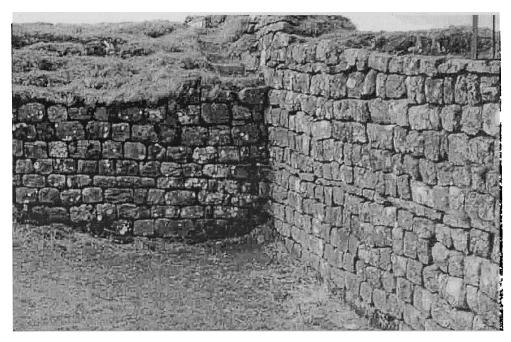
Plate 10 North wall of MC37, showing how irregularity of the stones makes precision of fixing unnecessary
