Durham E-Theses

Slope instability along the north-west coast in Malta

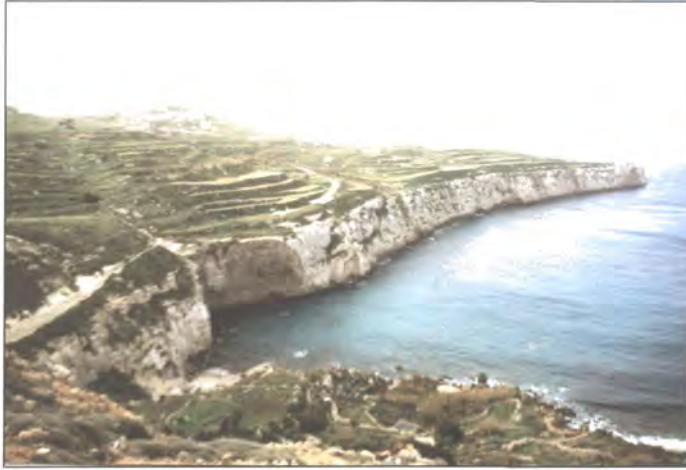
Plate 3.9: The western extremity of the Great Fault featuring Lower Coralline Limestone plunging cliffs. The Great Fault runs along the whole width of the island from Fomm ir-Rih on the west coast to Madliena on the east coast. The terraced fields are the result of human activity.

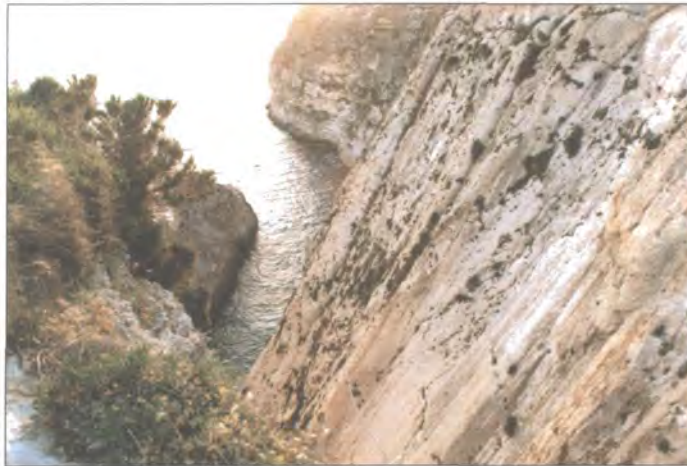
Plate 3.10: Slickenside at Ix-Xaqqa on the south-west coast. This is a result of the Maghlaq Fault which has produced here a vertical displacement of at least 240 m to the south-west. Lower Coralline Limestone (right side) and Upper Coralline Limestone (left side) are found in juxtaposition.

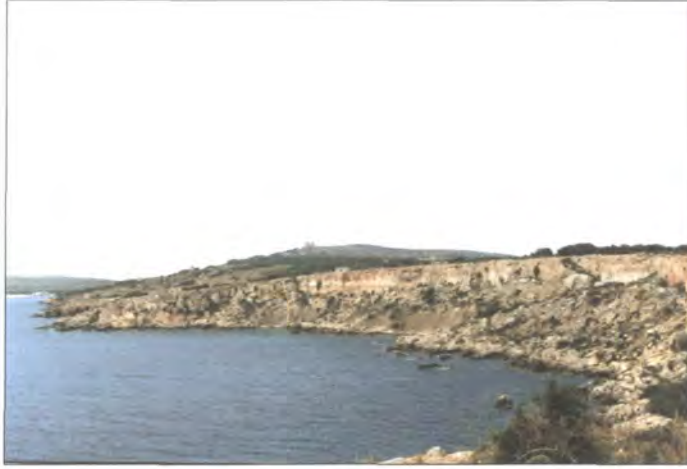
Plate 3.11: Rdum il-Hmar is an example of a semi-circular cove found on the northern shore of Mellicha Bay. Semi-circular coves represent a distinct feature of the Maltese coastline and originate from karstic landforms inundated by the sea.

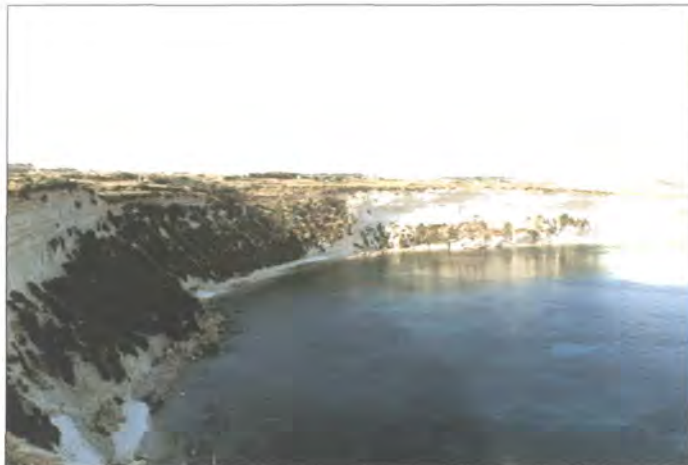
Plate 3.12: Il-Hofra z-Zghira features a semi-circular cove on the south-east coast of Malta. In this case the cove has developed in Globigerina Limestone and is surrounded by cliffs.

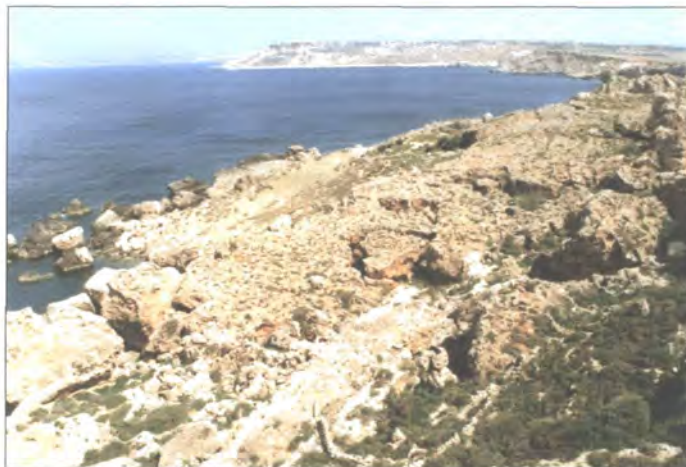
Plate 3.16: An example of a translational slide found at Rdum Majesa on the north-west coast. In the Maltese Islands this type of landslide occurs in the Upper Coralline Limestone. Usually these slides involve a displacement from the *in situ* material to several metres downslope and in some cases extending to the shoreline.

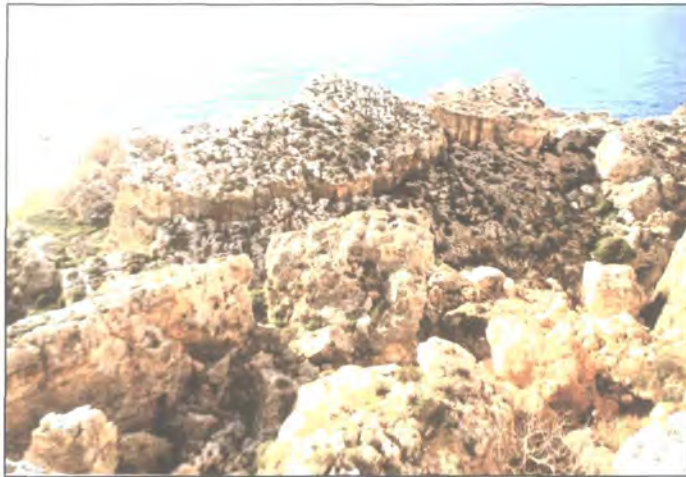
Plate 3.18: Complex of rotational slides at Ras il-Wahx on the north-west coast. Ras il-Wahx offers the best example of multiple rotational slides most commonly found at headlands along the Maltese coasts. Here rotational slides occur in multiple succession covering an area of about 400 m².

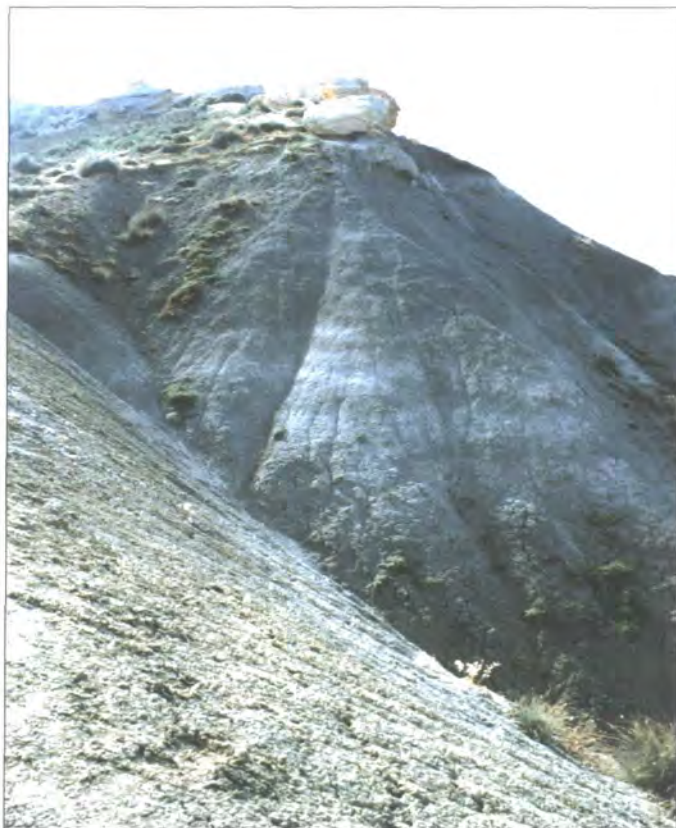
Plate 3.19: Where Blue Clay is exposed it features slopes. At the coast these slopes usually extend from the Upper Coralline Limestone plateau to sea-level. The clay slopes featured here are situated at the southern end of Ghajn Tuffieha Bay, overlooking Gnejna Bay and connecting Il-Qarraba with the mainland.

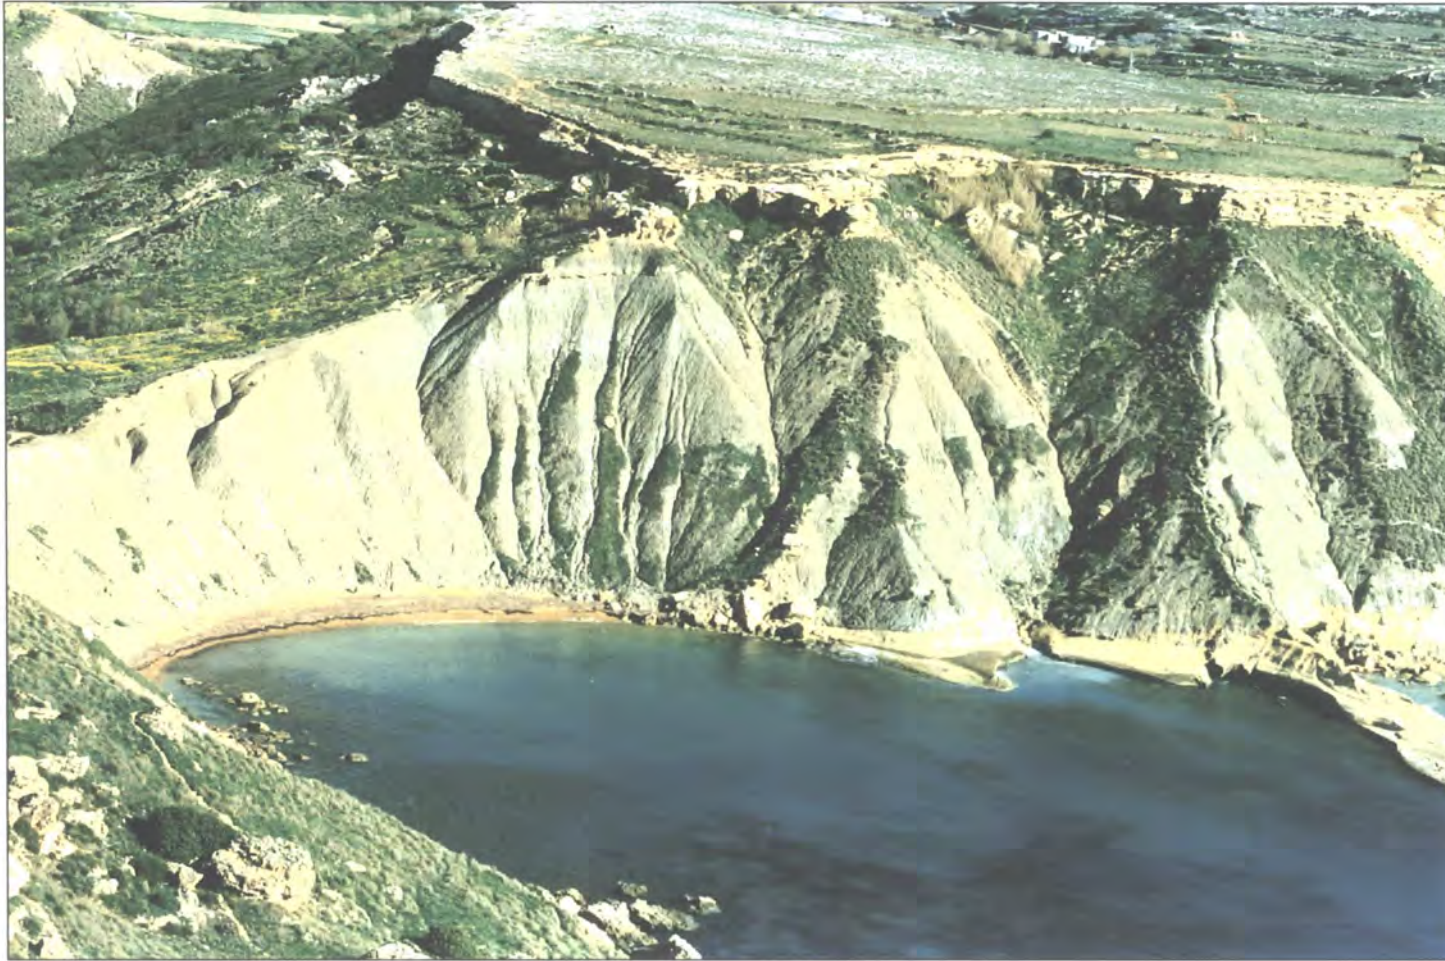
Plate 3.22: Clay slopes examined at Gnejna Bay, close to Il-Qarraba. In this section the clay slopes are almost completely bare of vegetation cover due to a steep gradient. Above the clay slopes the Upper Coralline Limestone plateau is evident. The vegetated clay slopes featured in the background on the left, are found at Ghajn Tuffieha Bay, whereas in the foreground part of Il-Qarraba is visible. A small sandy pocket and Globigerina Limestone shore platform are seen at the foot of the clay slopes. The shore platform closest to the sandy pocket marks the northern limit of the area under study.

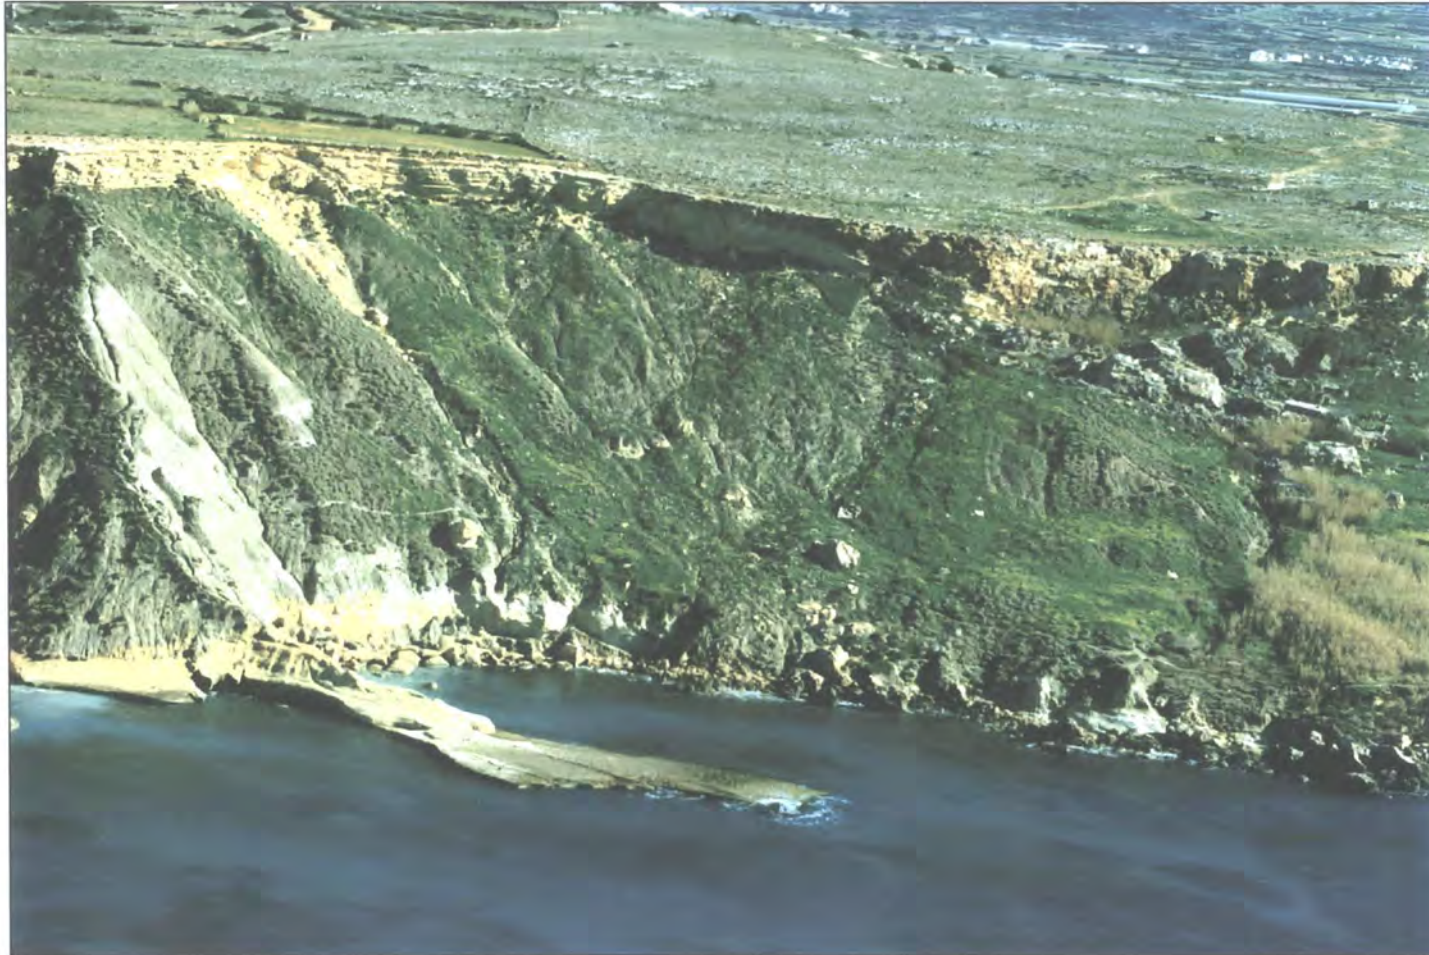
Plate 3.23: Clay slopes examined at Gnejna Bay, close to the reeds. Slopes in this section are vegetated since the gradient is not so steep. The Upper Coralline Limestone plateau and scarp face are visible in the background, whereas the Globigerina Limestone cliff and shore platform are seen in the foreground. The reeds at the lower right side mark the southern limit of the area under study.

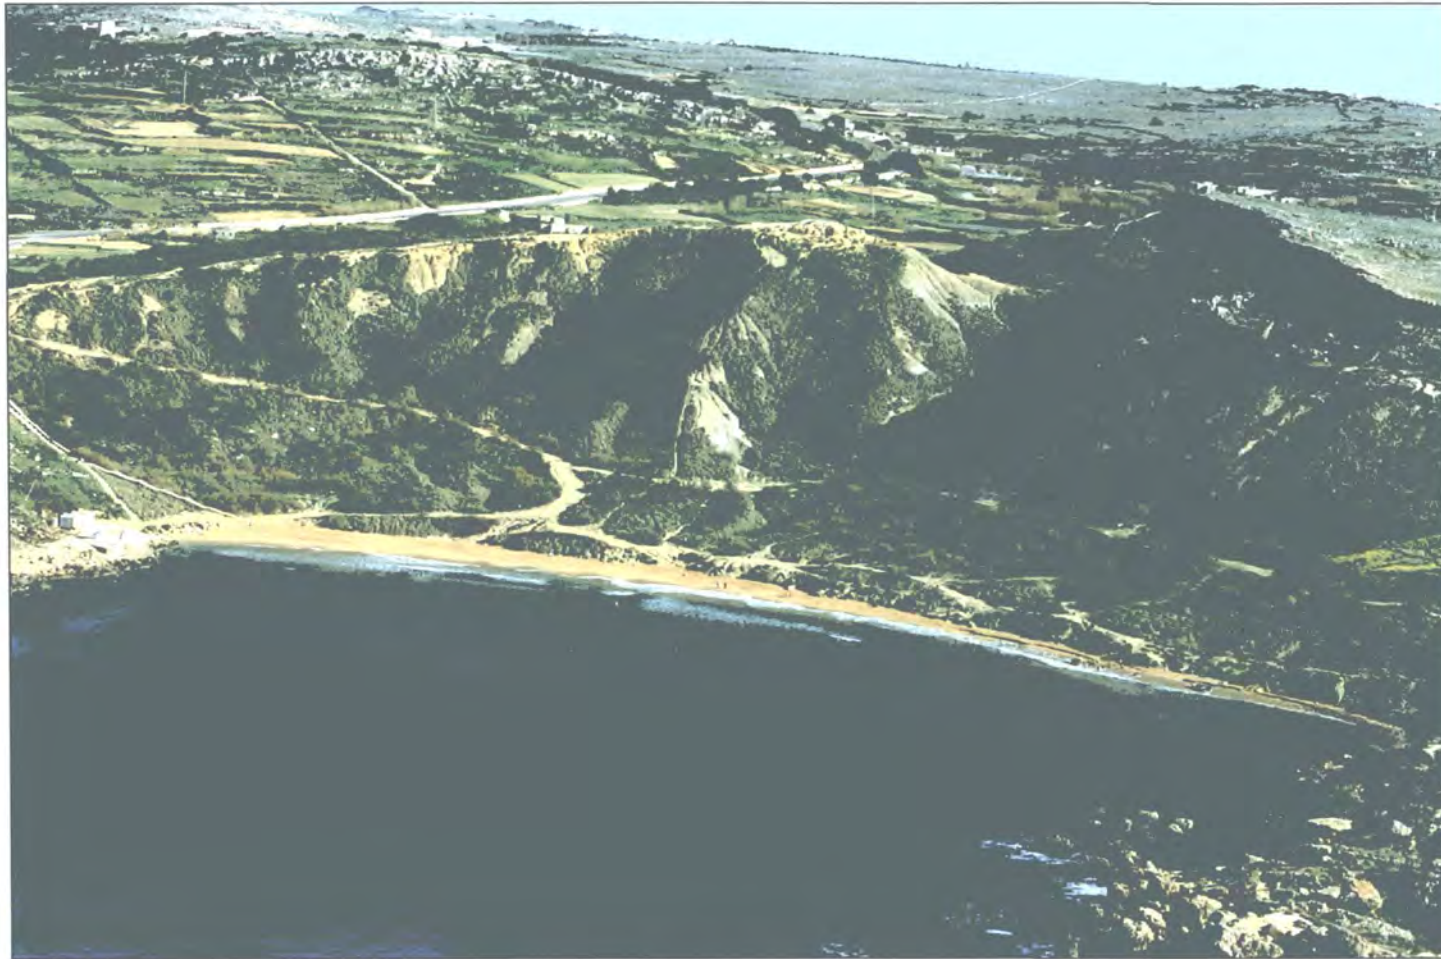
Plate 3.24: An aerial view of Ghajn Tuffieha Bay. The clay slopes extend from the back of the sandy beach to the base of the Upper Coralline Limestone plateau. The sandy beach stretches along the whole length of the Bay. Ghajn Tuffieha Bay has been designated as an area of ecological importance by the Planning Authority in 1995 and is a protected site by law. The Bay is at present managed by the GAIA Foundation, a Non-Governmental Organisation which was responsible for a recent afforestation project.
