## *Weathering and brittleness in shale fill dams and embankments*

# **WEATHERING AND BRITTLENESS IN SHALE FILL DAMS AND EMBANKMENTS.**

A thesis presented for the degree of Master of Science  
in the University of Durham.

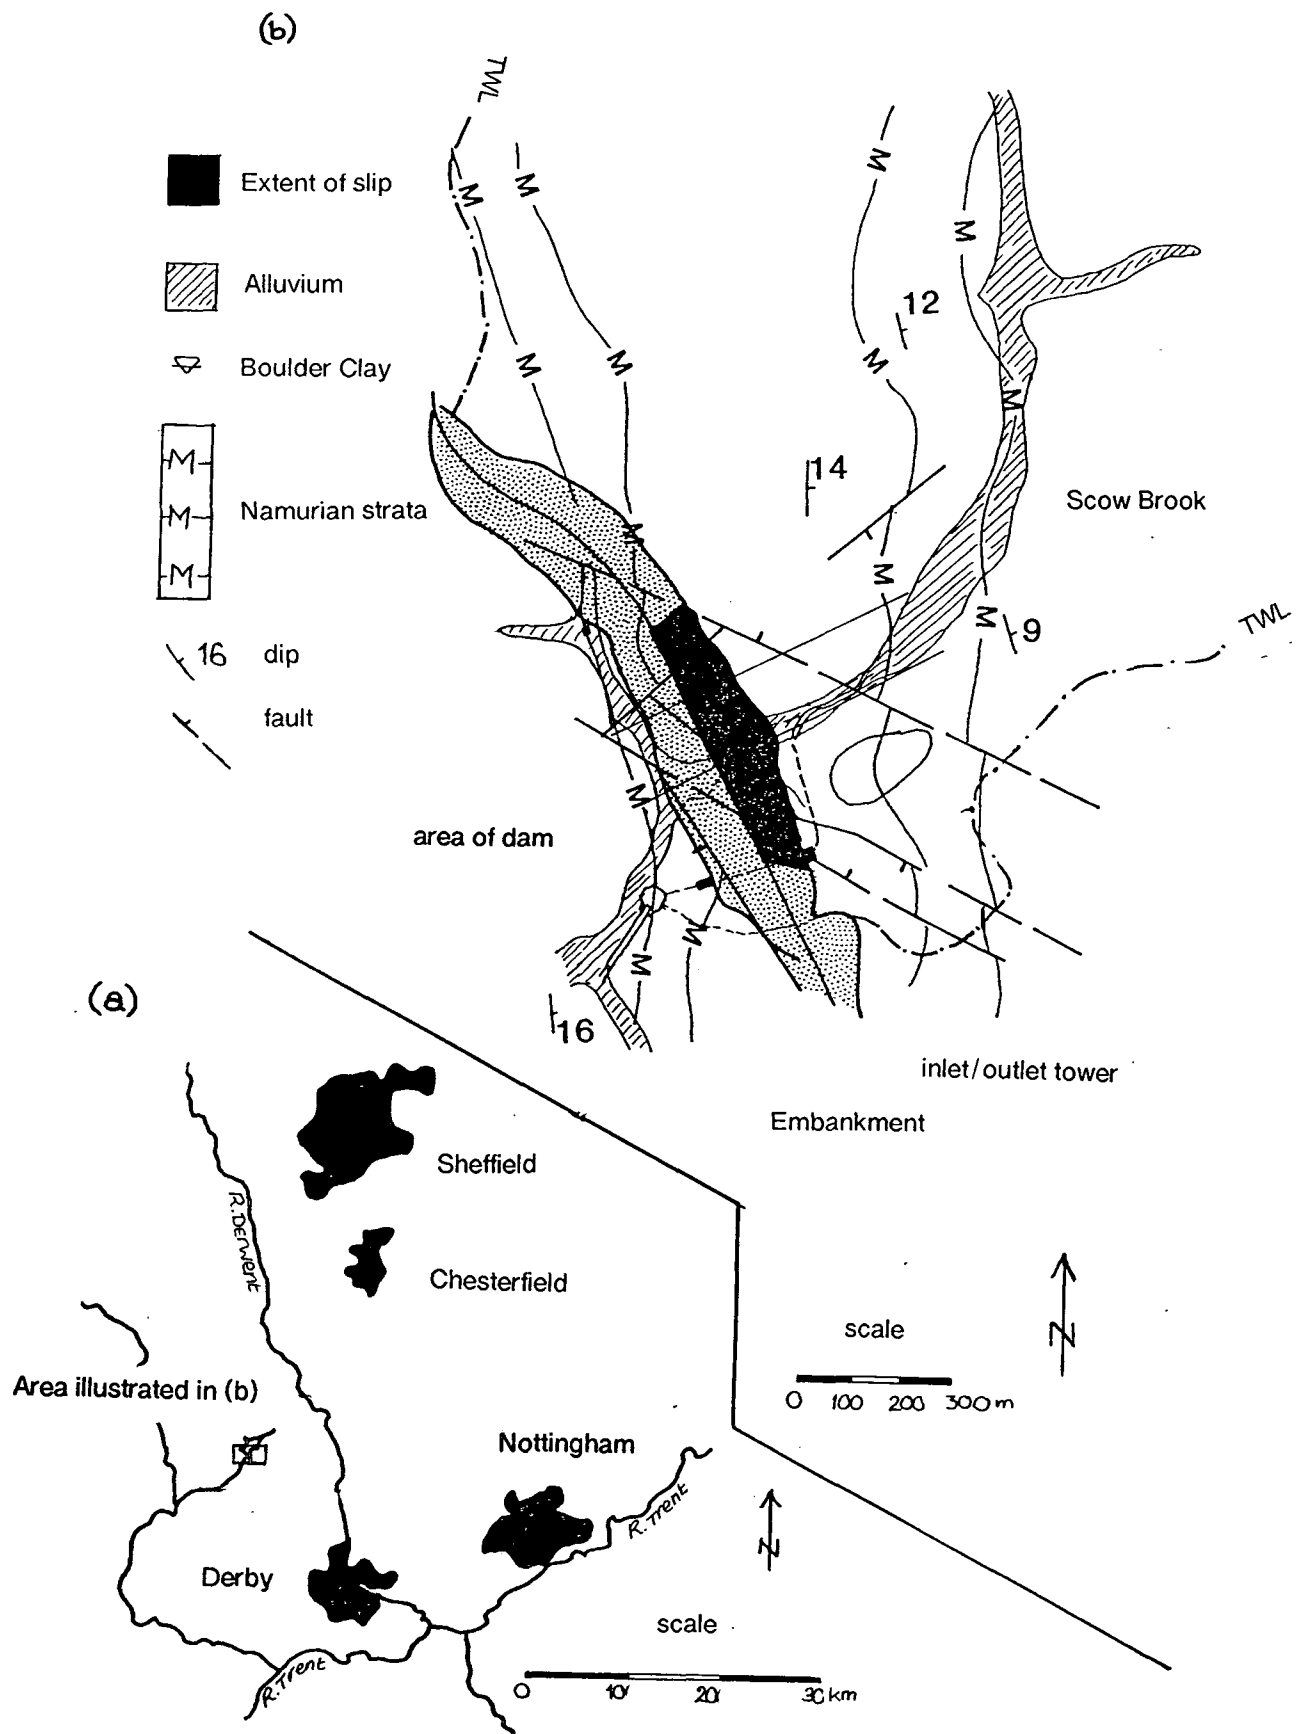
Figure 1.2 Carsington Dam: (a) Location plan, and, (b) plan of reservoir and dam area showing local geology and extent of slip.

Figure 1.2 shows the general geology in the area of Carsington Dam. The bedrock comprises Upper Carboniferous mudrocks which were found to be glacially brecciated, crumpled and weathered to a depth of several metres. This upper layer of weathered mudstone plus the head (*that is* solifluction deposits) which together became known as the 'Yellow Clay' contained many shear surfaces, some up to several metres in length. Prior to construction, alluvial deposits along with top and sub-soil were removed so that the dam was founded either directly on the weathered mudstone as in the valley floor in the area of chainage 850m \*, or elsewhere on the Yellow Clay, for example, at chainage 725m. Local materials were used in the construction of the dam which began in July 1982. The rolled central

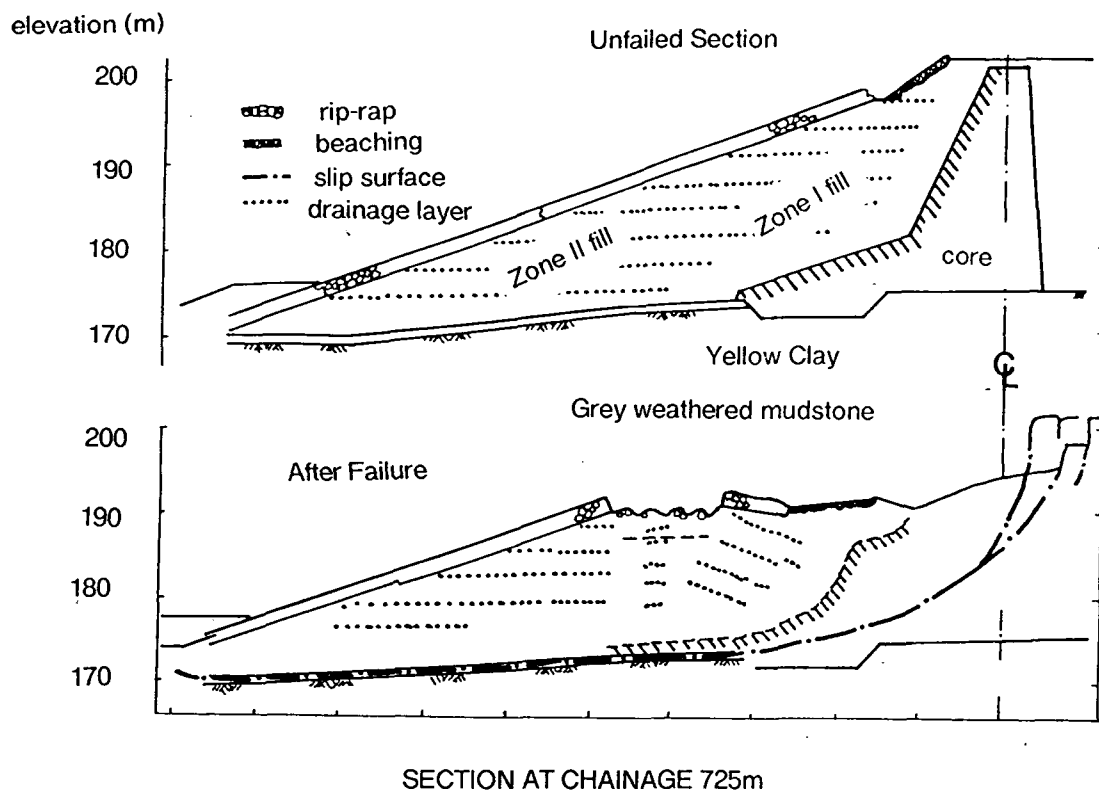
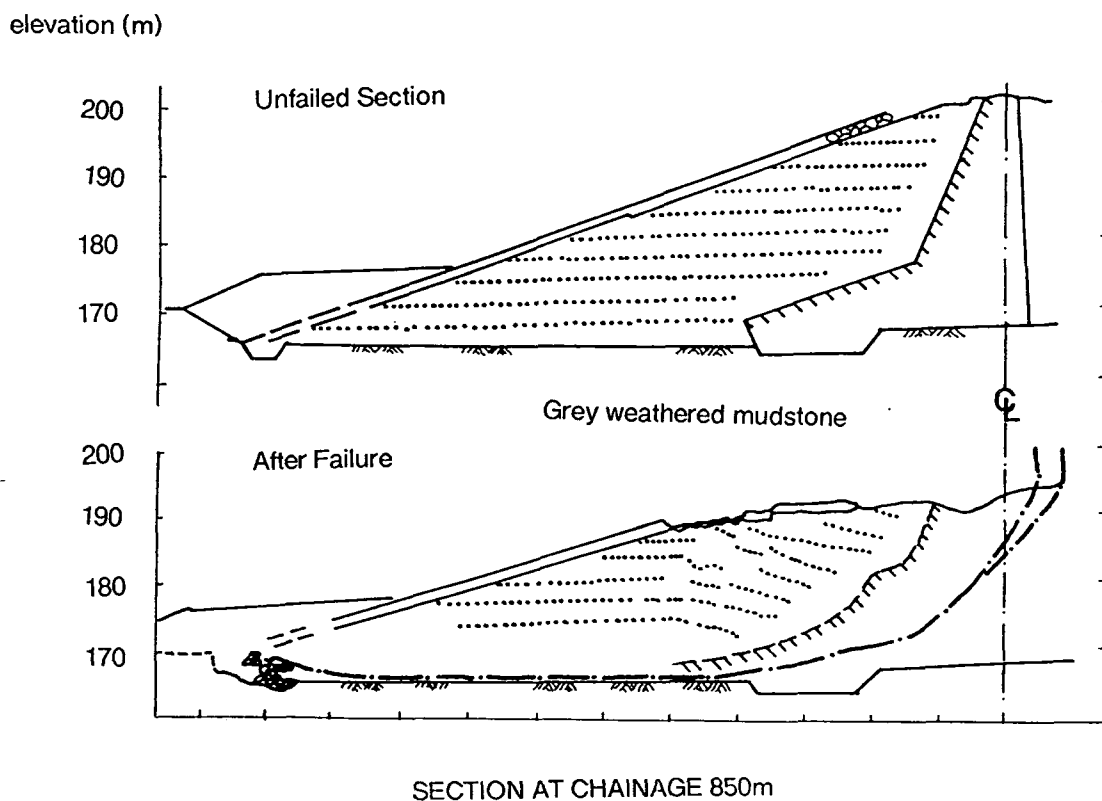
Figure 1.3 Cross sections of Carsington Dam at chainage 725m and 850m before and after failure (based on Coxon, 1986).

core with its boot-shaped upstream extension was constructed from weathered clay as shown in the cross sections in Figure 1.3, and the shoulders from blocky and brecciated mudstones compacted at their optimum moisture content with the finer grained material being used for the inner Zone I, and coarser material for the outer parts of the shoulders *that is*: Zone II.

Early observations in the area where first movement had occurred showed the position of the slip surface running through the core and boot, then through the Yellow Clay and thrust over the small rock fill toe. In the flood plain area at chainage 850m, where the Yellow Clay was absent, the slip passed through the Zone II fill. The dam itself was left with a near vertical backscarp approximately 10m deep at the crest and large blocks of the upstream face back rotated as thrust – graben features formed in the tension zone above the failure plane (Coxon, 1986). Figure 1.3 shows the cross section at two points (chainage 725 and 850m), before and after the failure.

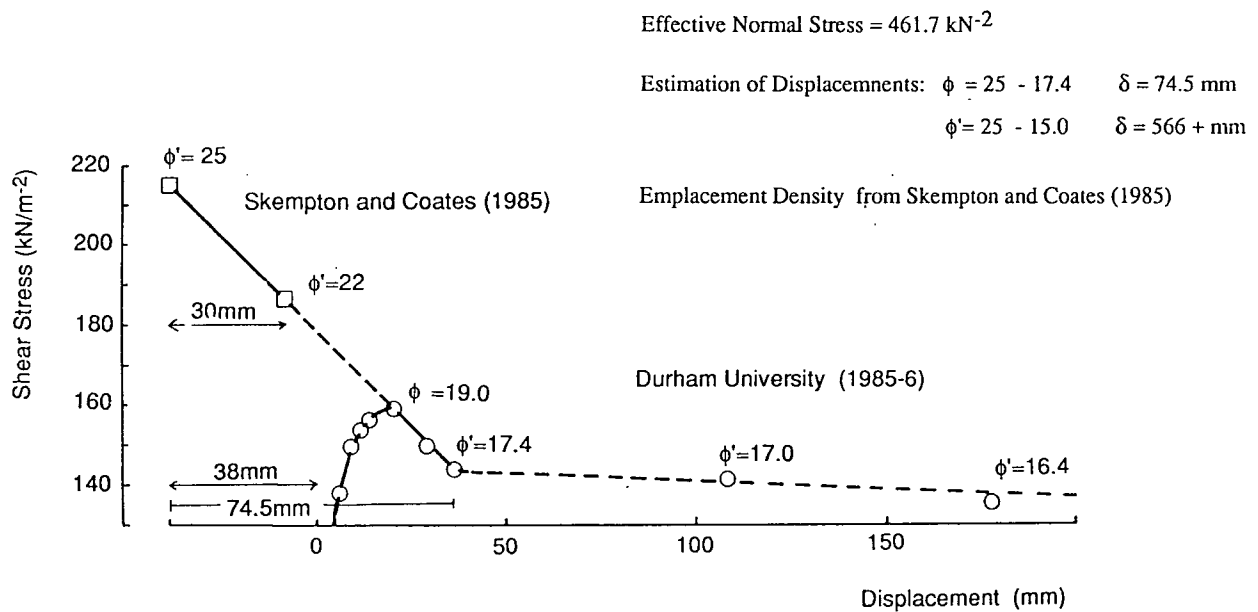
*Figure 1.4* Shear stress - displacement curve for post-failure shear box tests on material from Carsington Dam, using data from Skempton and Coates (1985) and University of Durham (1985 and 1986, unpublished). For explanation see Section 1.3.1.c.

3. Further Large Shear Box Tests on a remoulded sample of fill from Carsington Dam, originally dug from near the dam's surface and remoulded at natural moisture content yielded peak shear strength parameters of  $c_p = 0$ ,  $\phi_p = 22^\circ$  and residual parameters of  $c_p = 0$ ,  $\phi_p = 16.5 - 17^\circ$ . However, Skempton and Coats (1985) quote peak values of  $\phi_p = 28^\circ$  in freshly compacted shale and  $\phi_p = 25^\circ$  for shale in the dam. This drop of  $3^\circ$  was thought to be an indication that additional processes were acting on the outer zones of the embankment which had the overall effect of reducing shear strength. The Durham sample reached a residual strength after a smaller than expected displacement. This was attributed to weathering and degradation of the sample during placement and exposure. Considerable amounts of sulphate were observed on the shear plane after only 48 hours exposure in the laboratory at  $20^\circ\text{C}$ , which demonstrates the rapid nature of these weathering processes (Taylor, in Coxon 1986). These results are summarized in Figure 1.4.

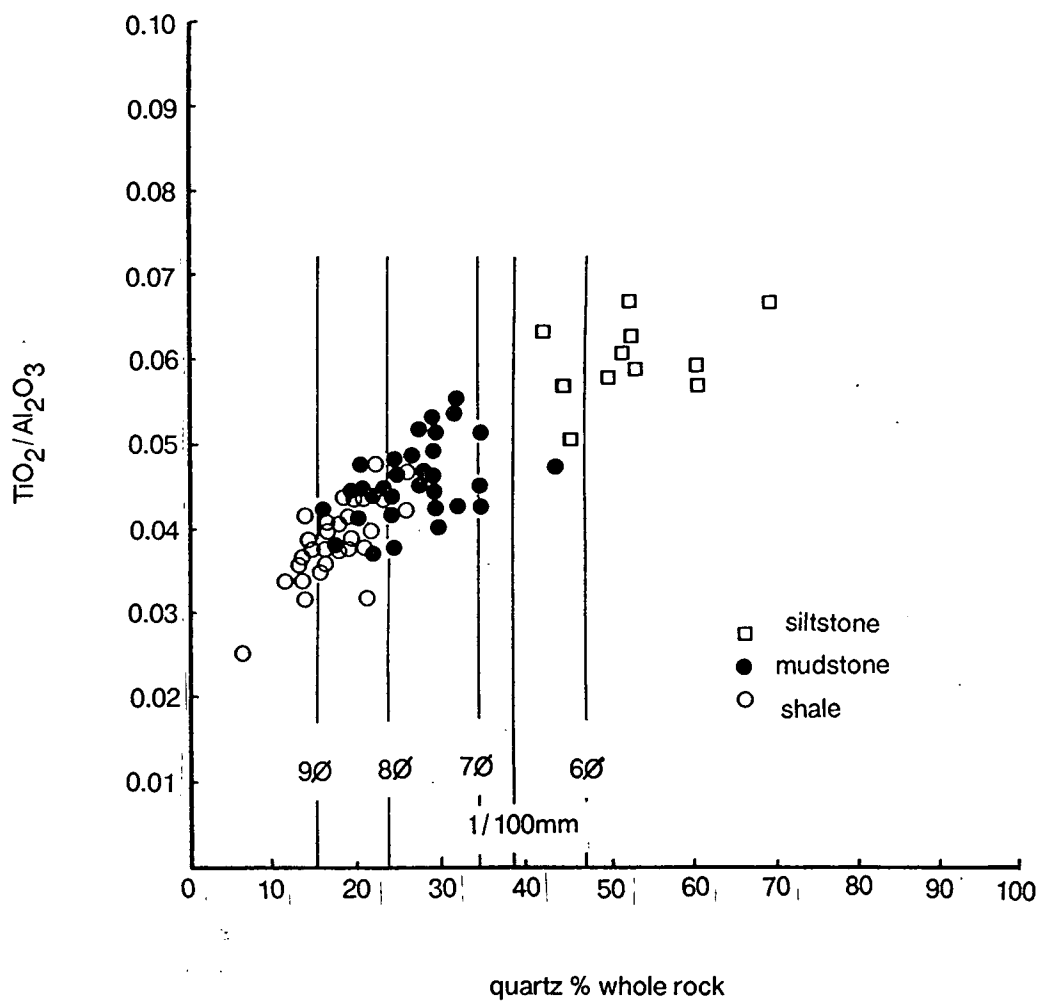
Figure 3.1 Relationship between grain size and clay mineral/quartz content (after Spears, 1980)

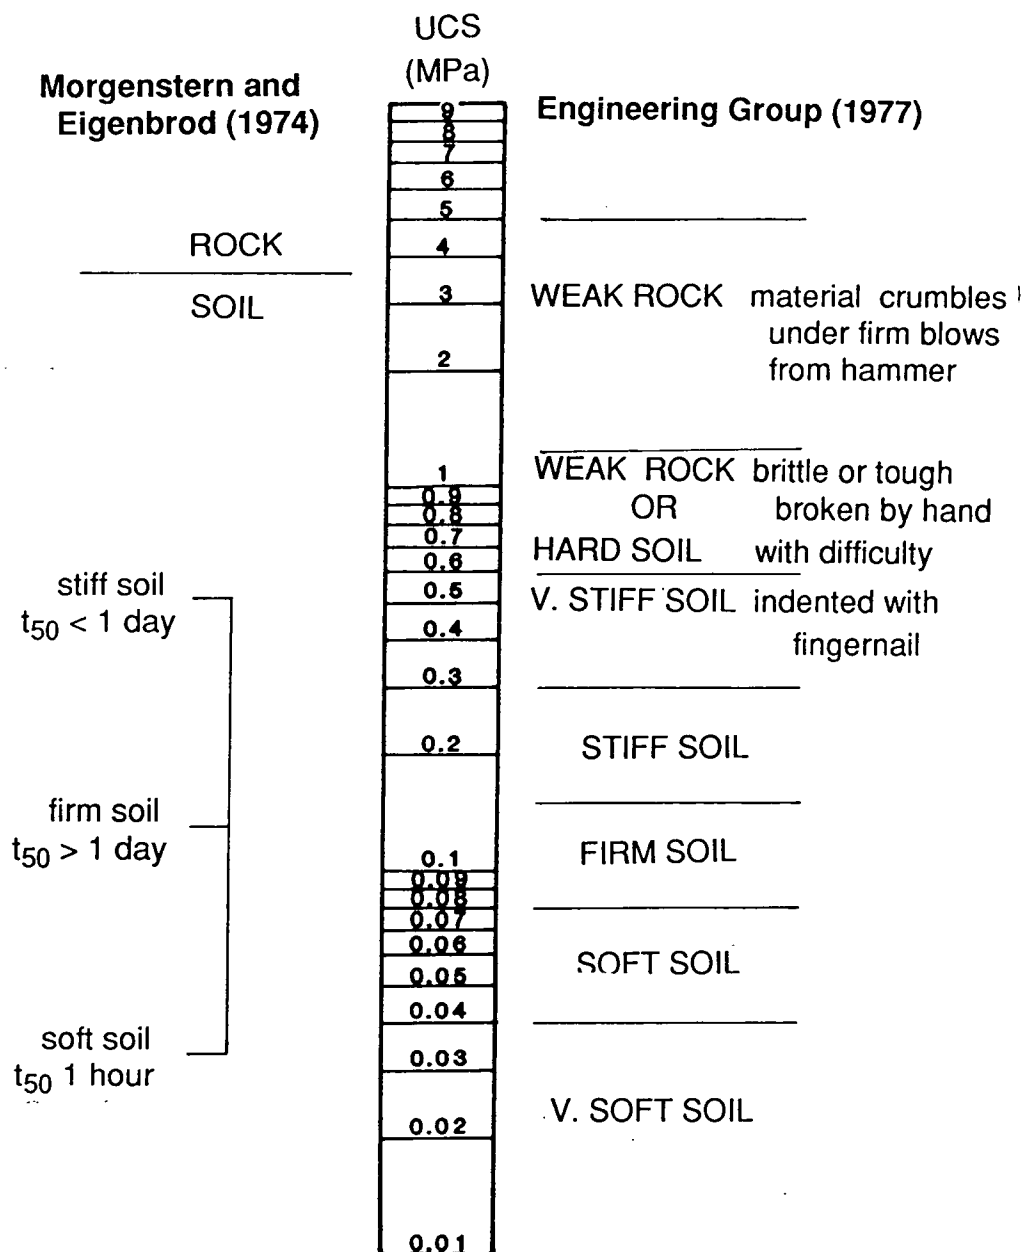
$t_{50}$  = soaking time required for reduction of 50% in UCS.

Figure 3.2 Strength (UCS) classification of mudrocks and muds according to Morgenstern and Eigenbrod (1974) and the Engineering Group (1977).

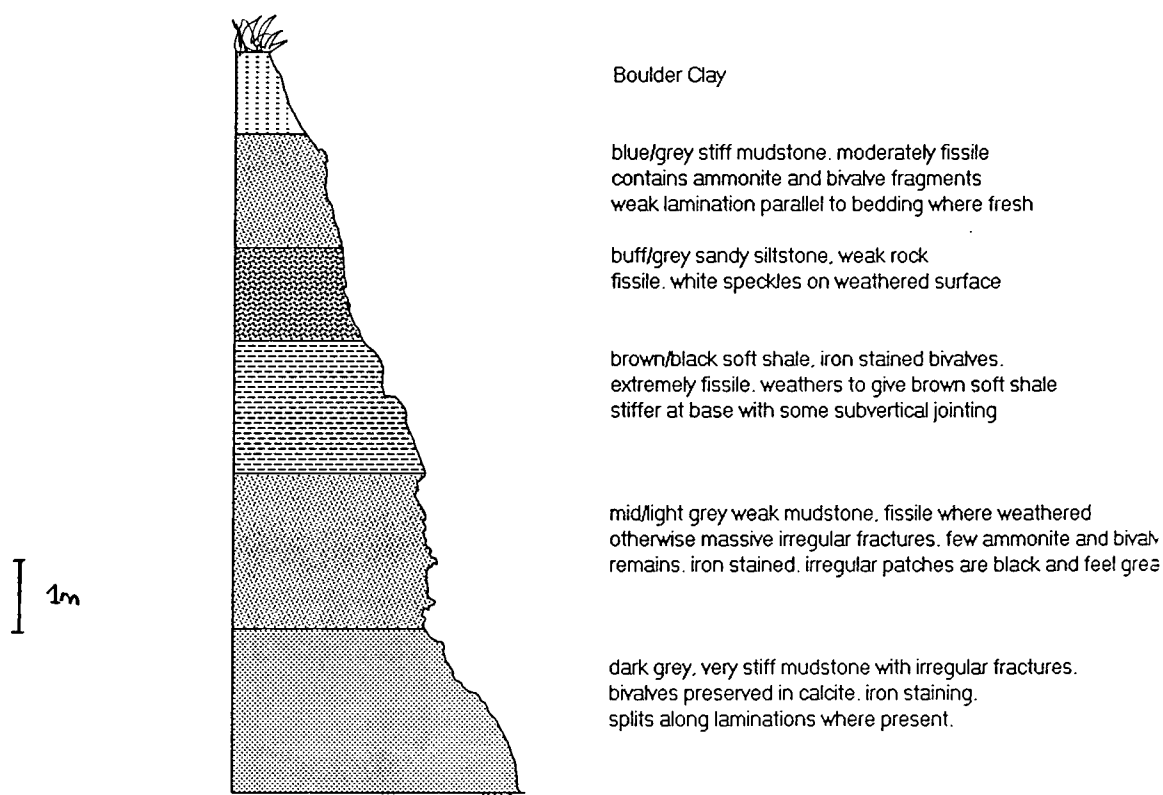
Figure 3.10 Quarry wall section in Kimmeridge Clay at Foxholes Quarry.

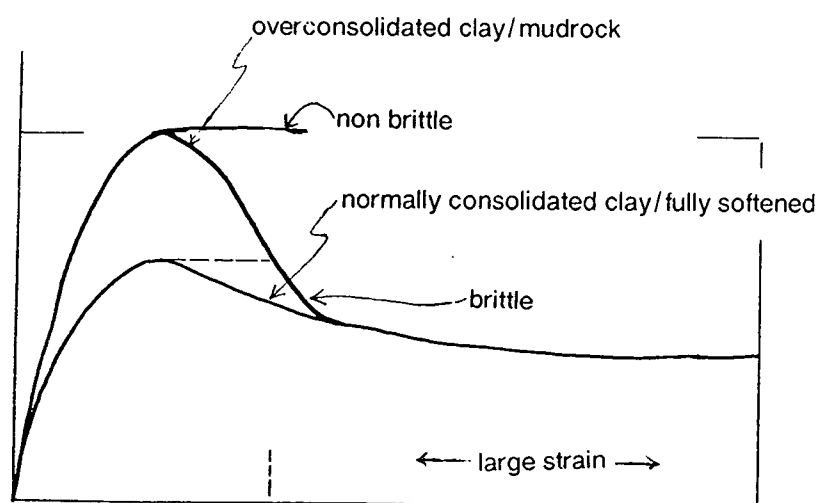
*Figure 4.1* Effective peak and residual shear strength parameters for progressively weathered mudrocks.

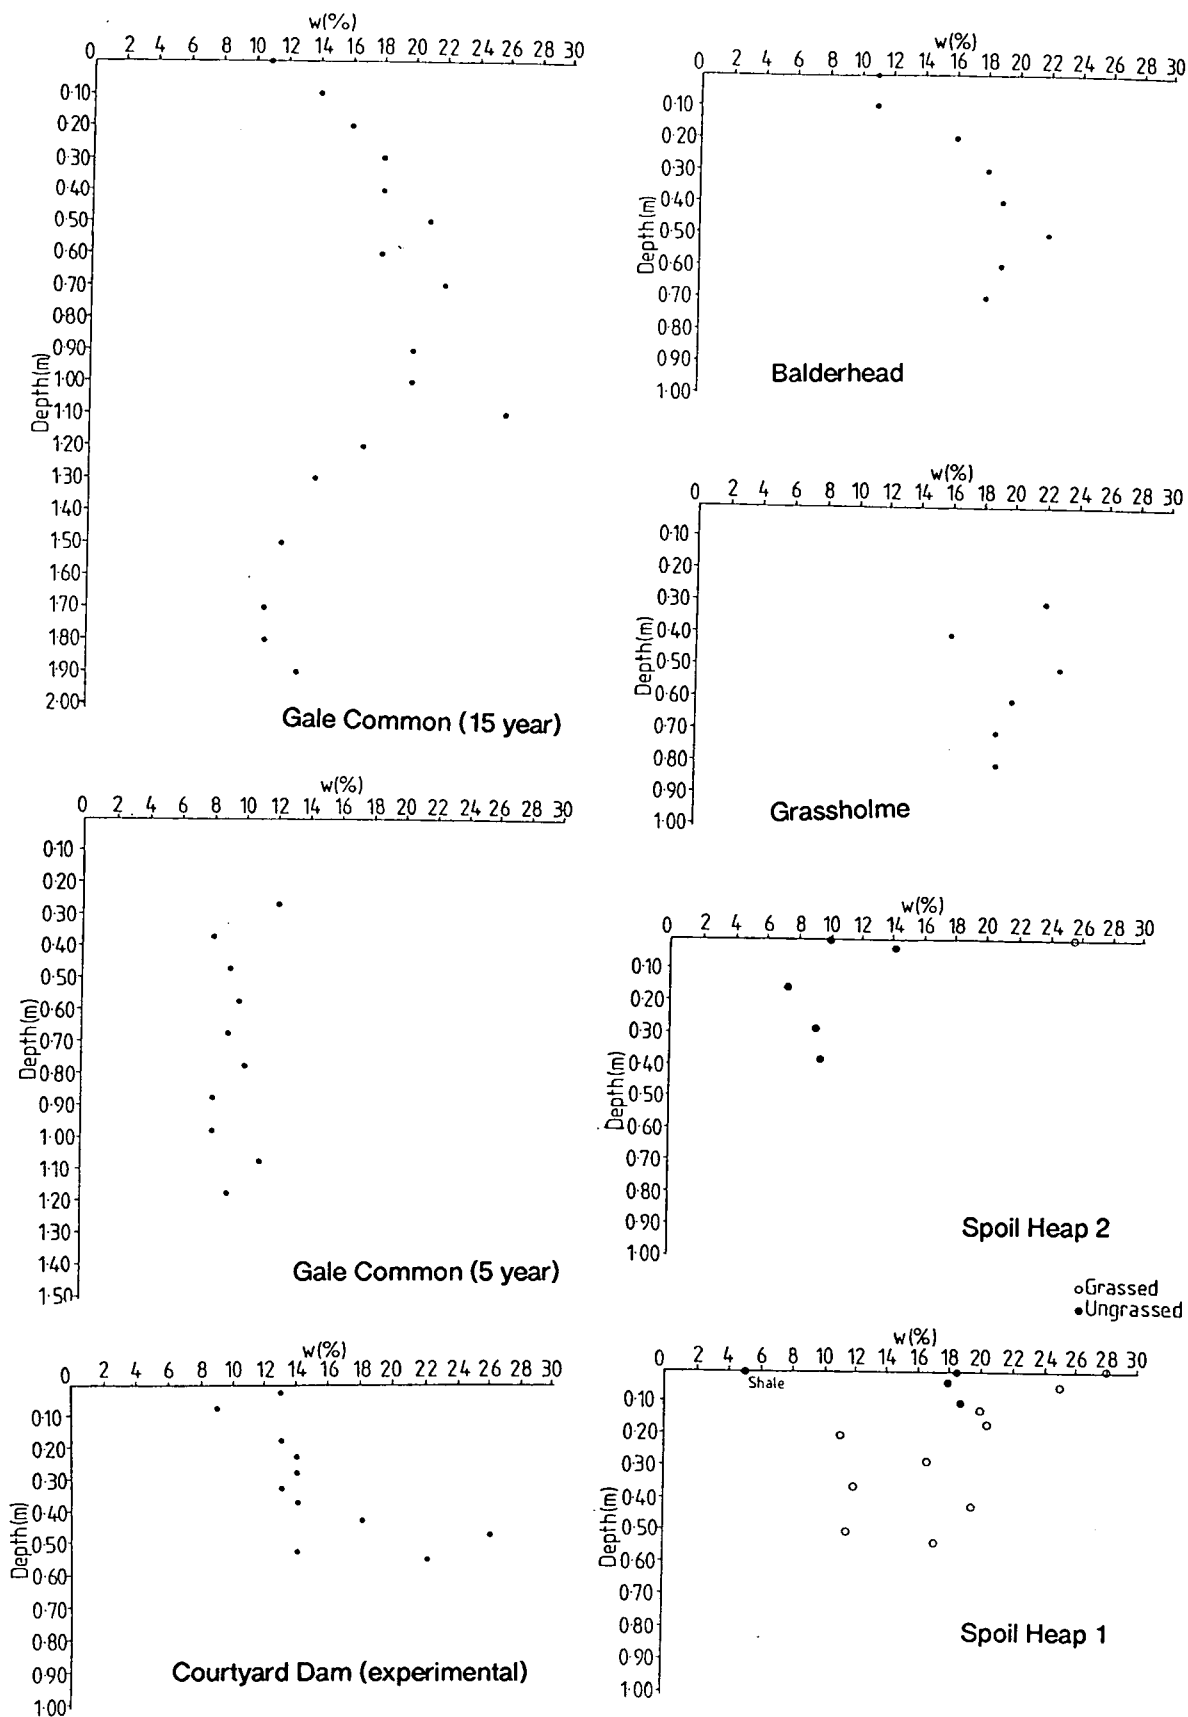
Figure 4.3 Moisture content – depth relationships.

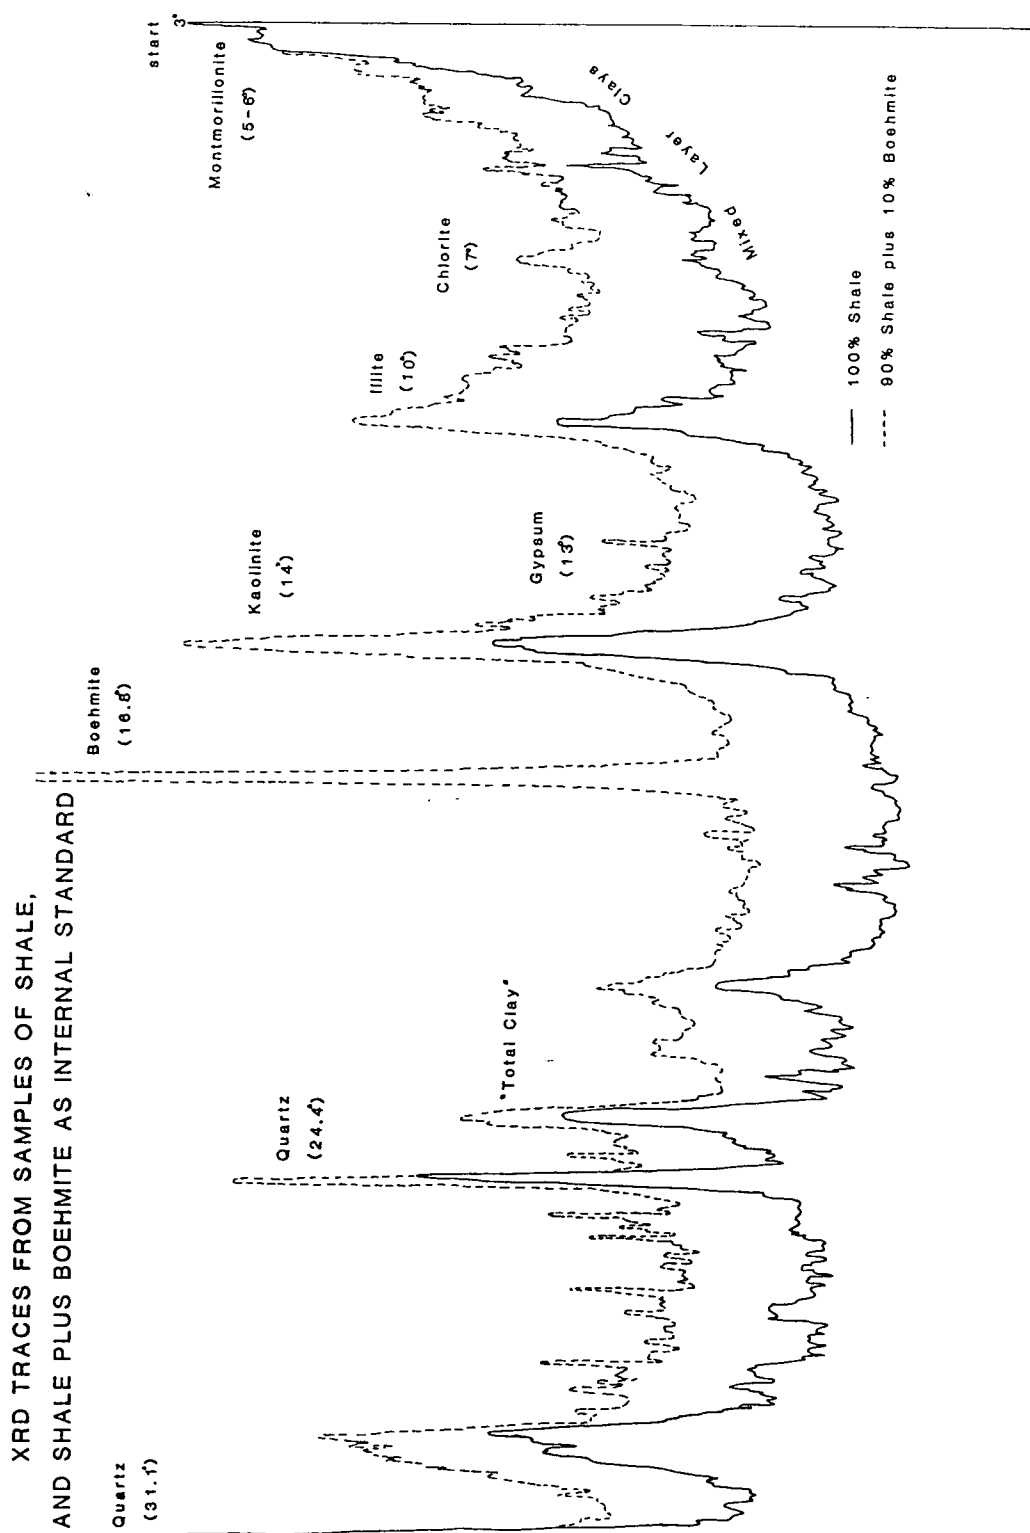
Figure 4.5 X-Ray diffractogram for Carboniferous shale with and without the addition of 10% boehmite.

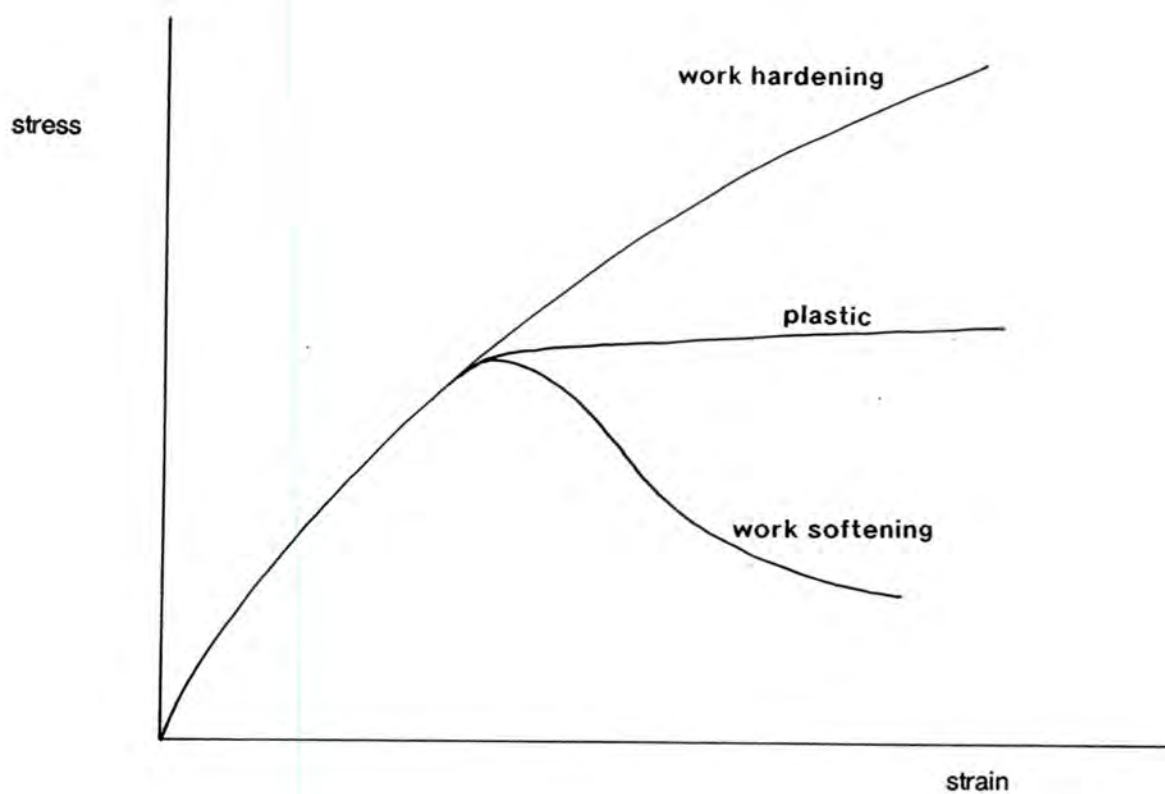
*Figure 5.1* Summary of post failure behaviour observed in different materials.

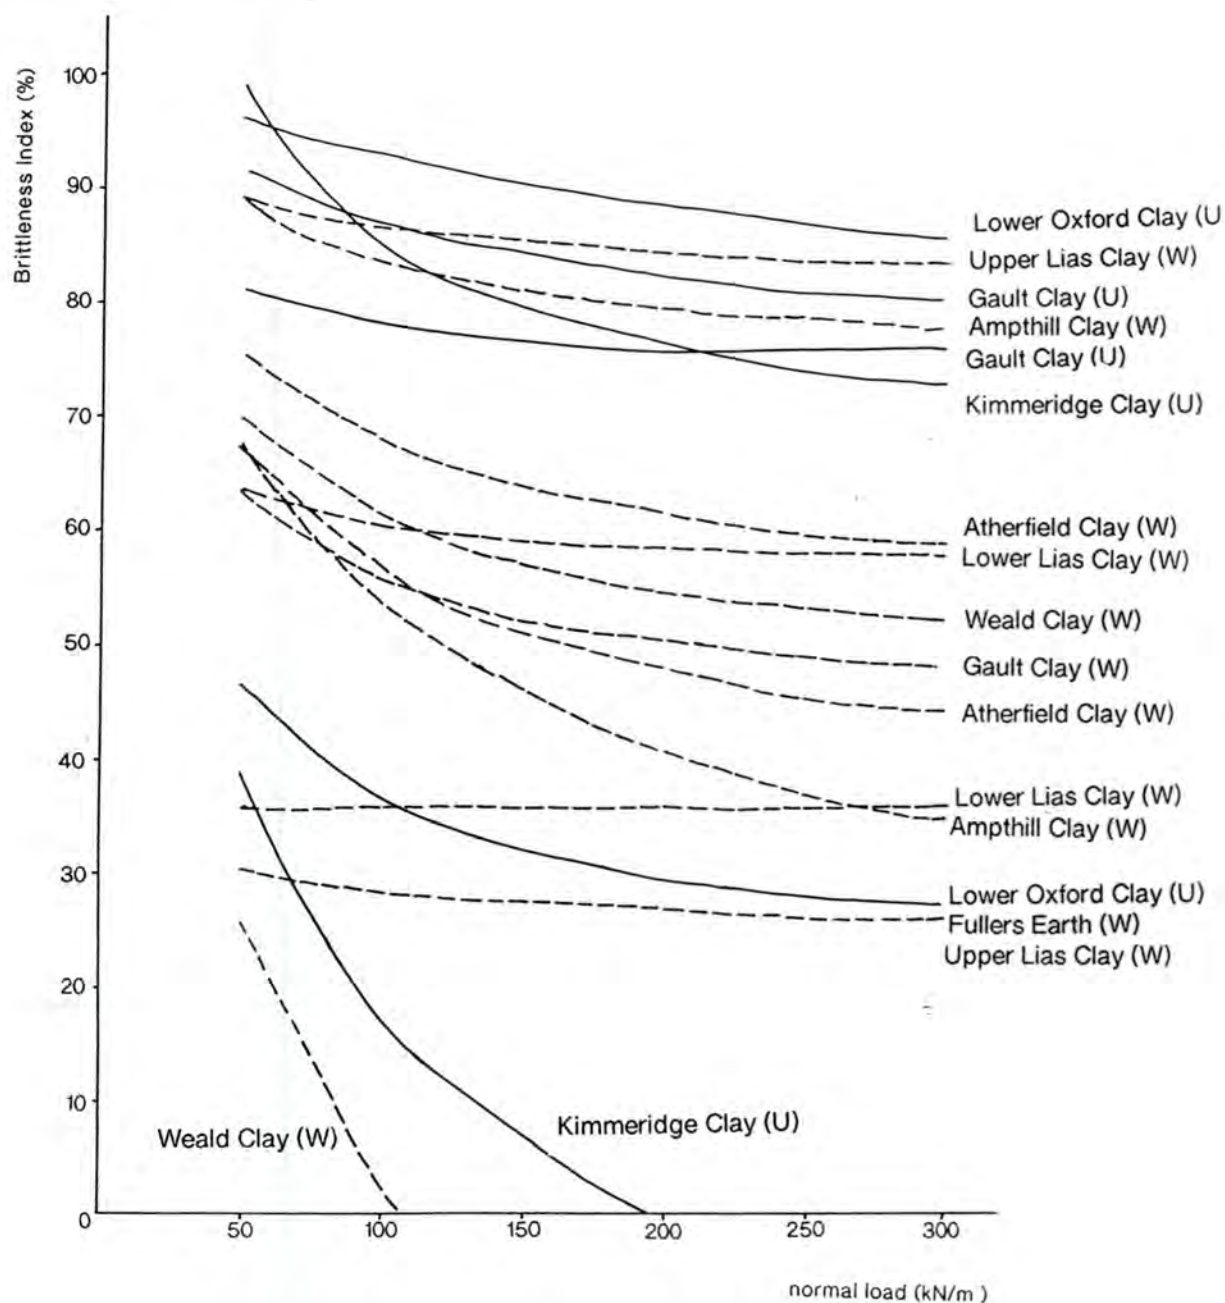
Figure 5.2 Brittleness index – normal load in Mesozoic overconsolidated clays and mudrocks.

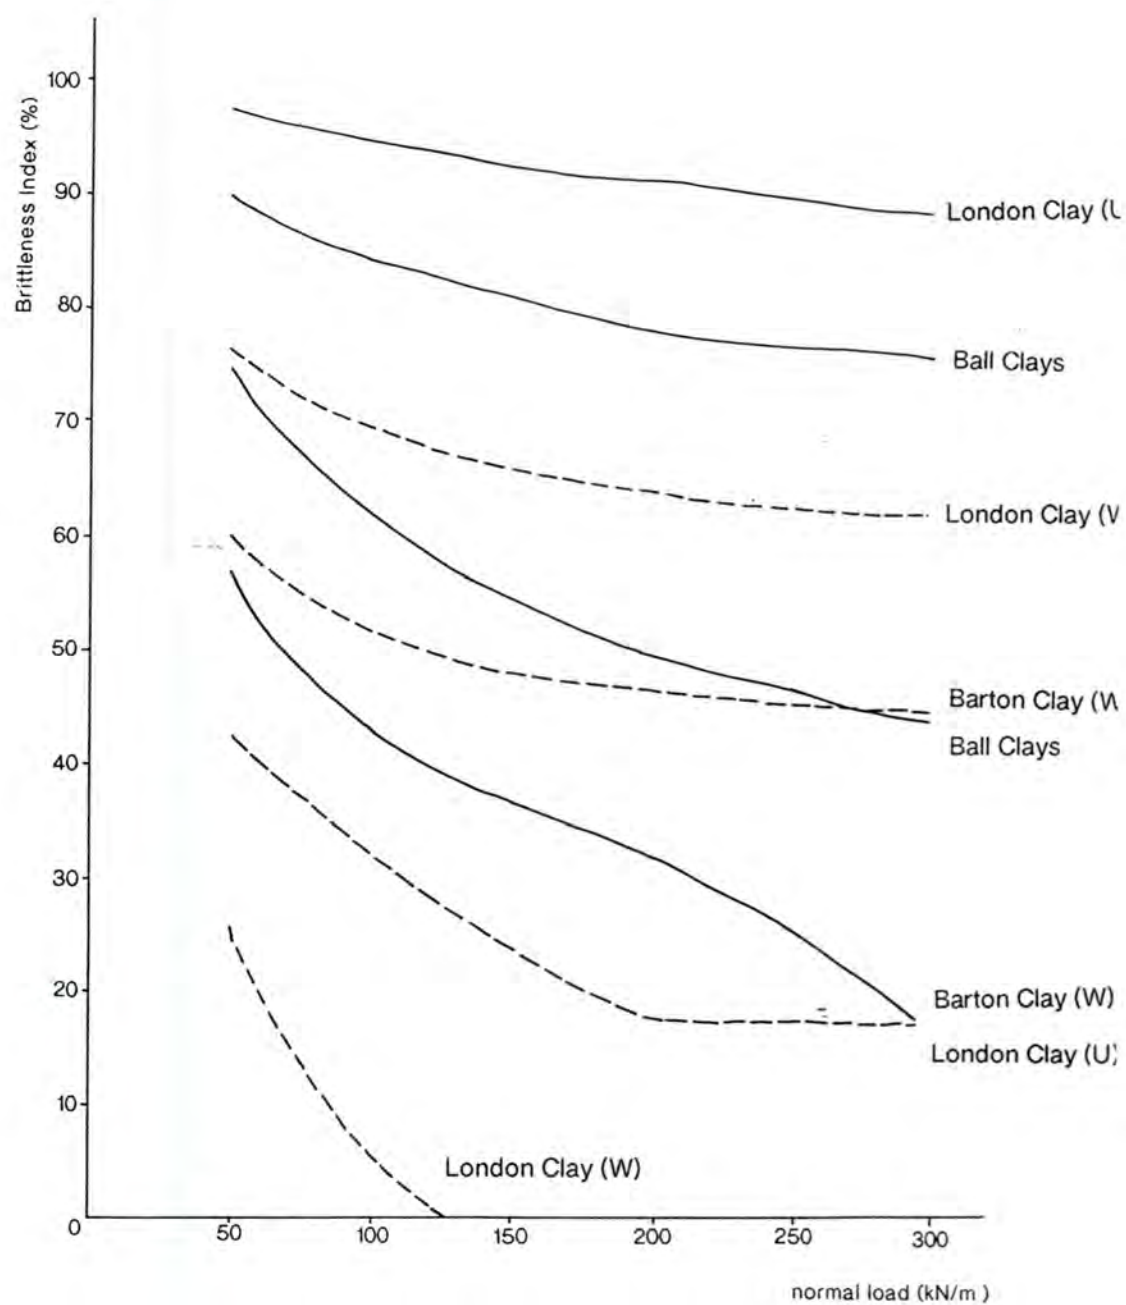
Figure 5.3 Brittleness index – normal load in Tertiary overconsolidated clays and mudrocks.

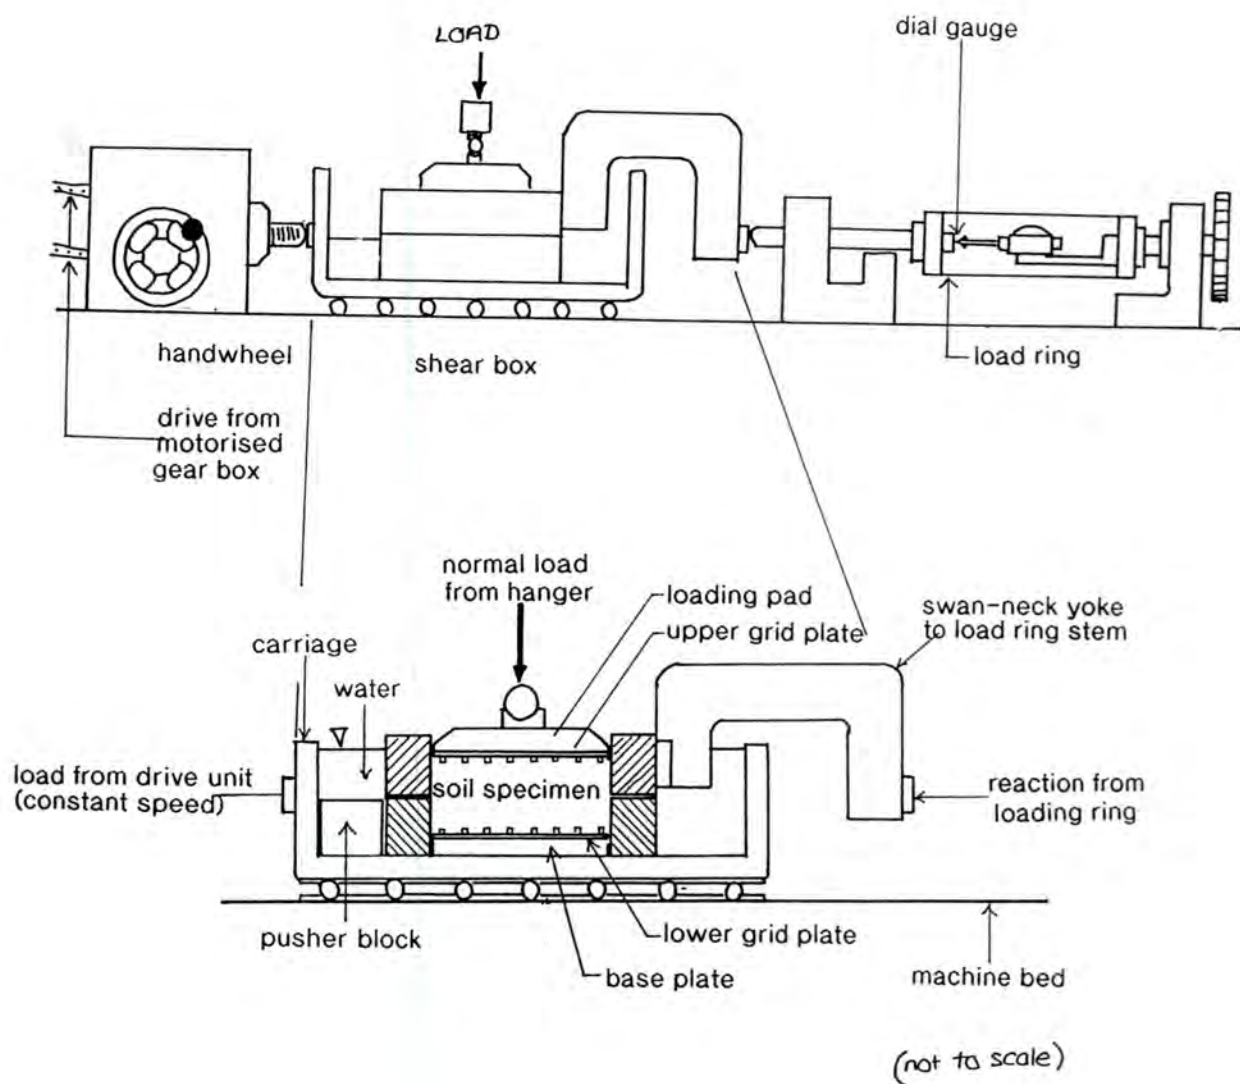
Figure 6.1: Basic design of shear strength apparatus

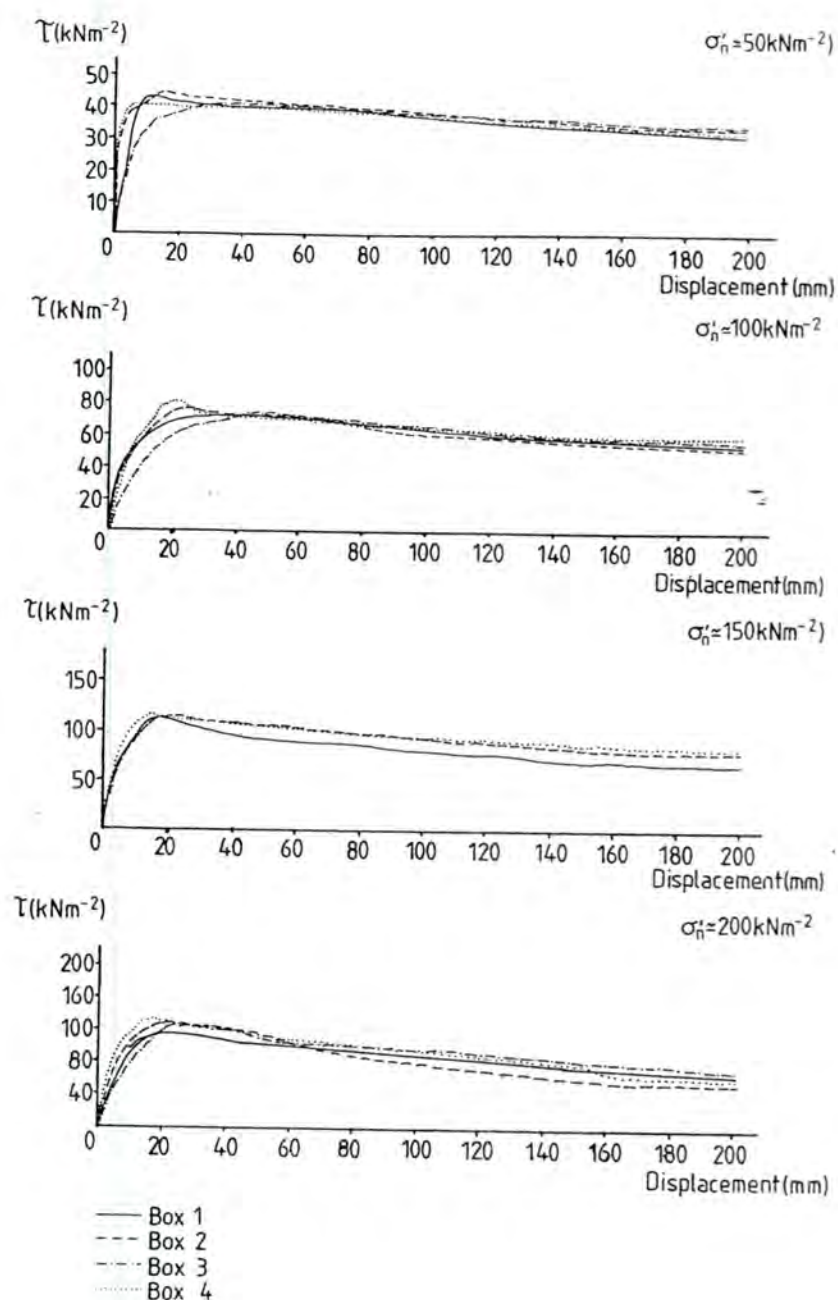
Figure 6.3 a – d: Shear stress – displacement curves: Coal Measures shale passing 2mm, at different normal loads. Tests to check precision of small shear boxes.

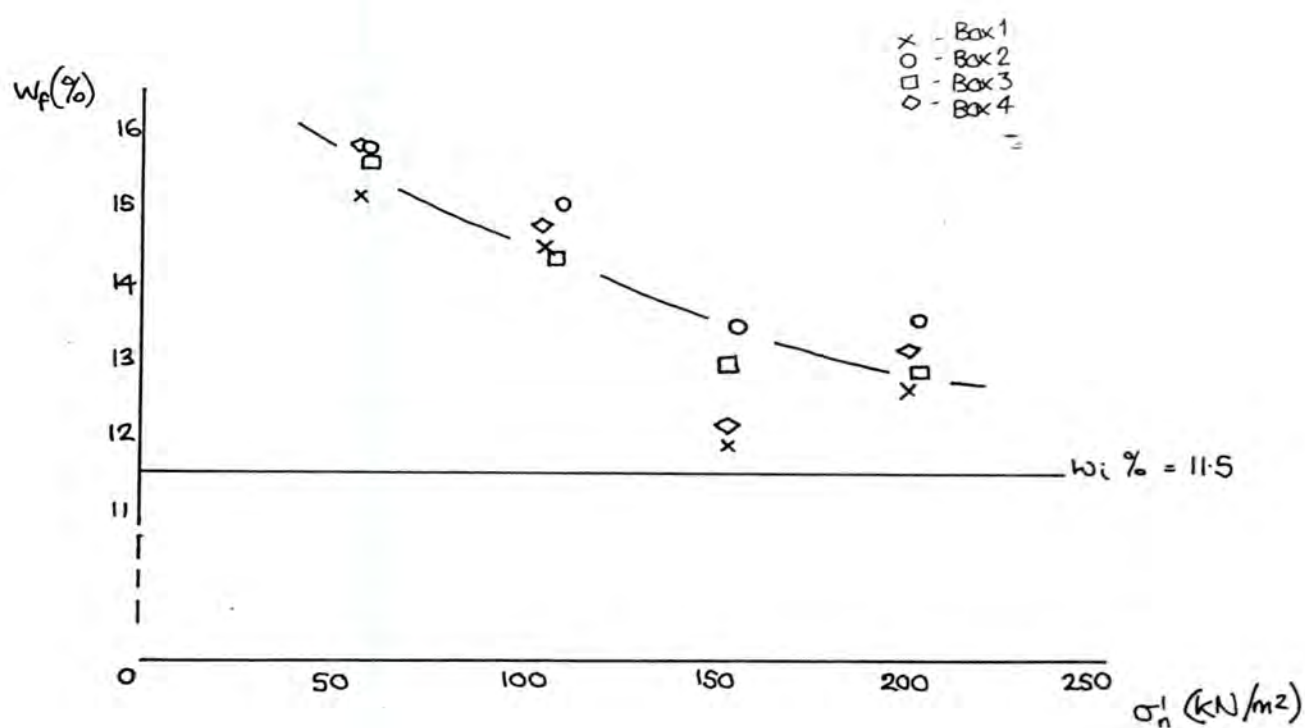
Figure 6.5: Initial and final moisture content: Coal Measures shale passing 2mm. Tests to check precision of small shear boxes.

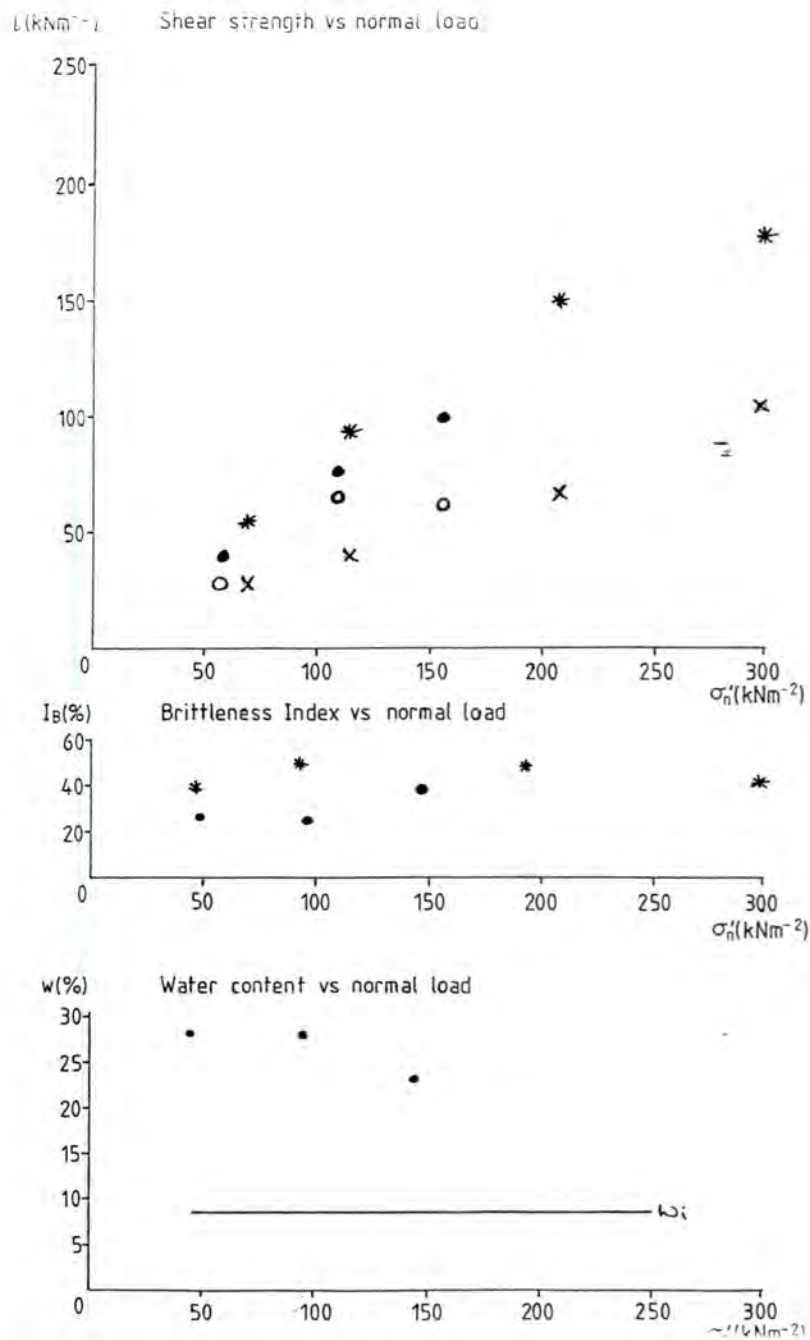
Figure 6.11: Shear stress – normal load, brittleness index – normal load and moisture content – normal load: Gale Common fresh shale.

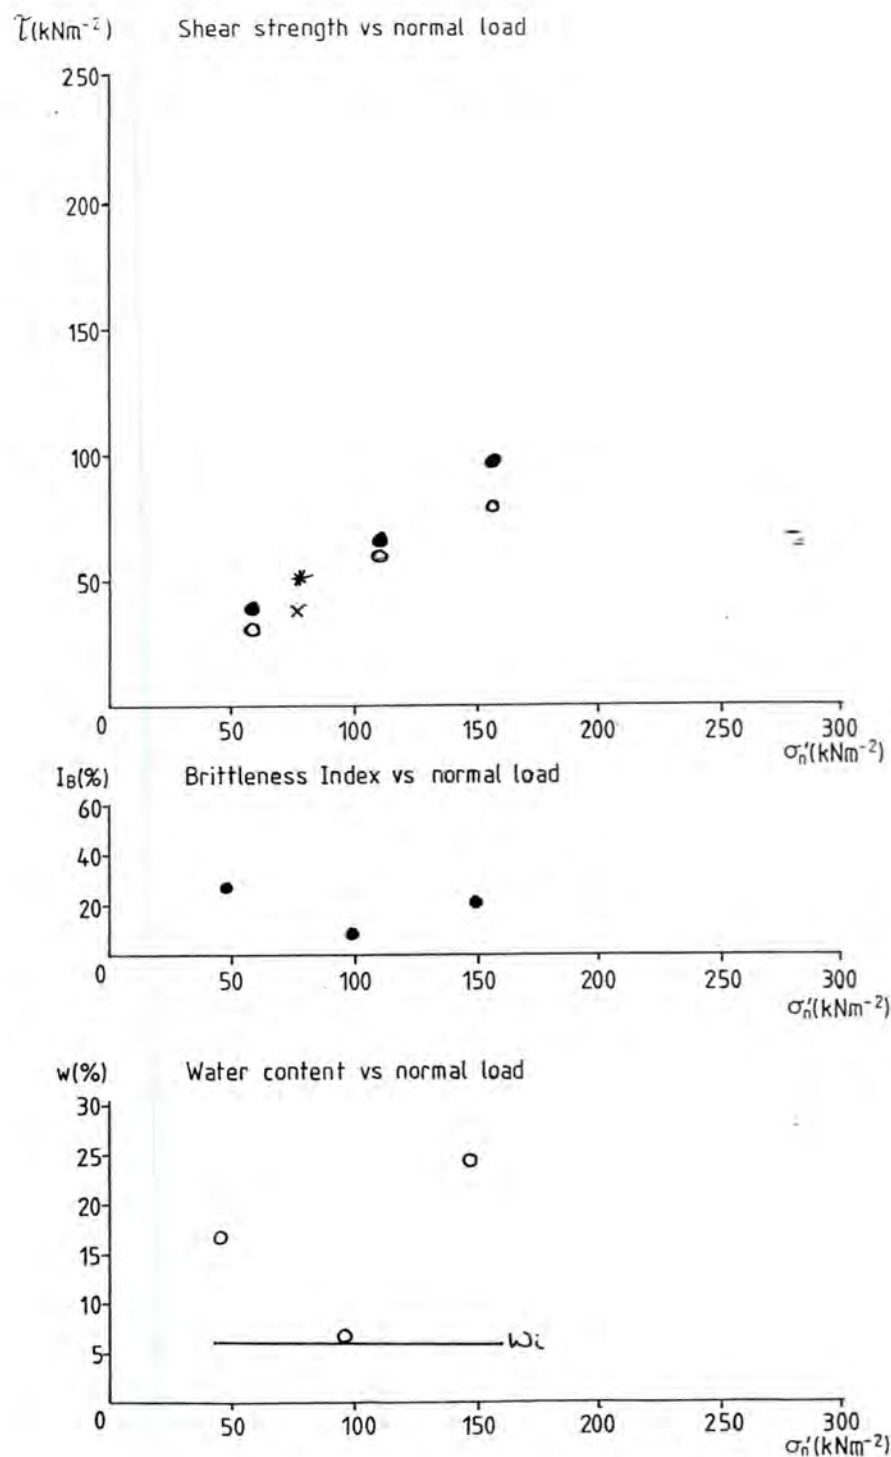
Figure 6.12: Shear stress – normal load, brittleness index – normal load and moisture content – normal load: Gale Common stockpiled shale.
