## *Weathering and brittleness in shale fill dams and embankments*

# **WEATHERING AND BRITTLENESS IN SHALE FILL DAMS AND EMBANKMENTS.**

A thesis presented for the degree of Master of Science  
in the University of Durham.

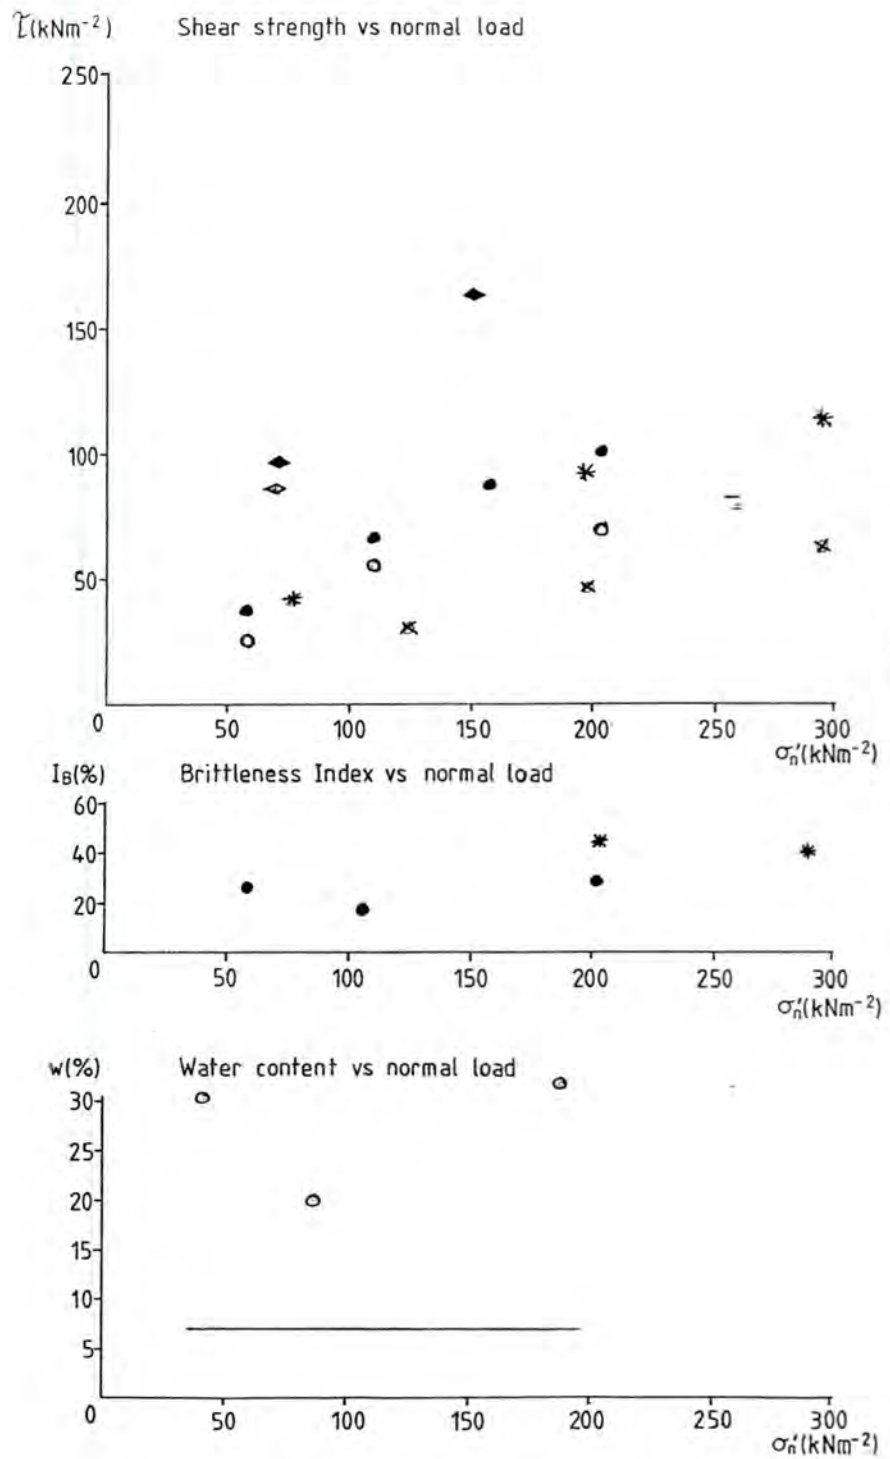
Figure 6.13: Shear stress – normal load, brittleness index – normal load and moisture content – normal load: Gale Common five year weathered shale.

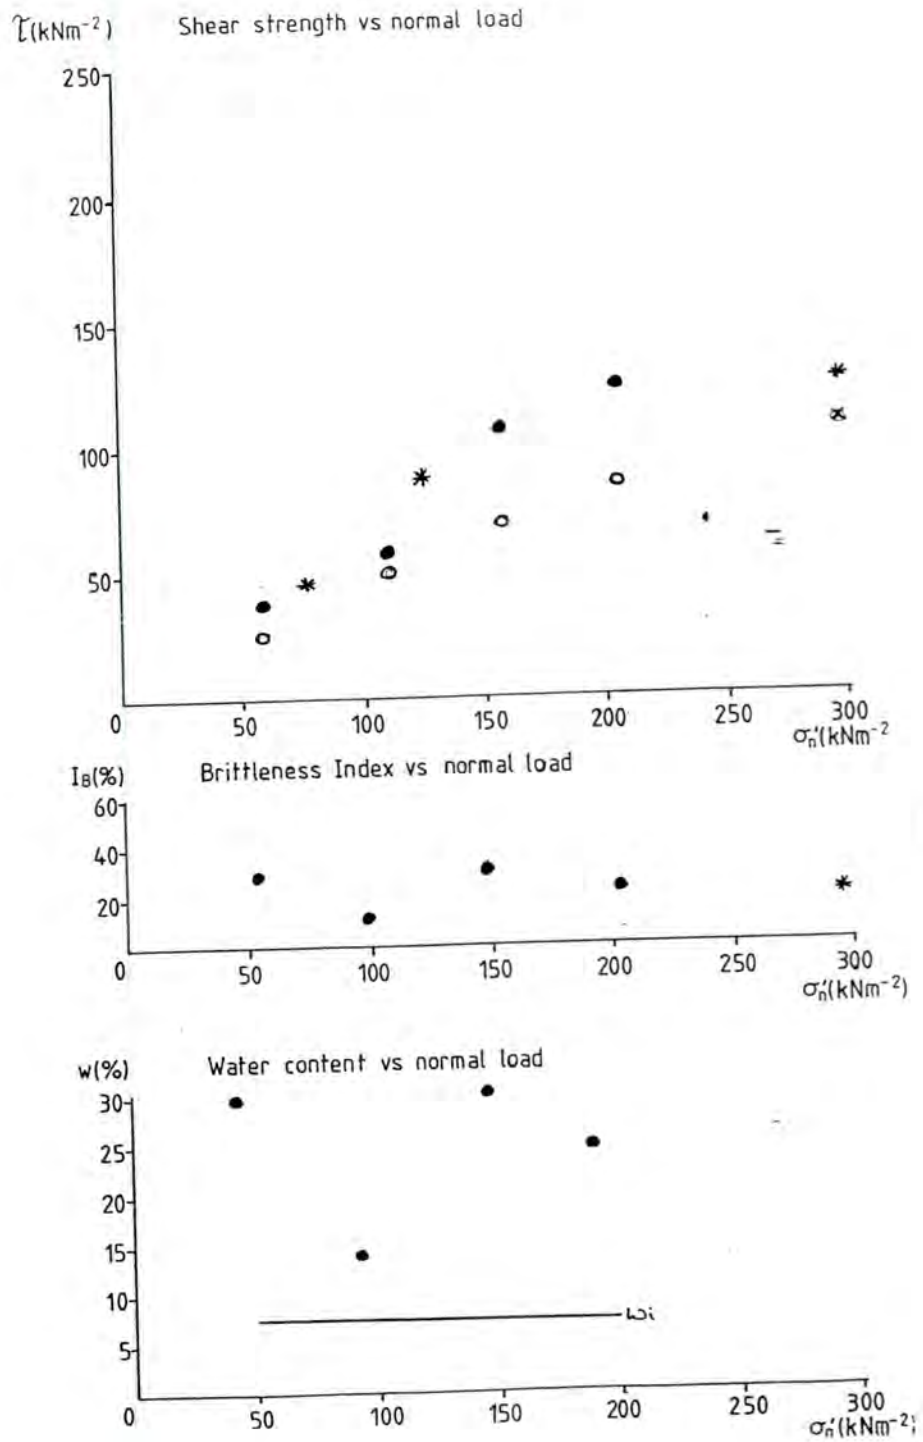
Figure 6.14: Shear stress – normal load, brittleness index – normal load and moisture content – normal load: Gale Common fifteen year weathered shale.

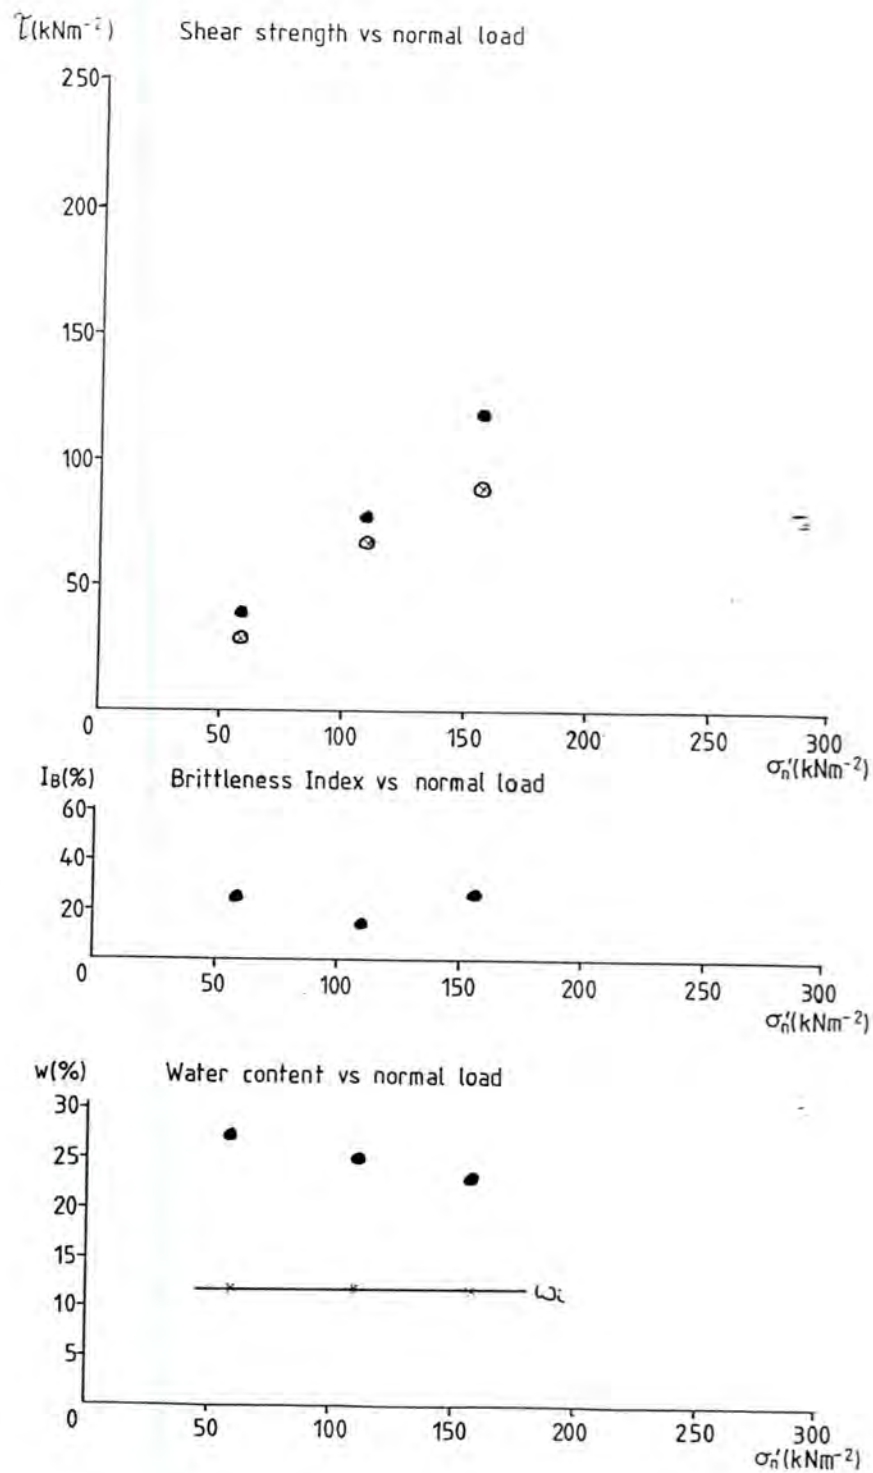
Figure 6.15: Shear stress – normal load, brittleness index – normal load and moisture content – normal load: Grassholme Dam.

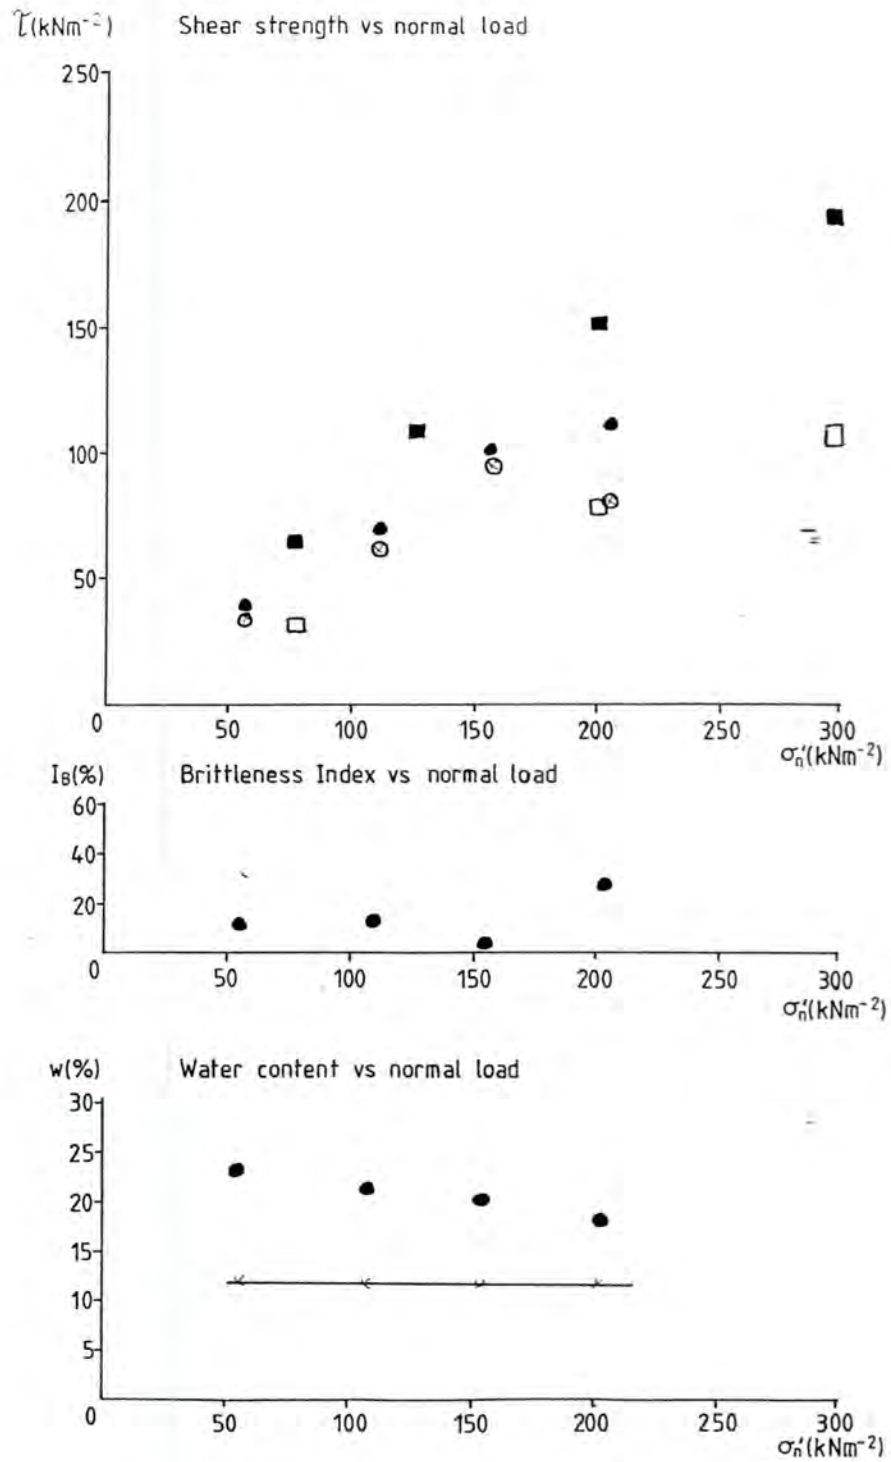
Figure 6.16: Shear stress – normal load, brittleness index – normal load and moisture content – normal load: Balderhead Dam.

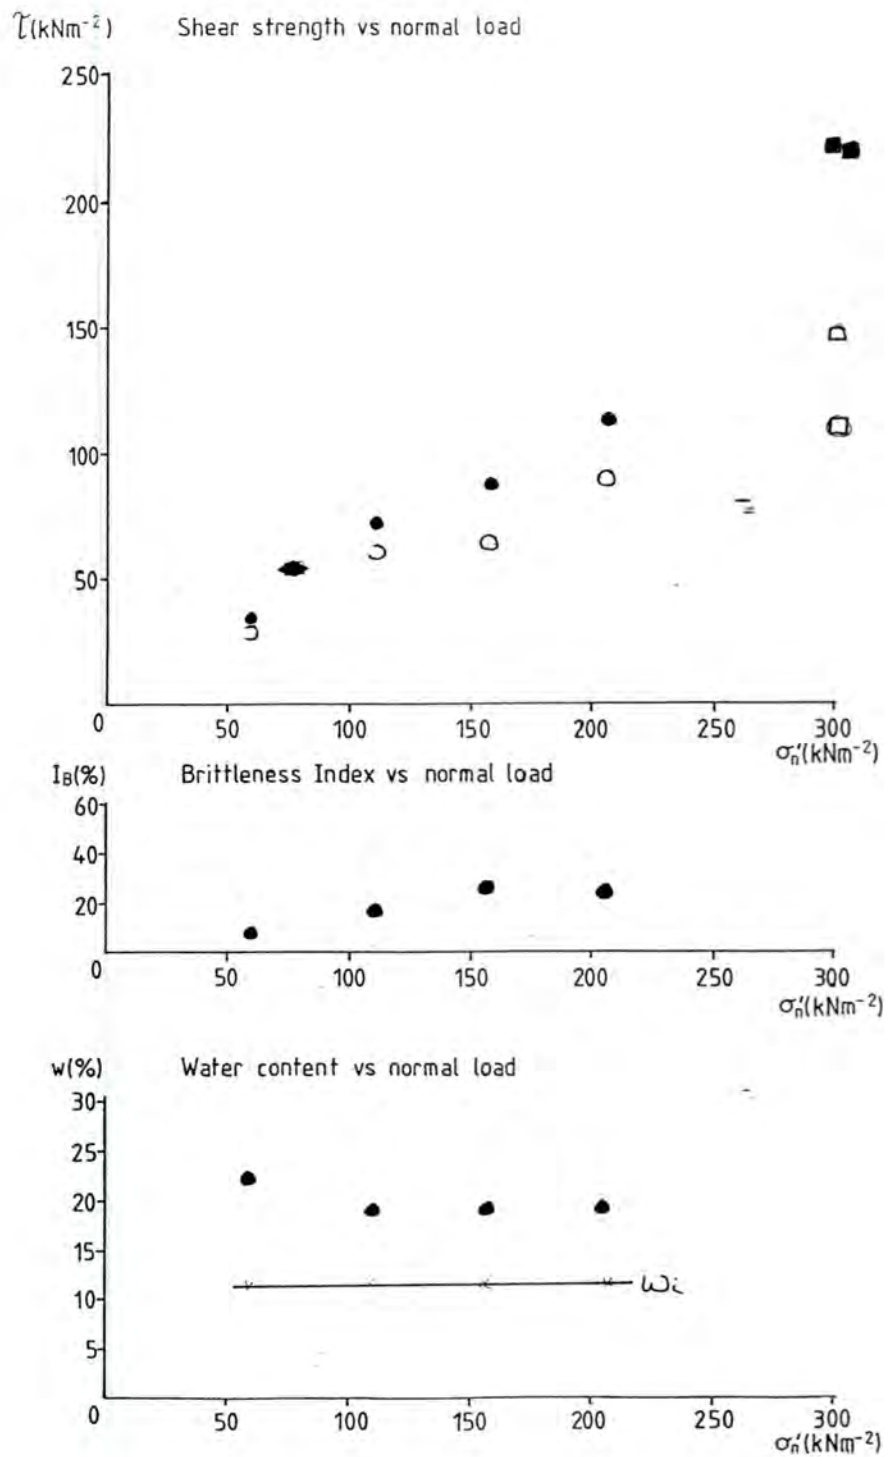
Figure 6.17: Shear stress – normal load, brittleness index – normal load and moisture content – normal load: Grassholme – Hury tunnel spoil heaps.

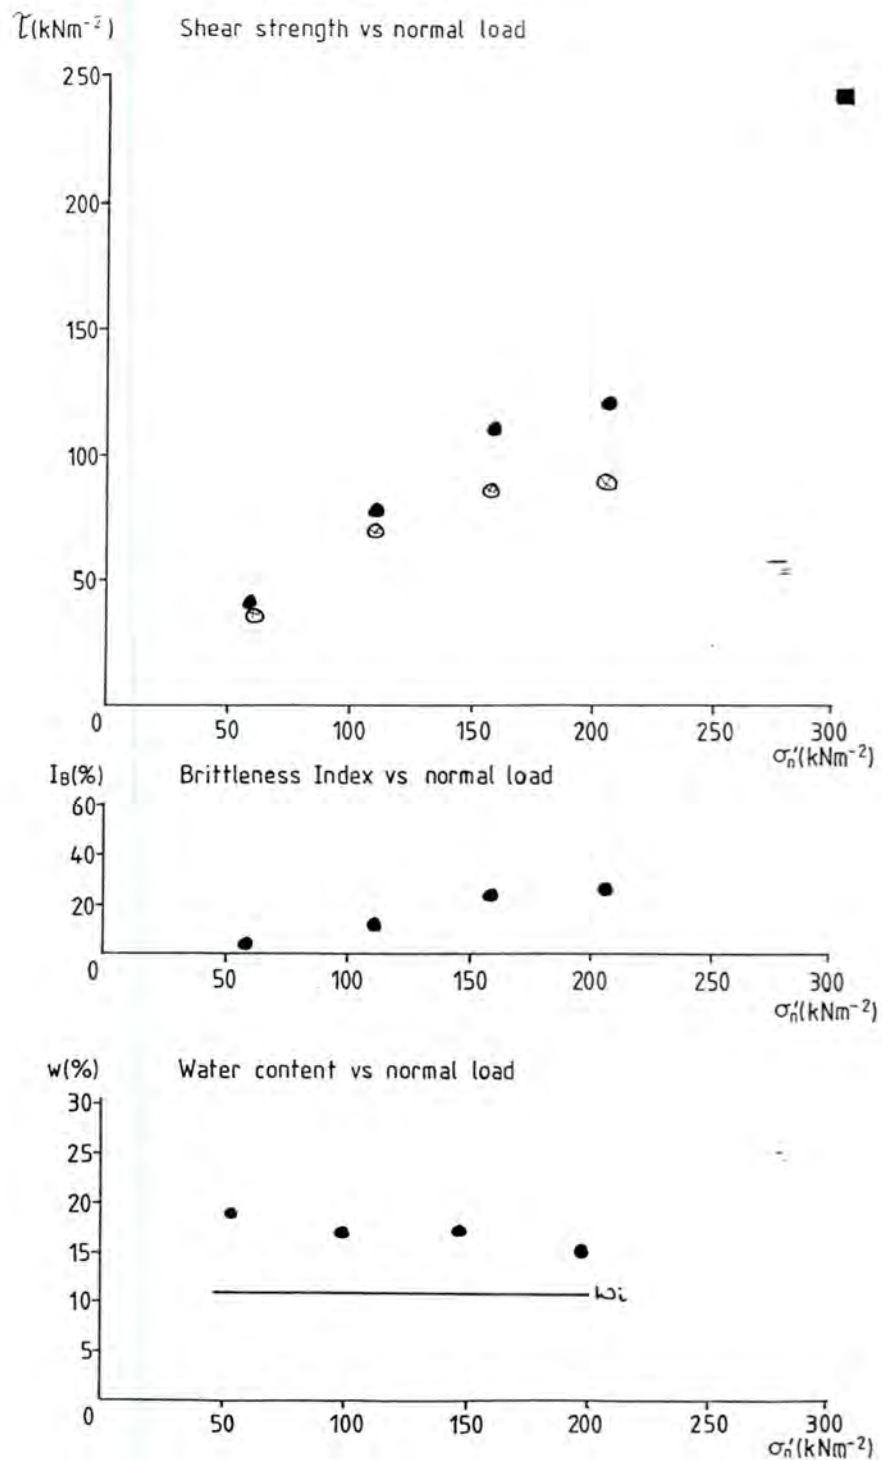
Figure 6.18: Shear stress – normal load, brittleness index – normal load and moisture content – normal load: Burnhope Dam

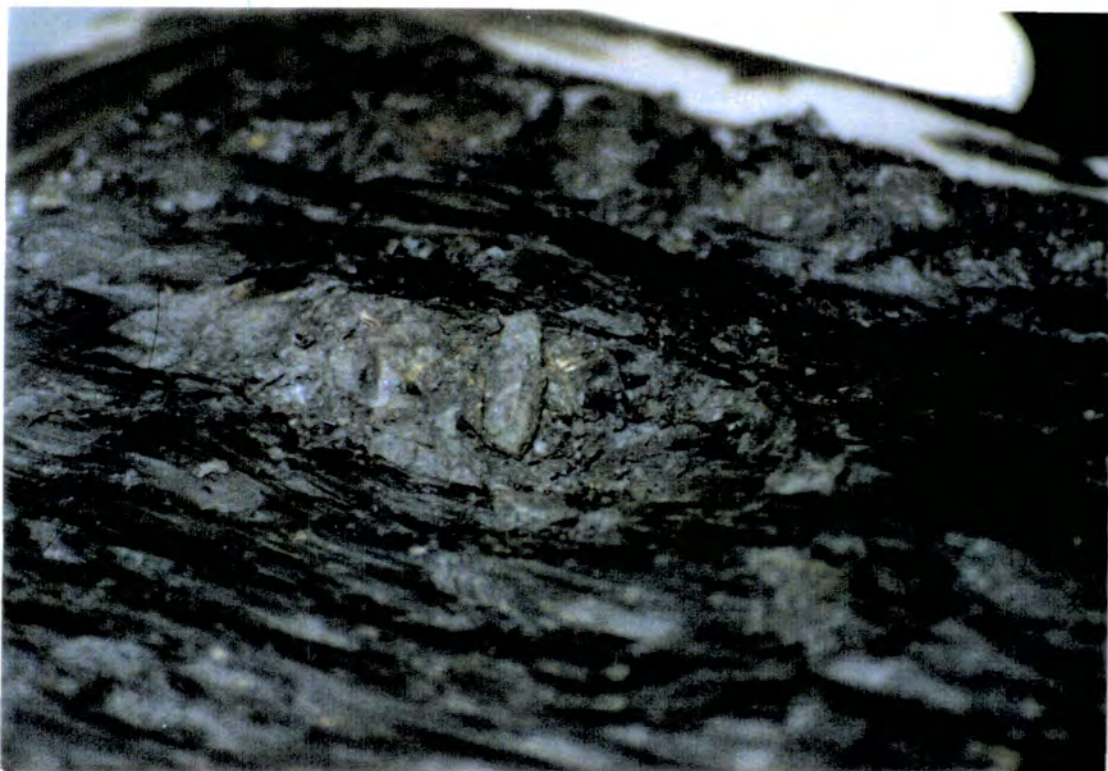
*Plate 6.3:* Interruption of shear plane by large clast in shear box test (undisturbed sample, Gale Common 5 year weathered shale)

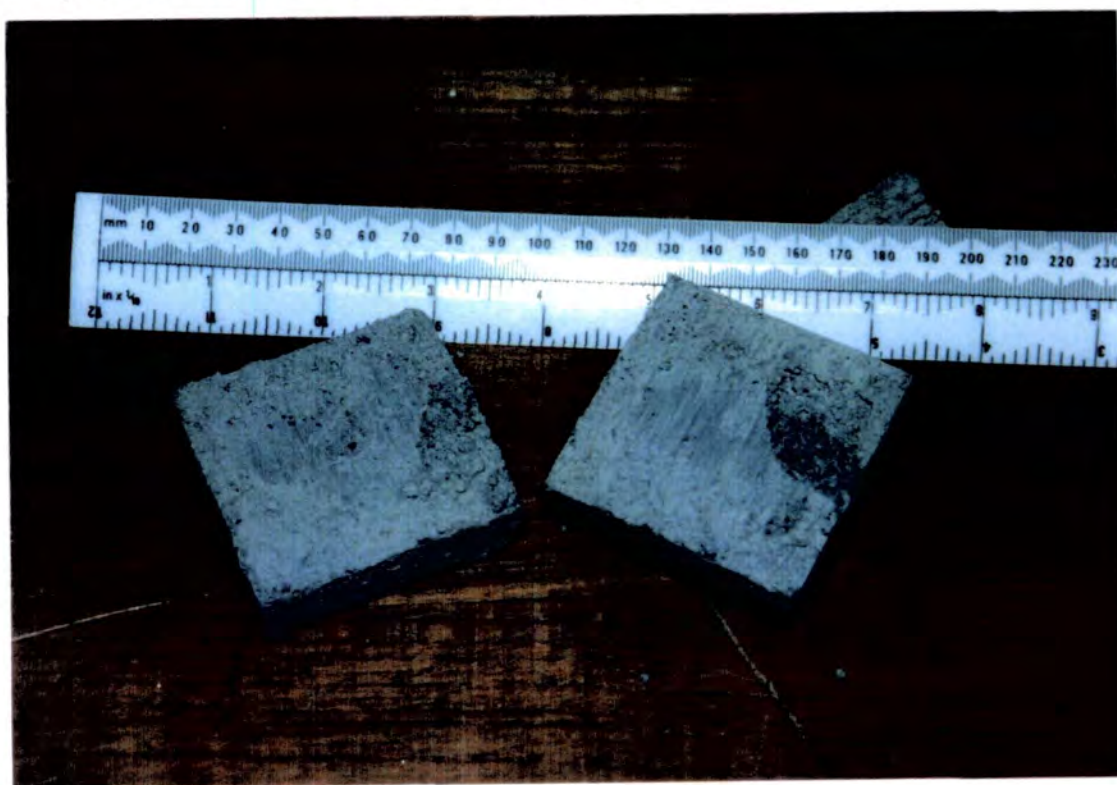
*Plate 6.4:* Sample from small shear box split after testing to reveal shear plane (Coal Measures shale passing 2mm sieve).

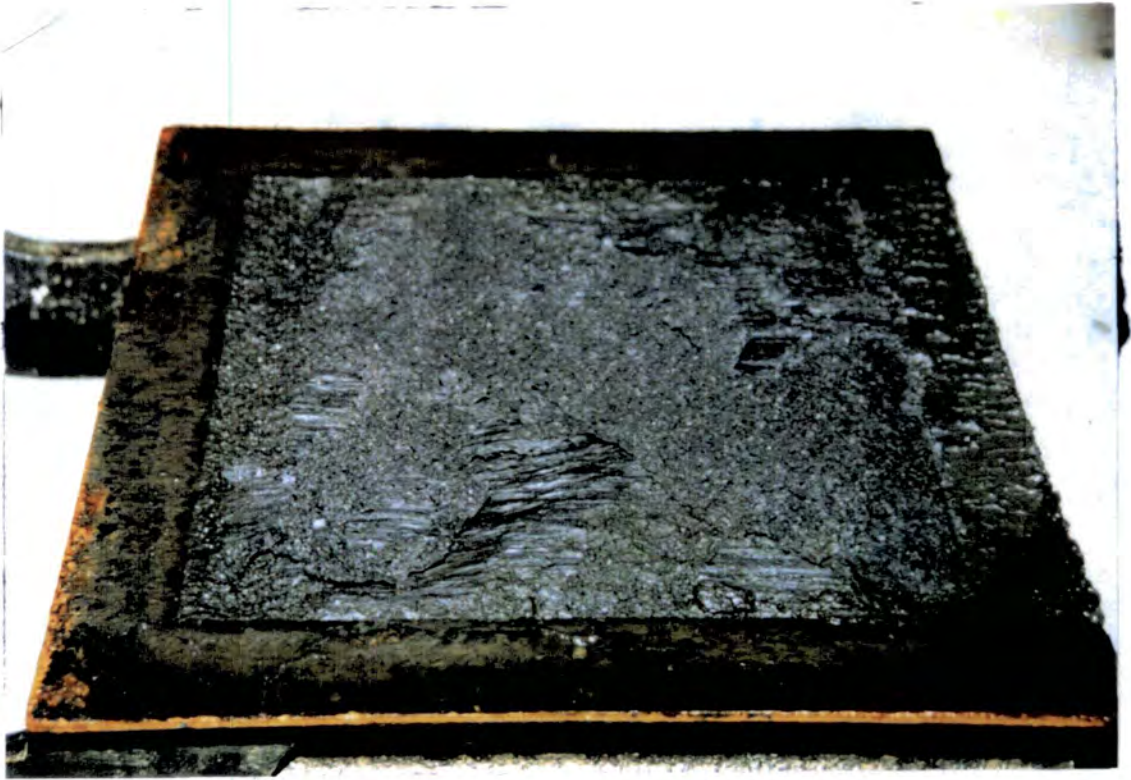
*Plate 6.5:* Shear plane from large shear box test (fresh Coal Measures shale passing 2mm sieve).

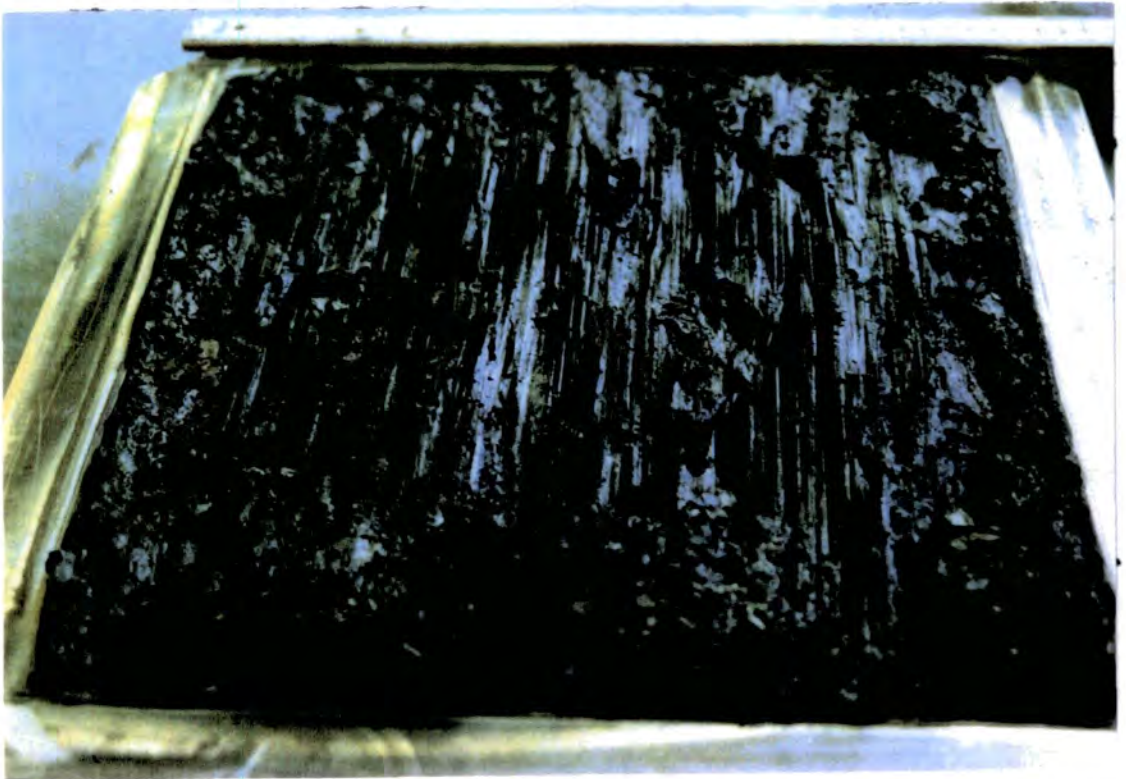
*Plate 6.6:* Shear plane from large shear box test (Gale Common 15 year weathered shale passing 20mm sieve)

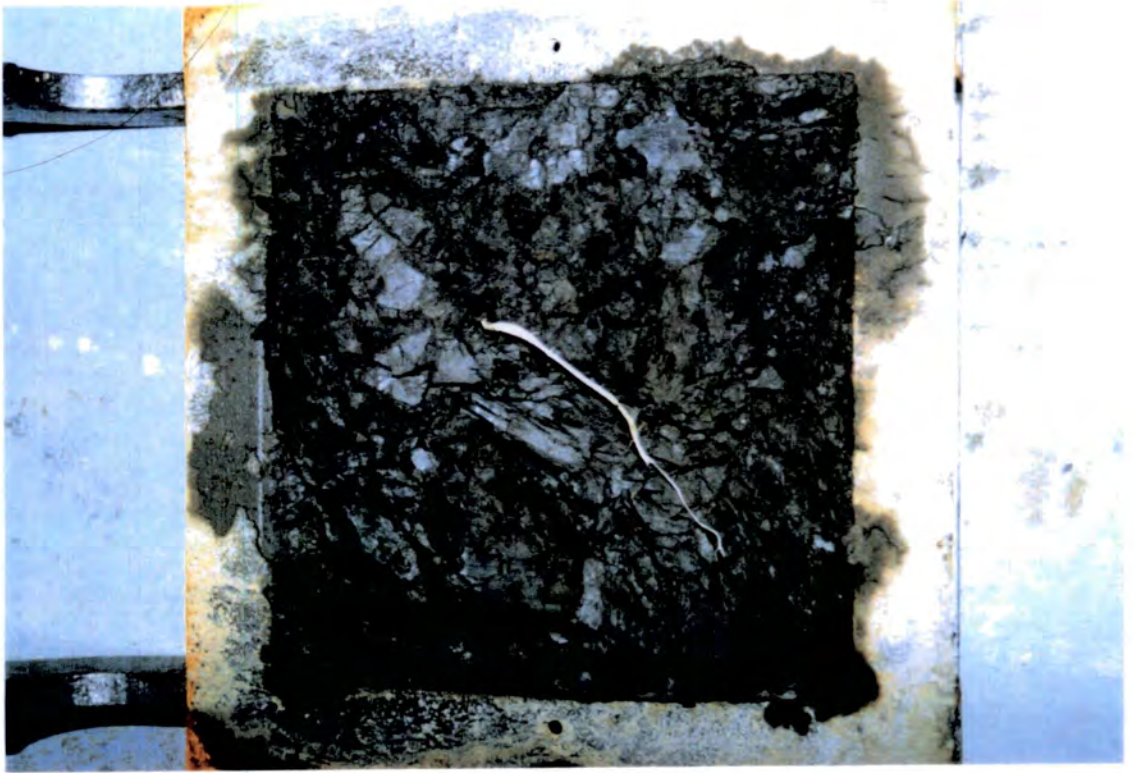
*Plate 6.7:* Shear plane from large shear box test (undisturbed Namurian shale from Grassholme Hury tunnel spoil heap).

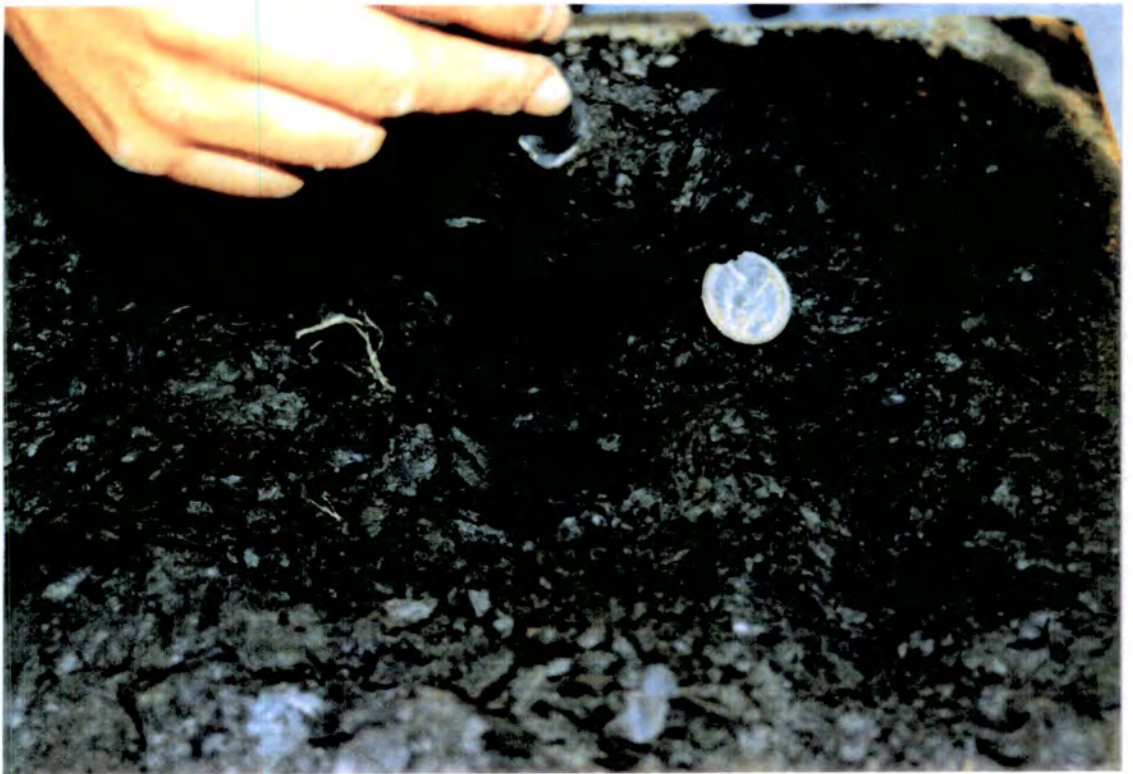
*Plate 6.8:* Close up of shear plane from Plate 6.7.

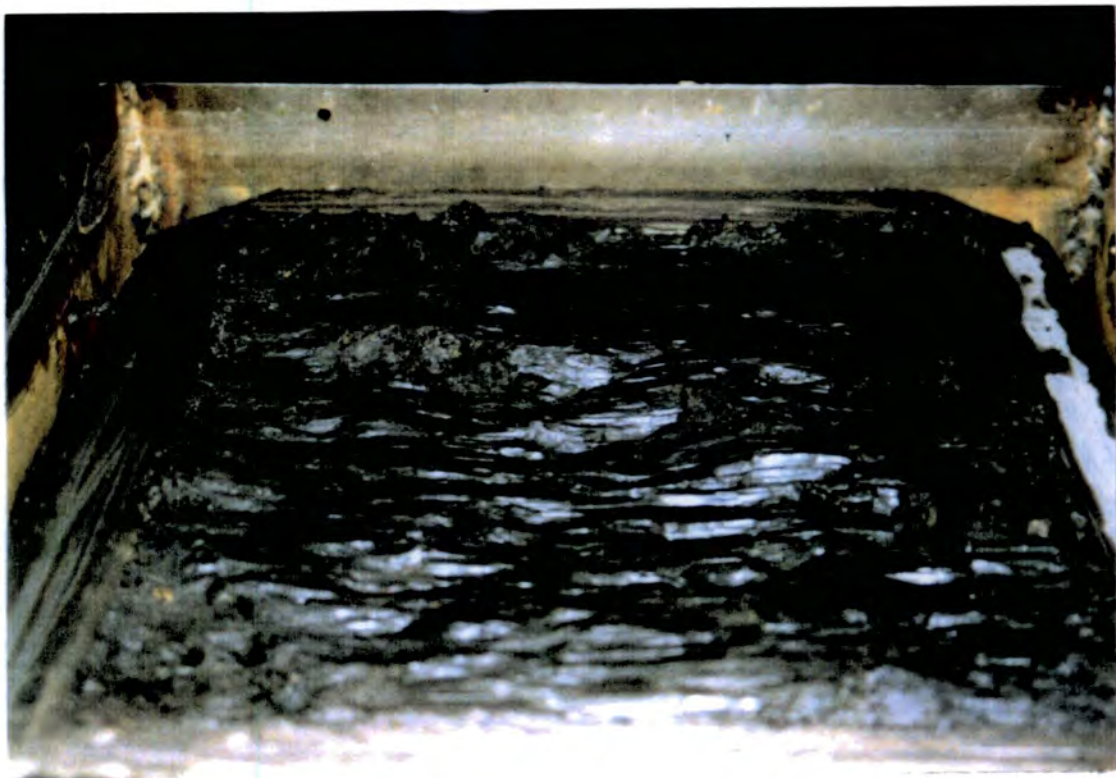
*Plate 6.9:* Shear plane in undisturbed sample of Namurian shale showing distortion of plane by large clasts.

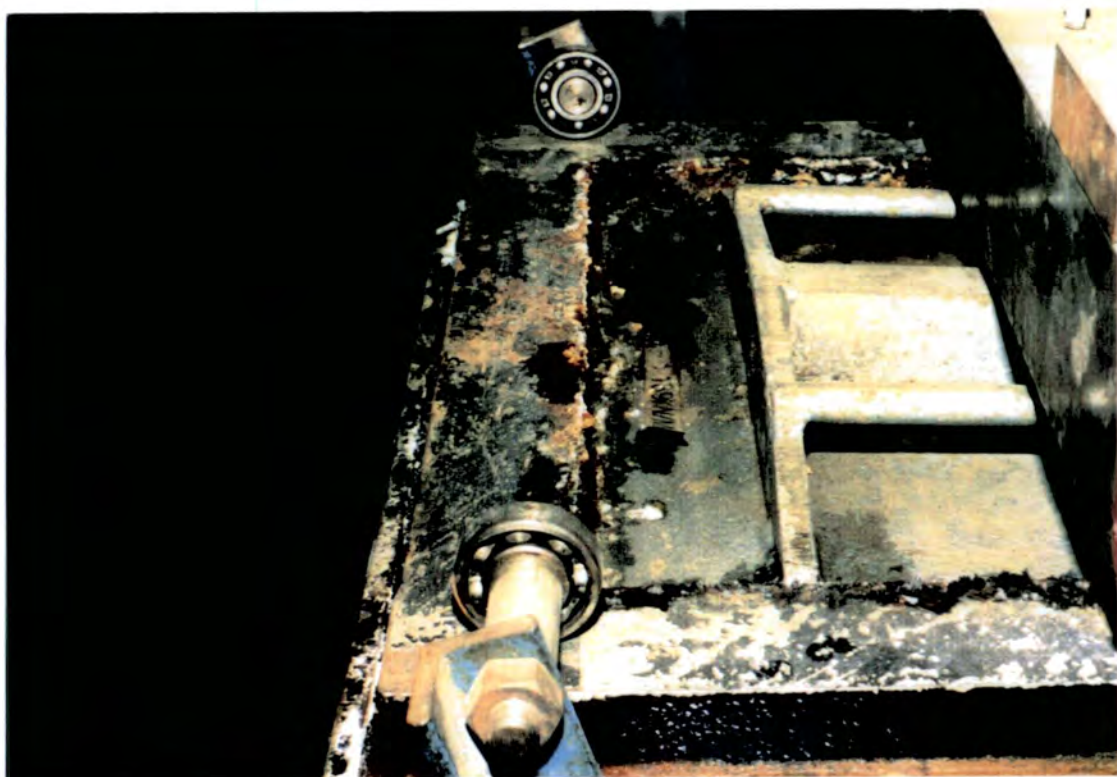
*Plate 6.10:* Crystalline growths around box lid observed during large shear box test (Gale Common 5 year weathered shale).

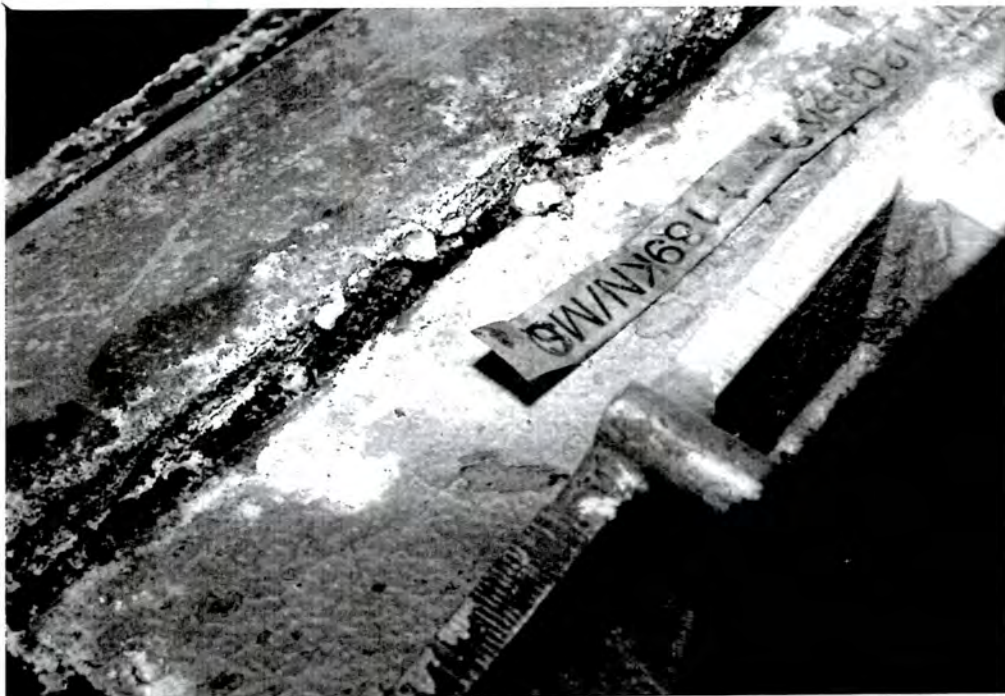
*Plate 6.11:* Close up of crystalline growth shown in Plate 6.10.

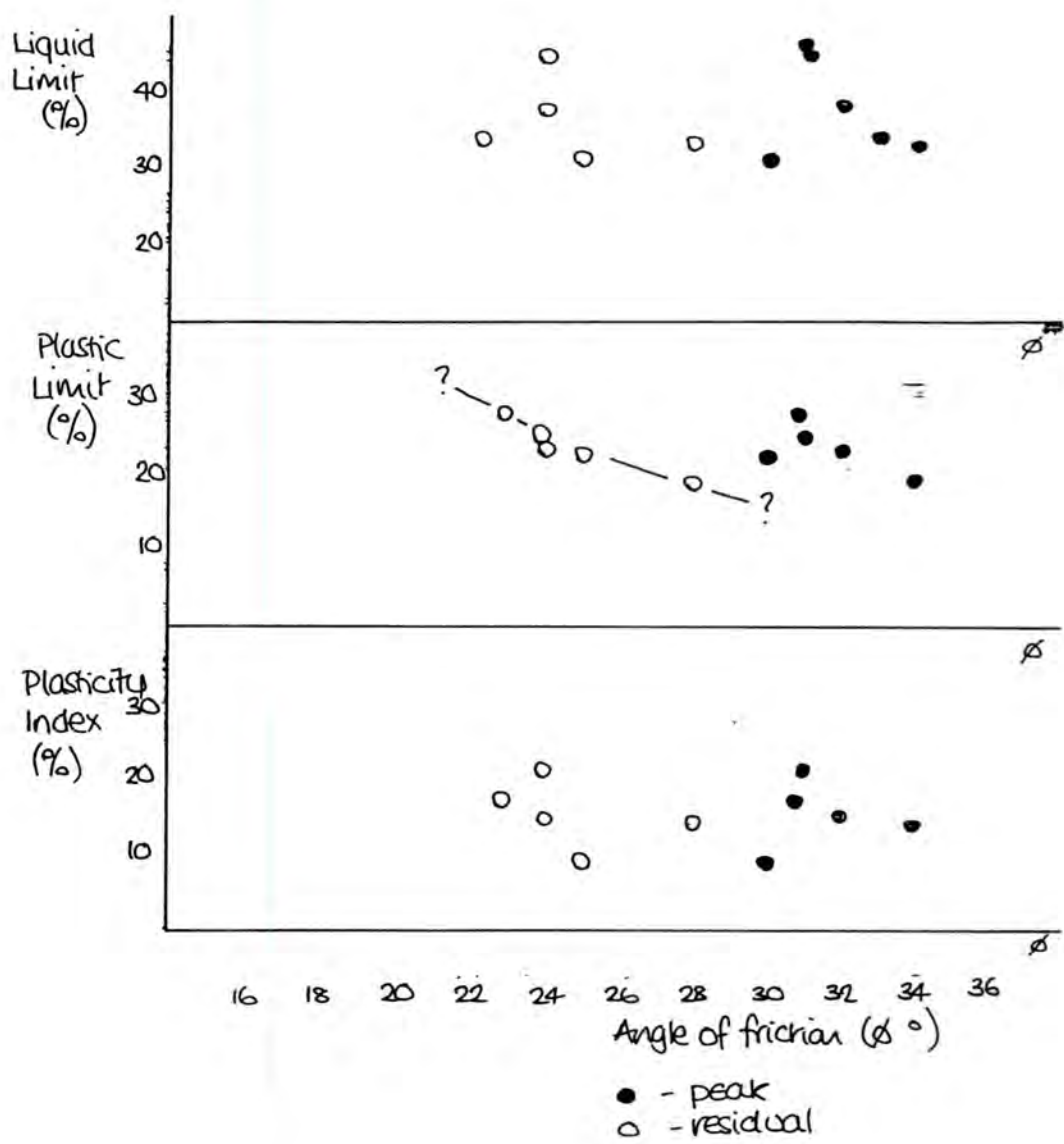
Figure 7.1 : Relationship between shear strength and other geotechnical data.

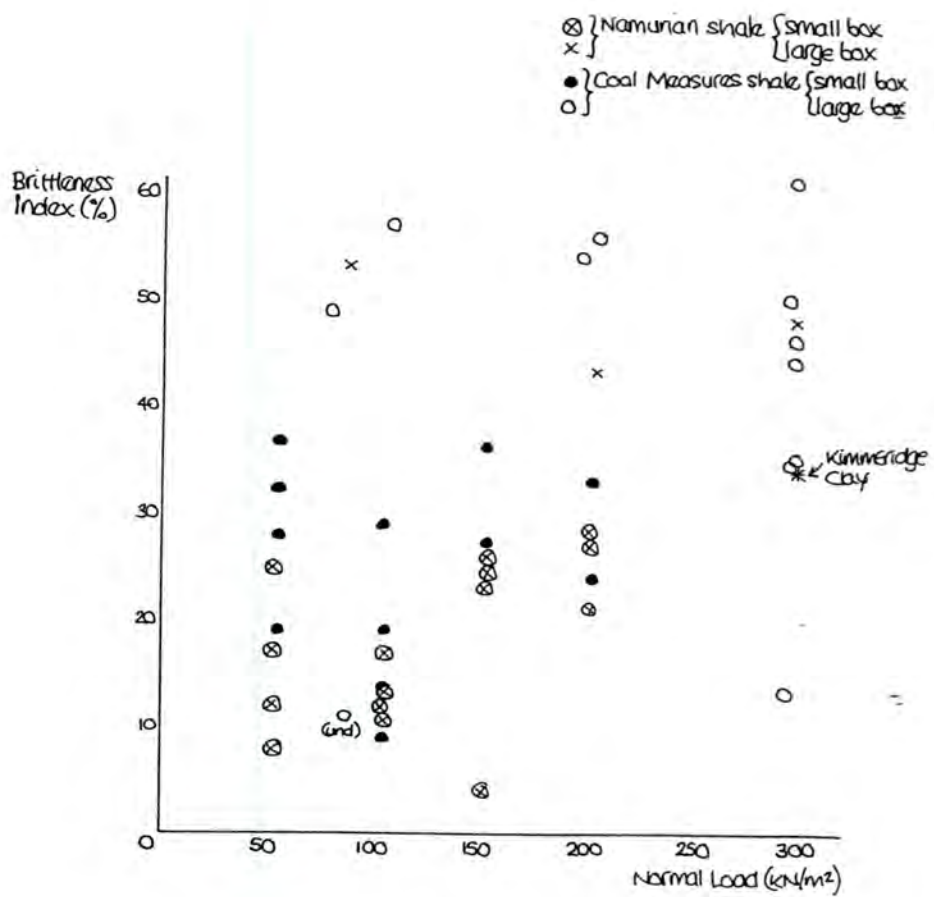
Figure 7.4 : Summary of brittleness data for all samples tested.
